Re: Defect Information Report (FL-467), NHTSA 05V-551

**Section 573.6 Non-Compliance Information Report
FL-467, Front Axle I-Beam; NHTSA no. 05V-551
Supplement No.: 6**

Subject: AAC Front Axle I-Beams

August 2006
FL467A-F
NHTSA #05V-551
REVISED NOTICE

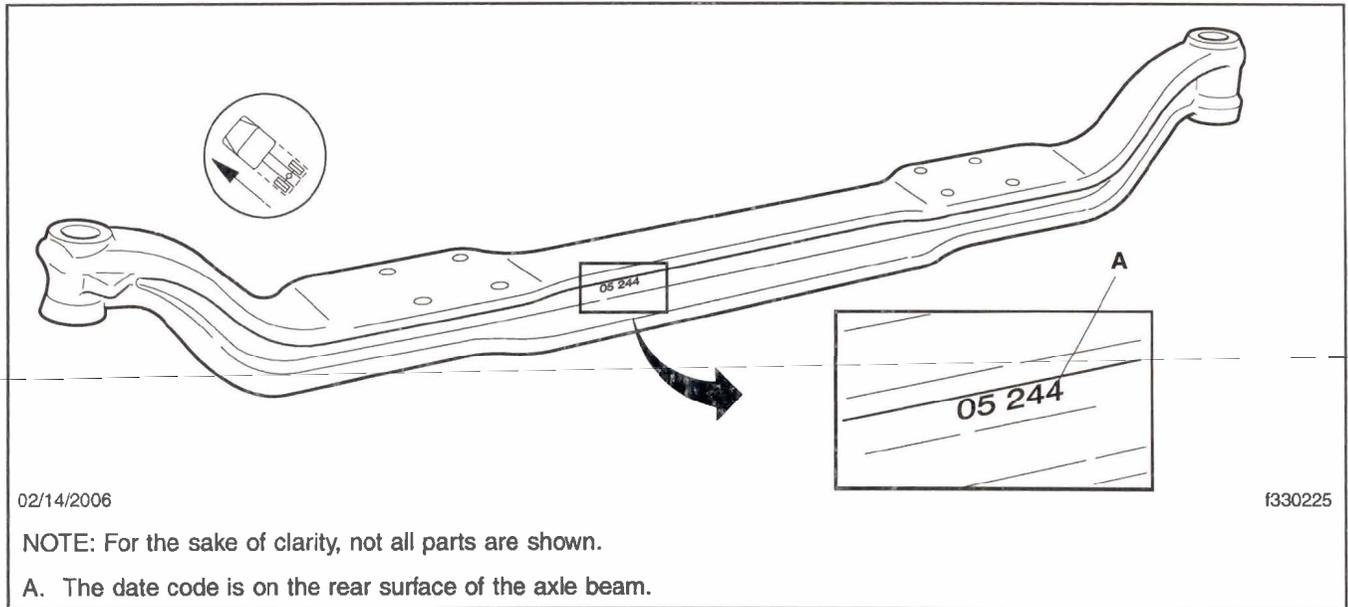
Fig. 1, Location of Date Code on Front-Axle Beam

1. Check the base label (Form WAR259) for a completion sticker for FL467 indicating this work has been done. On straight trucks and tractors, the base label is usually located on the passenger-side door about 12 inches (30 cm) below the door latch; on motorhomes, the base label is usually located on the front wall under the dash. If a sticker for FL467 is present, nothing further needs to be done. If no sticker is present, go to the next step.
2. Park the vehicle on a level surface, shut down the engine, set the parking brake, and chock the rear tires.
3. Find the date code on the rear surface of the axle I-beam web, on the driver's side and near the U-bolt pad. See **Fig. 1**. Affected axle beams are those with the date code *05 244*.

If the date code is NOT *05 244*, no further work is necessary. Clean a spot on the base label (Form WAR259). Write the recall number, FL467, on a blank red completion sticker (Form WAR260) and attach it to the base label.

If the date code IS *05 244*, go to the next step.
