06V-352  
(8 Pages)

Re: Workhorse Custom Chassis, Recall Bulletin No. 60601-C; 8.1 L Engine Fuel Rail Damper Retainer Clip

**BULLETIN NO:** 60601-C

**SUBJECT:** 8.1 L Engine Fuel Rail Damper Retainer Clip

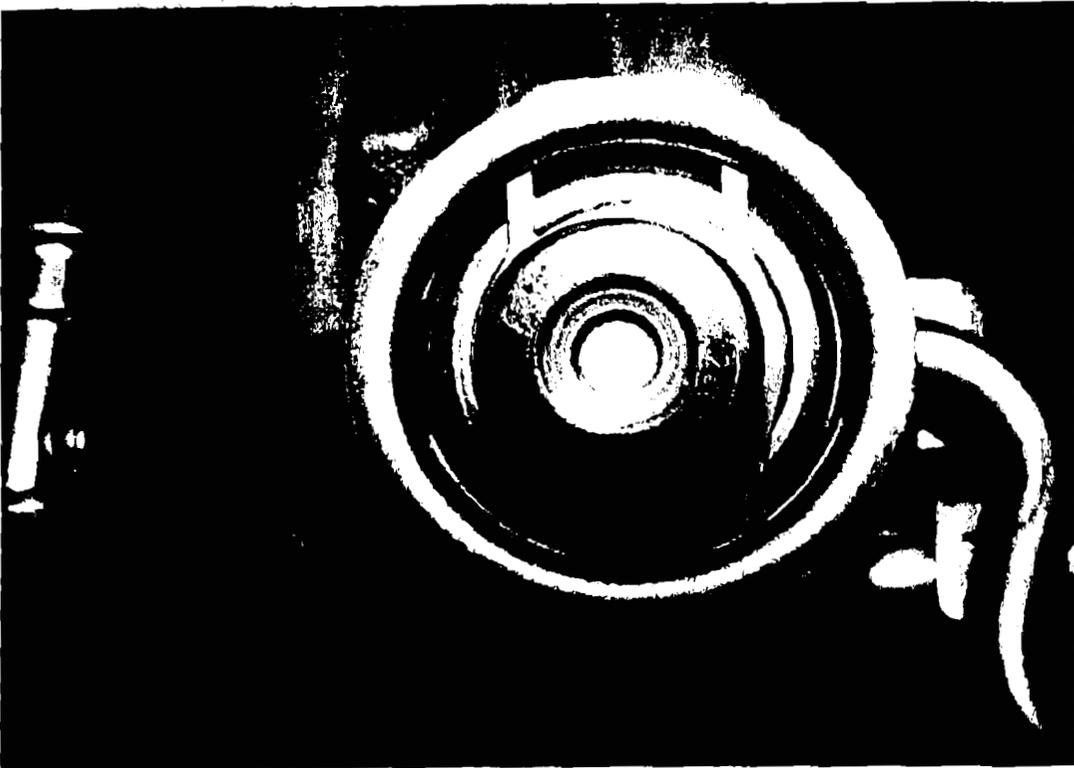
**The defect involves the possible installation of an improperly heat treated fuel rail damper retainer clip. An improperly heat treated clip may break resulting in a gasoline fuel leak at the fuel rail damper. A vehicle fire can result if the leaking fuel is ignited by a spark, or flame.**

**Photo 2 and 3 retaining clip and damper held by the clip**

6. Push down on the fuel damper while using a flat screw driver to remove the existing clip. (See photos 2 and 3)
7. Do not remove the fuel damper from the fuel rail. If the damper is removed the fuel damper o-ring must be replaced at the technician's/dealer's expense.

8. While holding down the damper, install the new clip in same position as removed clip.
9. Reconnect the negative battery cable.
10. Tighten the fuel filler cap.
