**GM SERVICE AND PARTS OPERATIONS**  
**DCS1667**  
**URGENT - DISTRIBUTE IMMEDIATELY**

Subject: Product Safety Recall 06080A  
Fuel Rail Pulse Damper Retainer Clip  
Service Procedure Revised

Models: 2004-2006 Chevrolet Avalanche, Silverado, Suburban  
2004-2006 GMC Sierra, Yukon XL  
2006 Chevrolet Kodiak  
2006 GMC TopKick  
Equipped with 8.1 L Engine (RPO L18 – VIN G)

**SUBJECT: FUEL RAIL PULSE DAMPER RETAINER CLIP**

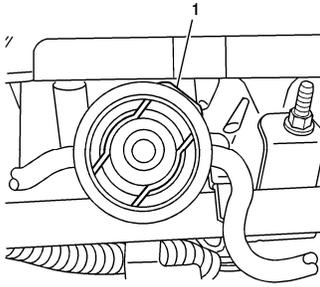
SIO 1254422

**CAUTION:** If the fuel pressure is not relieved as instructed in step 8, or the dampener is not held in position during the replacement of the dampener clip, the dampener O-ring may not seat or seal properly. A damaged or improperly seated O-ring may result in a fuel leak. A fuel leak in the presence of an ignition source may result in a fire.

17. Push down on the fuel dampener and install the new fuel pressure dampener clip (1).
18. Install the fuel fill cap.
19. Connect the negative battery cable. Refer to Battery Negative Cable Disconnection and Connection in SI.
20. Use the following procedure to inspect for leaks:
  - 20.1 Turn the ignition ON, with the engine OFF, for 2 seconds.
  - 20.2 Turn the ignition OFF for 10 seconds.
  - 20.3 Turn the ignition ON, with the engine OFF.
  - 20.4 Inspect the fuel rail, fuel rail dampener, and fuel rail pressure cap and valve for fuel leaks.

If a leak is present, a dampener kit with new O-ring must be installed. Relieve the system pressure as described in steps 4-14 above. Clean dirt and/or debris from dampener cavity and lubricate the new O-ring with clean engine oil prior to installation of the dampener. When finished, repeat steps 20.1-20.4.

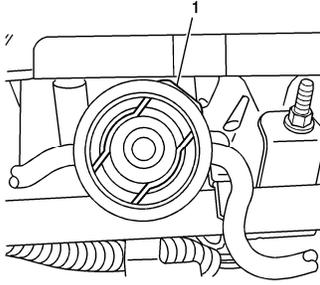
SIO 1254422

- CAUTION:** If the fuel pressure is not relieved as instructed in steps 7-9, or the dampener is not held in position during the replacement of the dampener clip, the dampener O-ring may not seat or seal properly. A damaged or improperly seated O-ring may result in a fuel leak. A fuel leak in the presence of an ignition source may result in a fire.
- CAUTION:** Do not remove the fuel dampener from the fuel rail. If the dampener is removed, a fuel dampener kit with new O-ring must be installed. If the dampener and O-ring is not replaced, a fuel leak may result. Clean dirt and/or debris from dampener cavity and lubricate the new O-ring with clean engine oil prior to installation of the dampener.
- NOTICE:** Push down on the fuel dampener until steps 11 and 12 are completed to avoid damaging the dampener O-ring.

11. Push down on the fuel dampener and remove the fuel pressure dampener retainer (1). Discard old dampener retainer.
12. Push down on the fuel dampener and install a new fuel pressure dampener retainer (1).
13. Install the 20A/25A ECM-B/FUEL PUMP fuse.
  - 13.1 Turn ON the ignition for 2 seconds.
  - 13.2 Turn OFF the ignition for 10 seconds.
  - 13.3 Turn ON the ignition.
  - 13.4 Inspect the fuel rail and fuel rail dampener for leaks. If a leak is present, a dampener kit with new O-ring must be installed. Relieve the system pressure as described in steps 7-9 above. Clean dirt and/or debris from

dampener cavity and lubricate the new O-ring with clean engine oil prior to installation of the dampener. When finished, repeat steps 13-13.4.
