EA94-018

ENGINEERING ANALYSIS CLOSING REPORT

SUBJECT: Fuel Injector Assembly Leakage.

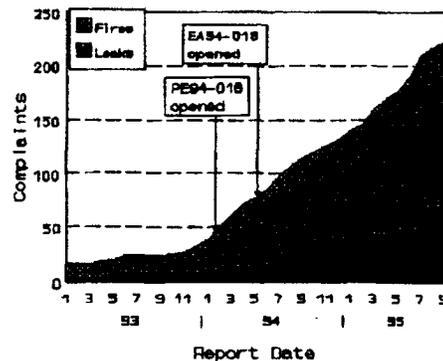
BASIS: This Engineering Analysis was opened June 23, 1994, when ODI upgraded its Preliminary Evaluation, PE94-018, of engine compartment fires in 1986 through 1988 Nissan 300ZX and Maxima vehicles. The Preliminary Evaluation was opened February 22, 1994, prompted by 19 reports of engine compartment fire and 6 reports of fuel injector assembly leakage. In opening PE94-018, ODI noted an increase in reports of fuel injector assembly leakage and engine compartment fire. Ten of the fire incident reports and 3 involving injector assembly leakage had been received within the two month period preceding the investigation. In responding to PE94-018, Nissan identified the subject vehicles as the 1984-89 Z31 300ZX and 1985-88 U11 Maxima vehicles. The scope of the investigation was broadened in the Engineering Analysis to include the full range of subject vehicles. Figure 1 shows the trends of ODI engine compartment fire and fuel injector assembly leakage inputs for subject vehicles from January 1993 through September 1995.

Figure 1 - ODI Complaint Trend, Cumulative Reports.

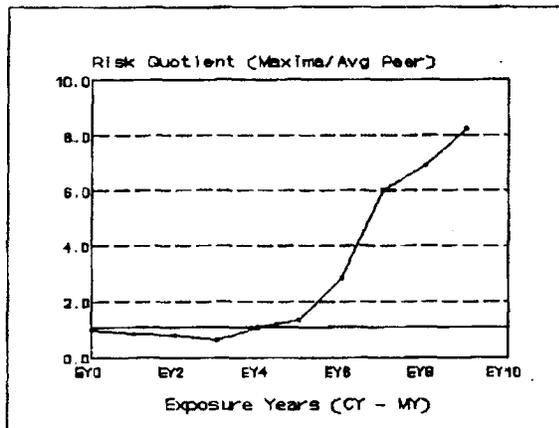
- The subject vehicle fire incidence rate ranks high among previous ODI engineering analyses of issues involving the potential for engine compartment fire.
- The subject vehicles are older than other vehicles ODI has investigated for issues related to non-collision engine compartment fire. The average failure mileage for the reported fire incidents is slightly over 100,000 miles.
- Analysis of insurance fire claim data shows that the subject vehicles' fire experience is slightly below that of their peers for the first five years, but increases sharply relative to peers after about the sixth year of service (Figures 2 and 3).

Figure 2 - Maxima Fire Rate Trend, Relative to Peer Average.

REASON FOR CLOSING: In a letter dated October 27, 1995, Nissan confirmed its intention to conduct a campaign (95I-006) to replace the fuel injectors and related hoses in all subject vehicles which remain in service at no cost to owners. The campaign will notify owners of the potential for fuel leaks developing in the injector assembly which could result in a vehicle fire originating in the engine compartment and explicitly confirm that such a fire would pose a safety risk. ODI believes that the action proposed by Nissan will provide the appropriate remedies for both the fuel hose and fuel injector leakage conditions.

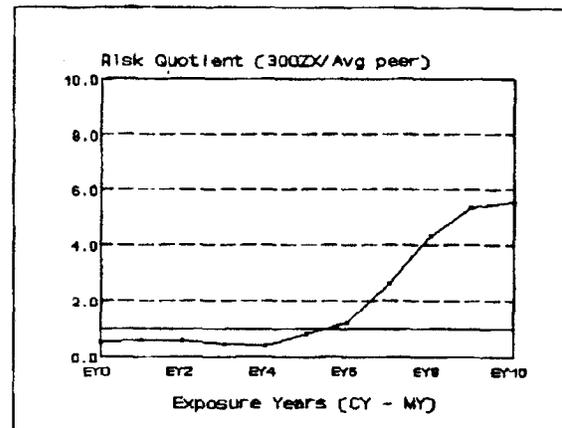
Figure 3 - 300ZX Fire Rate Trend, Relative to Peer Average.
