ENGINEERING ANALYSIS CLOSING REPORT

SUBJECT: Alleged Inadvertent and Sudden Vehicle Acceleration (SA) in Certain Nissan 280ZX and 300ZX Vehicles.

EA No.: EA85-029 **Date Opened:** 5/9/85 **Date Closed:** JUL 11 1989

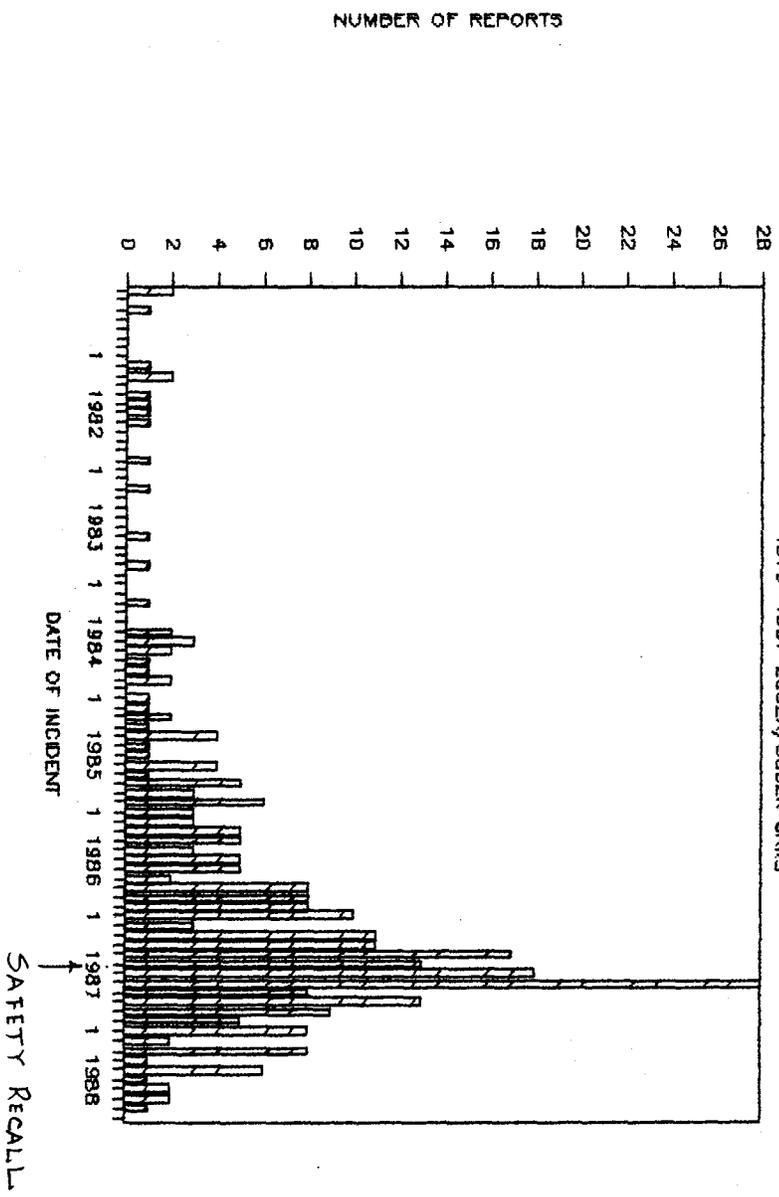
1. Both numbers of SA incidents (when the incident allegedly occurred) and complaints (when the complaint report was dated) appear to be substantially reduced since July 1987 as shown in Figure 1 and 2. This indicates the Nissan safety recall campaign starting in June 1987 is effective.

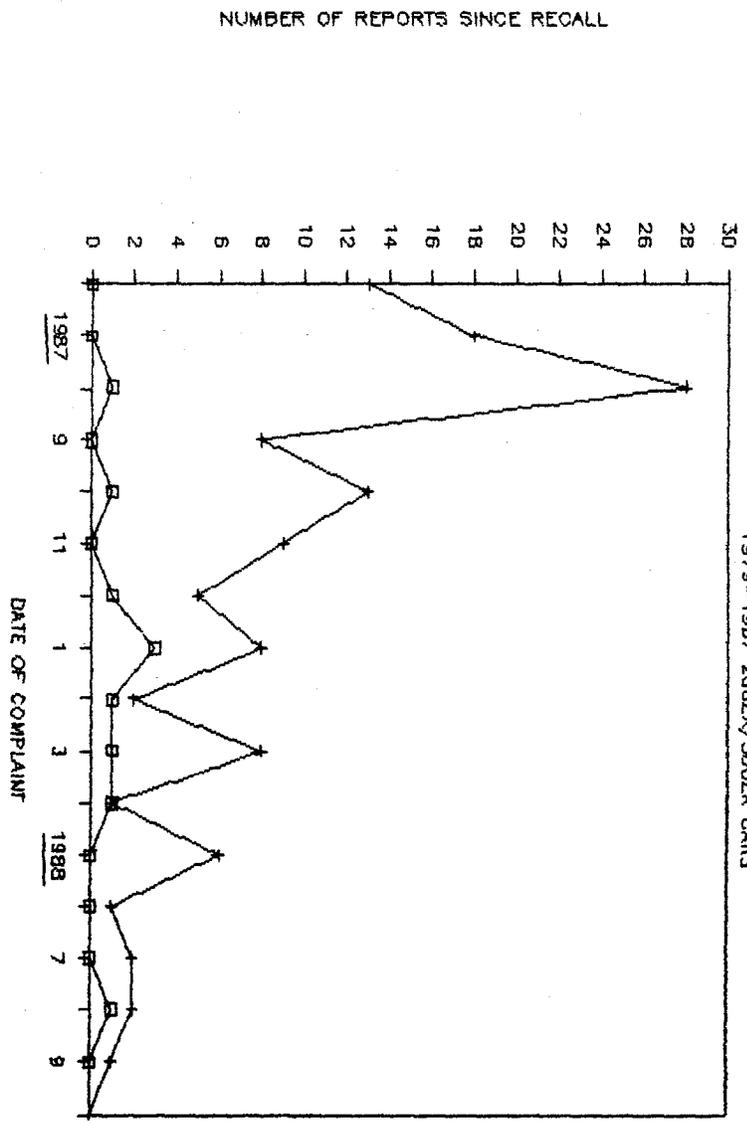
FIG. 3 COMPLAINTS RECEIVED SINCE JUNE 1987 (RECALL).

2. Since July 1987, there have been 128 SA complaints received. Among those reports, ten involved SA incidents after the shift interlock system was installed in the vehicle. Figure 3 shows distribution of those complaints per month since June 1987. Nissan investigated the ten incidents and found that three vehicles had the shift interlock system improperly installed; four had the transmission already in "Drive" or "Reverse" at the time of incident and the shift interlock worked properly; the other three had no identifiable defects.

124 + ALL COMPLAINTS
 10 □ COMPLAINT CARS EQUIPPED WITH
 THE SHIFT INTERLOCK SYSTEM

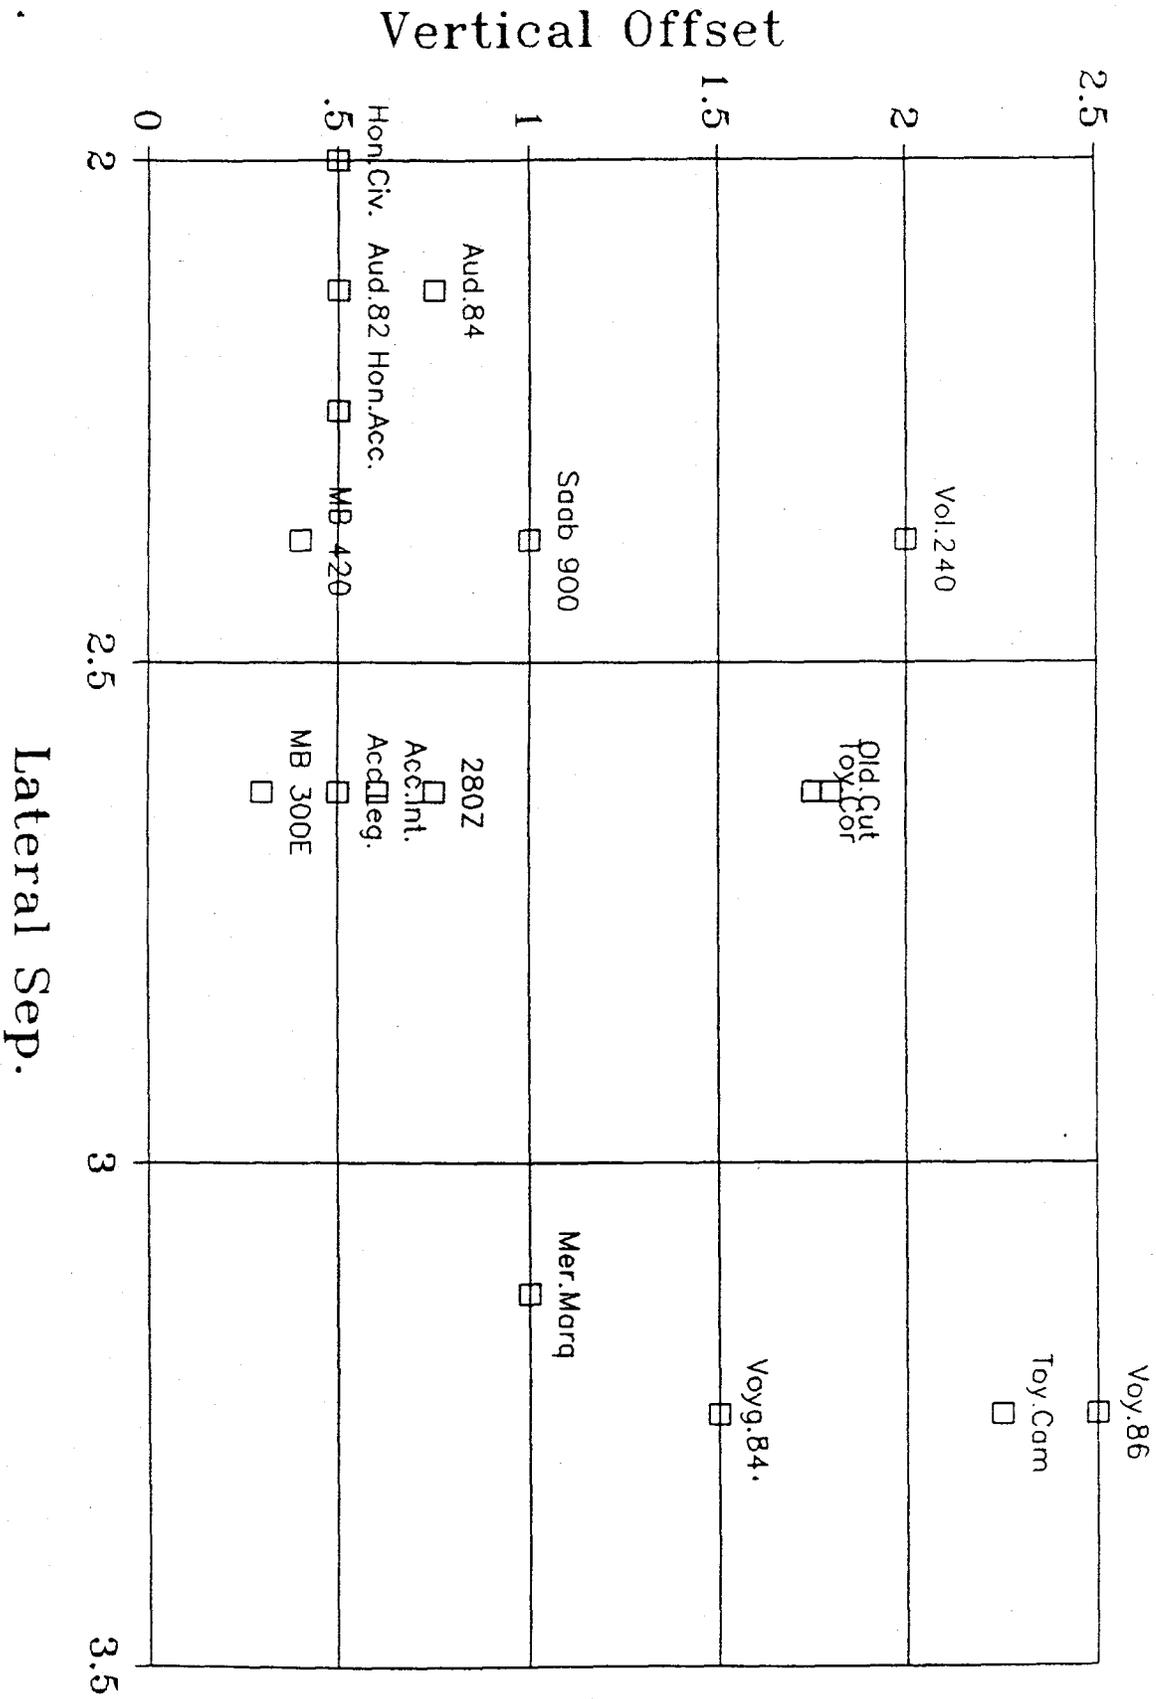
Figure 5: Pedal Separation and Vertical Offset for Selected Vehicles

5. The VRTC asked each of 49 male and female drivers to drive a 1985 model Nissan 300ZX and observed each driver's driving habits. About 67 percent of the 49 drivers in the driving test started the test vehicles with their foot on the accelerator pedal. Approximately 71 percent of the 36 male drivers found it easy to overlap the brake and accelerator pedals.
6. No instances of unexpected vehicle acceleration were observed or experienced on any test vehicles.
7. There is no evidence of braking effectiveness loss in any test mentioned above.
8. In two 1985 Nissan 300ZX test vehicles, the brake pedal free height and depressed height were found to be about 1/4 to 3/4 inch lower than manufacturer specifications.
