AMERICAN SUZUKI MOTOR CORPORATION

Subject: Recall No. 07V-315

Technical Bulletin

SUBJECT: SAFETY RECALL CAMPAIGN “KY” FRONT SEAT BELT BUCKLE ASSEMBLY REPLACEMENT

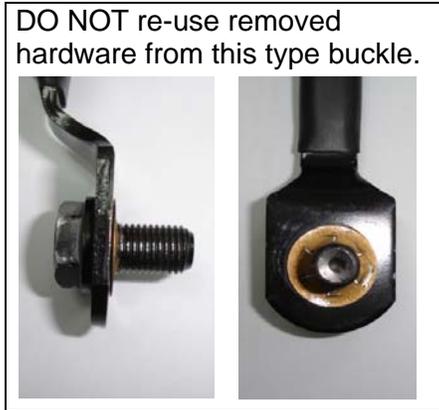
figure 1

Certain vehicles produced before December, 2005 have buckles with a smaller mounting hole which use the bolt and a steel lock washer shown in figure 1. That bolt and steel lock washer **MUST NOT** be re-used for the new buckle installation.

Before December, 2005

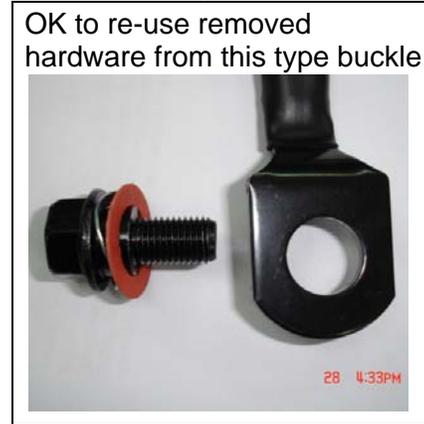
After December, 2005

The **CORRECT** hardware shown in figure 2 must be used.
