SAFETY RECALL RVXX0702 AUGUST 2007

SAFETY RECALL BULLETIN

SUBJECT: Steering Shaft Lock Nut

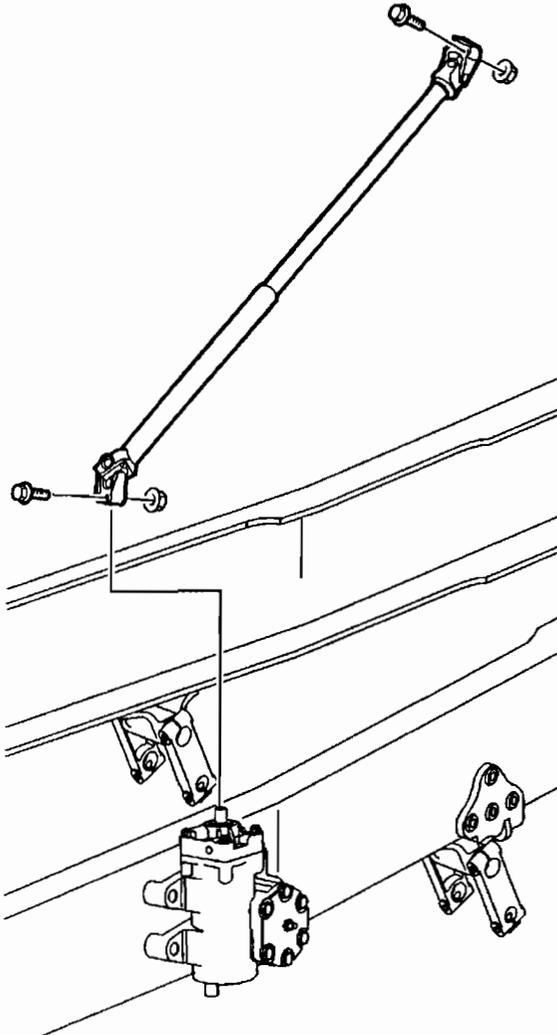
W6001611

Typical VN-2, VHD-2 and VT steering shaft

On VN-2 VHD-2 and VT models install the new pinch bolt (20924949) and nut (971086).
Tighten the pinch bolt to 60 ± 10 Nm (45 ± 7 ft-lb).

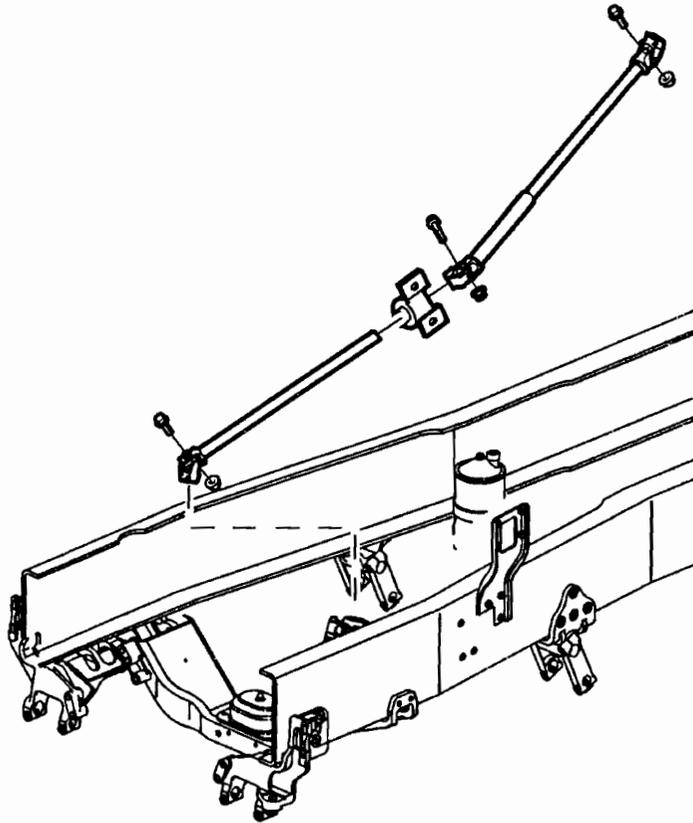
W6001612

VHDF-2 Steering Shaft

On VHDF-2 models install the new pinch bolts 20924949) and nut (971086) one at the steering gear and one at the support bearing. Tighten the pinch bolts to 60 ± 10 Nm (45 ± 7 ft-lb).
