**Subject: Compliance Recall Campaign Q8 (07V-442)**

Subject: Compliance Recall Q8  
Headlamp Inspection/Modification

# Compliance Recall Circular

**Headlamp Inspection/Modification**

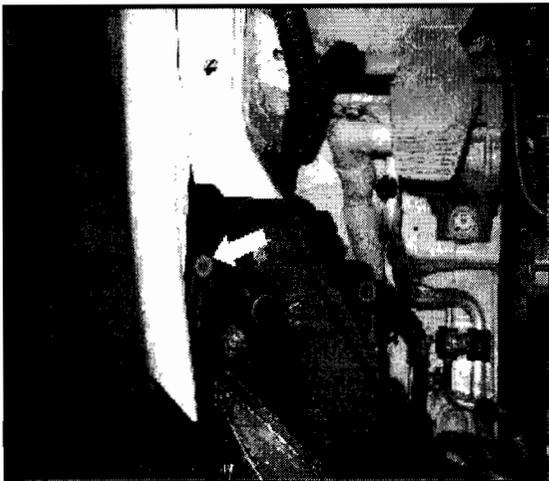
- Locate either headlamp on vehicle
- Visually inspect the horizontal headlamp adjuster by looking between the fender and headlamp bucket (as shown here) -arrow-
