FREIGHTLINER
LLC

Re: NVS-214bby / PE06-033

This letter responds to the above referenced request for information concerning missing or broken welds on the steering columns of certain Freightliner Century Class and Columbia trucks.

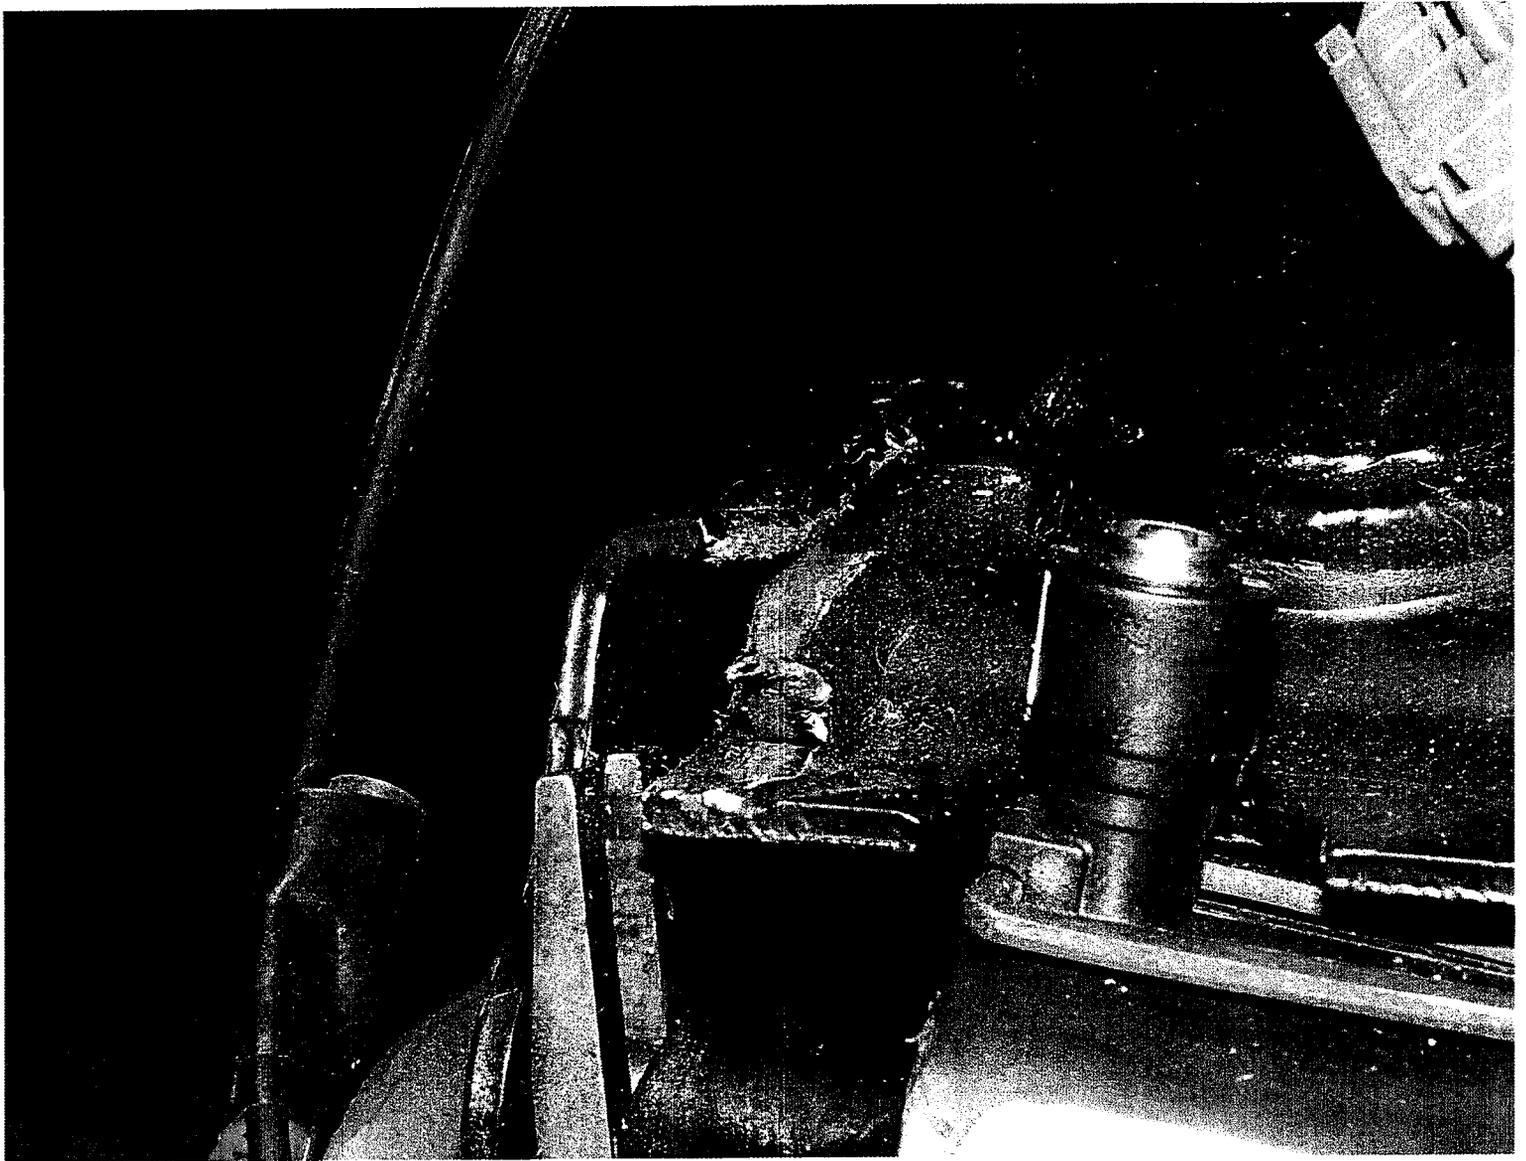
PICTURE U97814B SHOWS BOTH BROKEN WELDS AND IS JUST A LITTLE FURTHER BACK.

Welds
broke

REPLACE WITH CORRECTLY MANUFACTURED COLUMN.

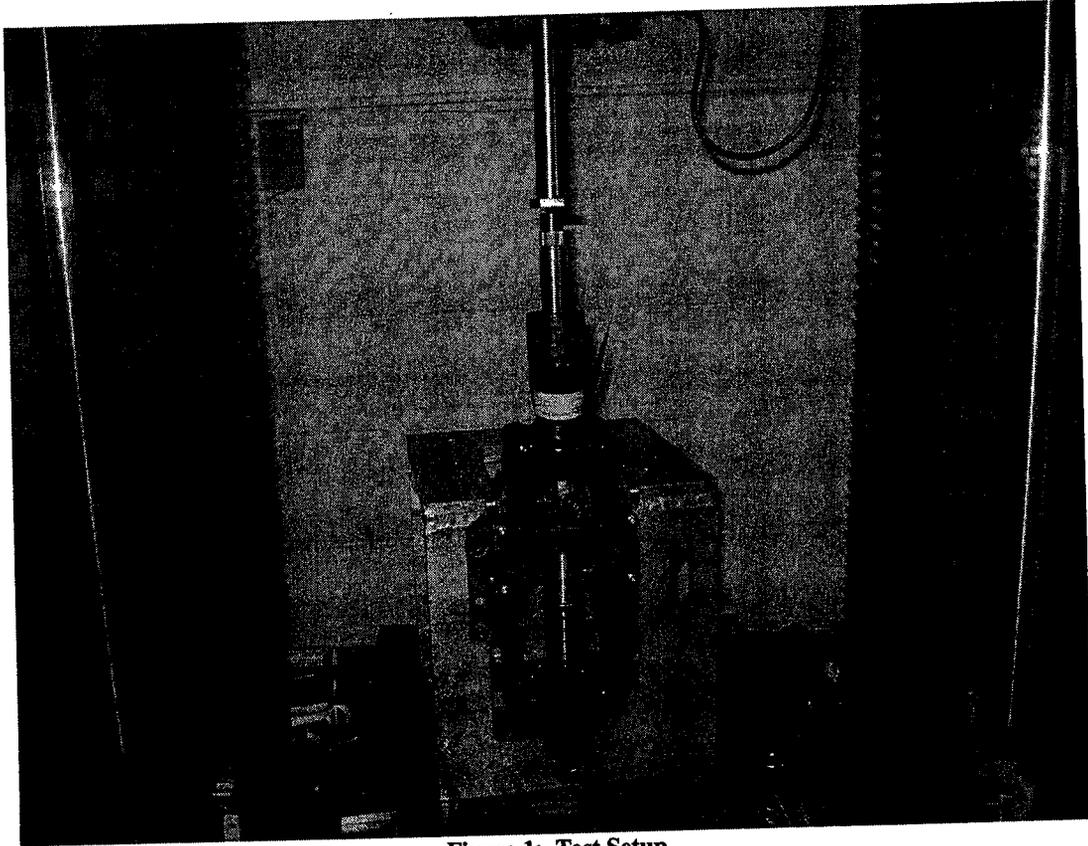
Figure 1: Test Setup

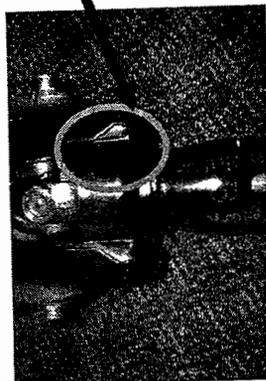
Good Weld

Operator Must verify all welds are present and only place completed parts in finished parts container
