Subject: FINAL REPORT: "Workhorse-Bosch Trip Report"

Workhorse-Bosch Trip Report

Date: November 13&14, 2007

Purpose: Examine a complaint vehicle that had experienced a thermal event at a wheel-end with representatives of the chassis and brake manufacturers.

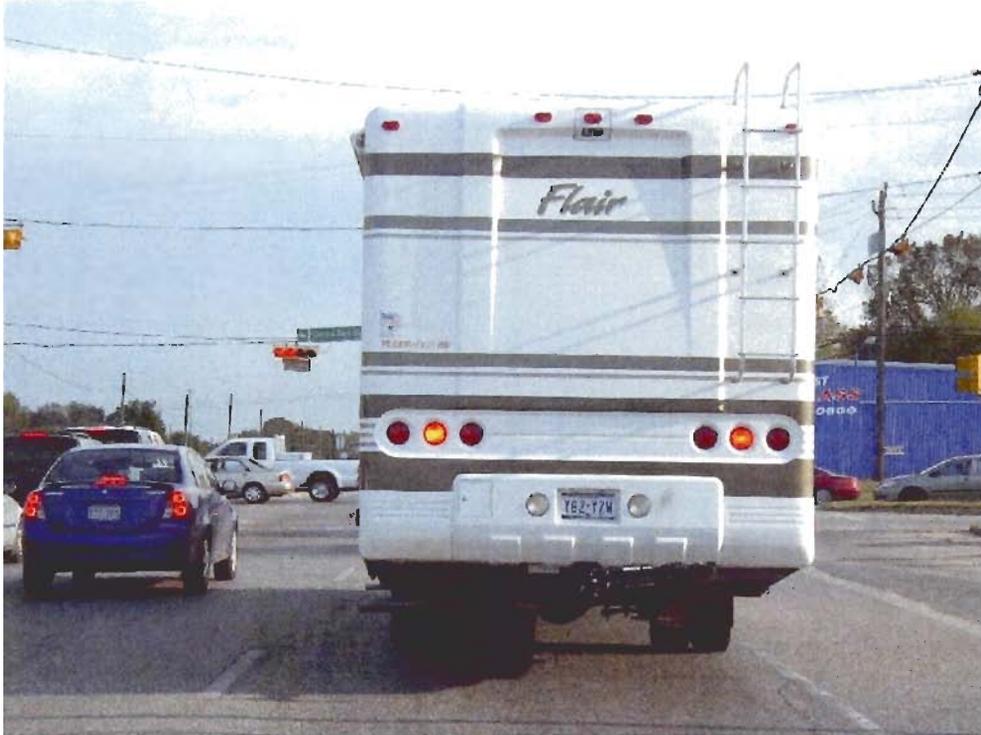
Figure 1 - View of the Complaint Vehicle during Test Drive with the Owner

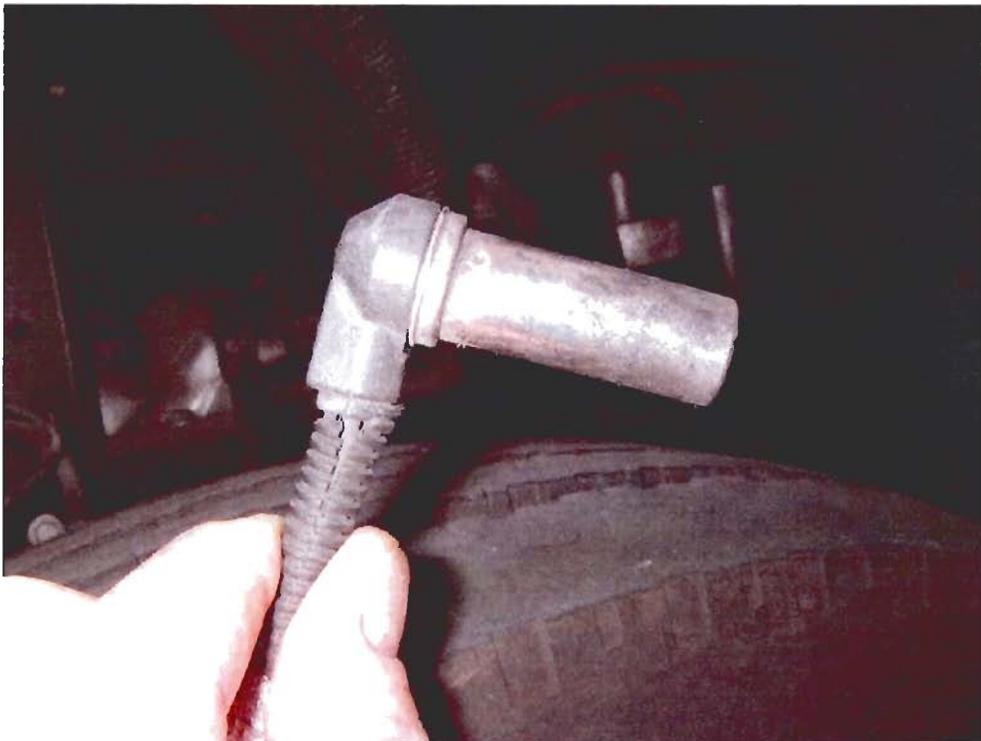
Figure 2 - The ABS Sensor from the Left Front Wheel Appeared to be in Good Condition and had not been Overheated

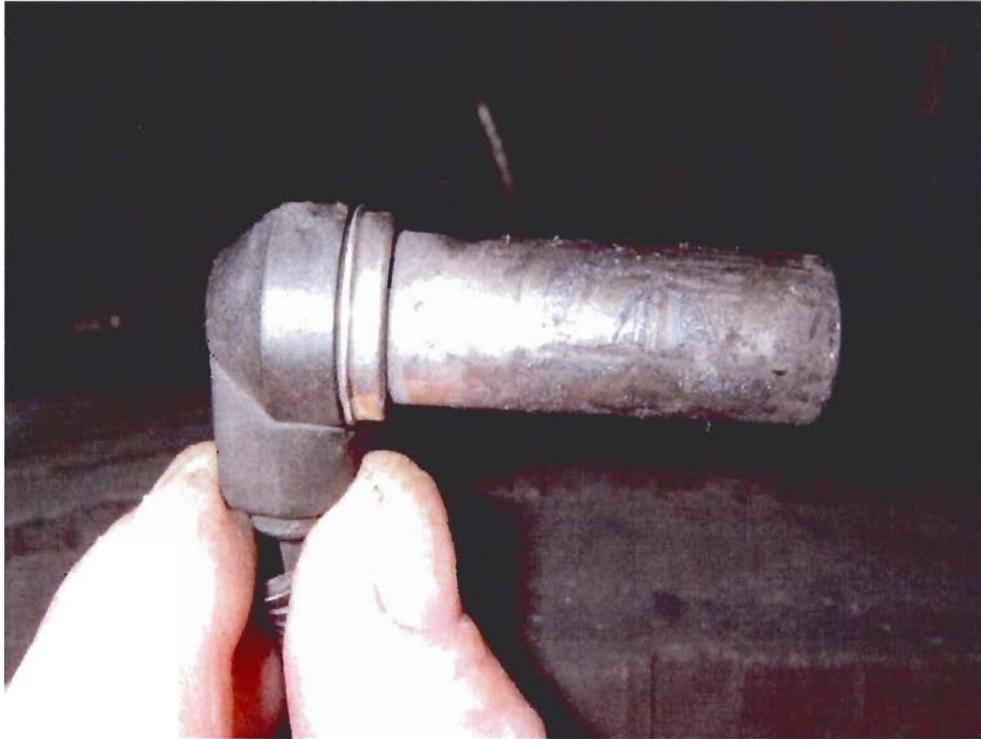
Figure 3 - The ABS Sensor from the Right Front Wheel Appeared to be in Good Condition and had not been Overheated

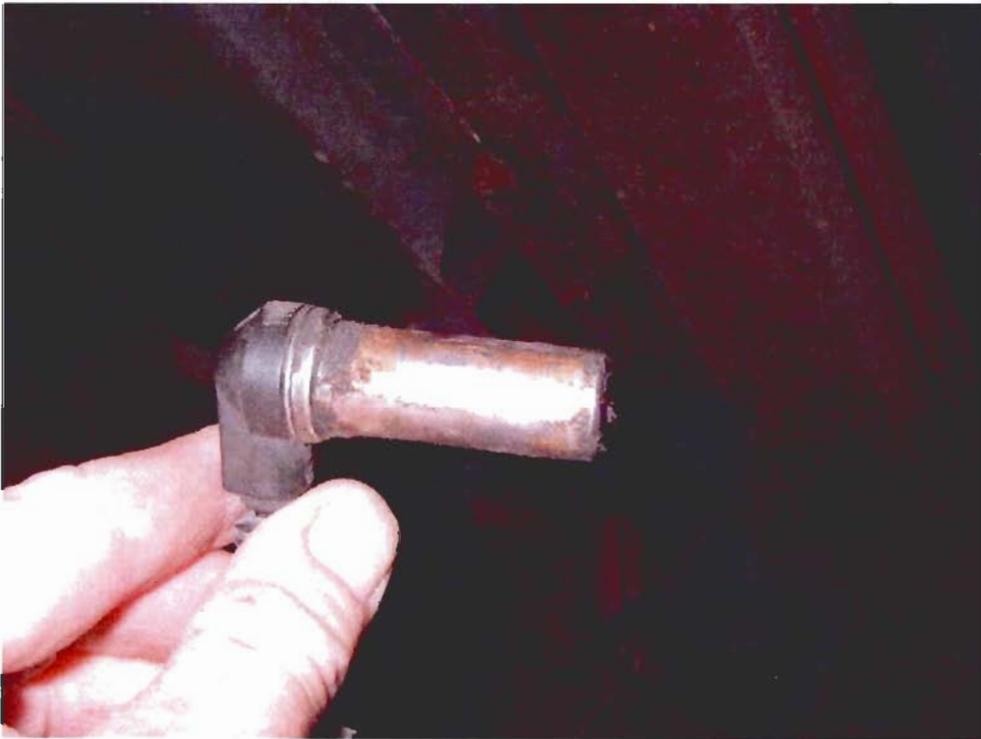
Figure 4 - The ABS Sensor from the Left Rear Wheel Appeared to be in Good Condition and had not been Overheated

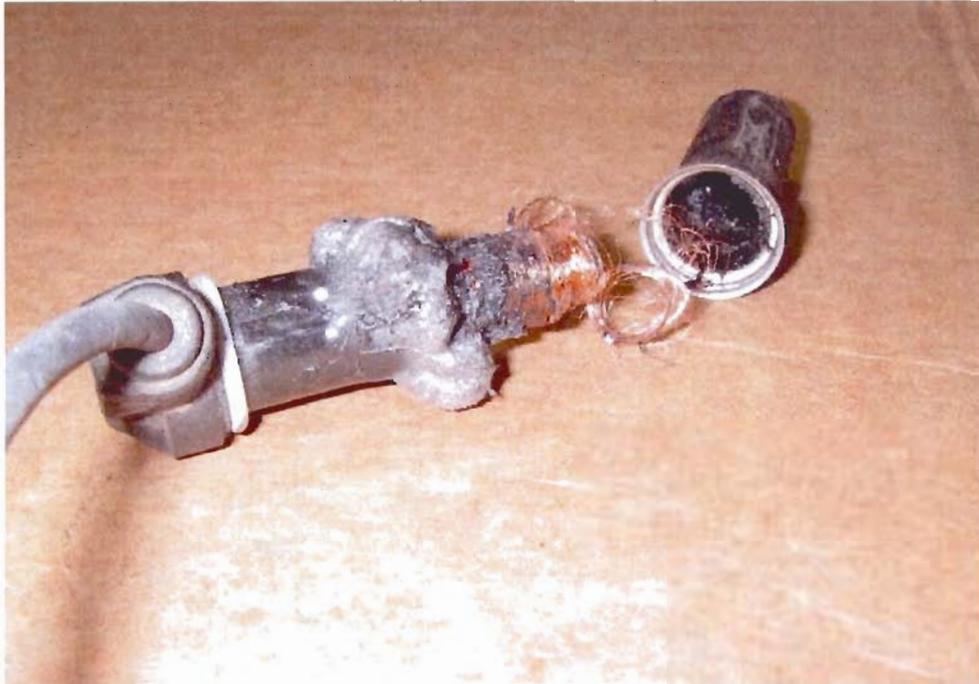
Once at the dealership, the owner departed and the vehicle was driven into the truck bay relatively quickly. The vehicle was raised onto jack stands and the service technician immediately spotted the melted right rear ABS wheel speed sensor. The wheels were turned by hand with the transmission in neutral and the parking brake off. The front wheels were harder to turn than expected, but could be turned by one hand with a medium force. The rear wheels were expected to have more resistance than the front due to the drivetrain, but they were difficult to rotate requiring both hands and leaning body weight into the attempt. The bellcrank was checked and found to be free and returning to the full off position. The bleeder valves were opened one at a time resulting in a dribble at three calipers and a significant forceful squirt at the right rear caliper. This indicates trapped pressure to this one channel. The rear axle wheel-ends are supposed to have common brake line pressures, unless the ABS unit has closed the

Figure 5 - The ABS Sensor from the Right Rear Wheel was found Melted and was Hanging by the Sensor Wire Outside of the Metal Housing

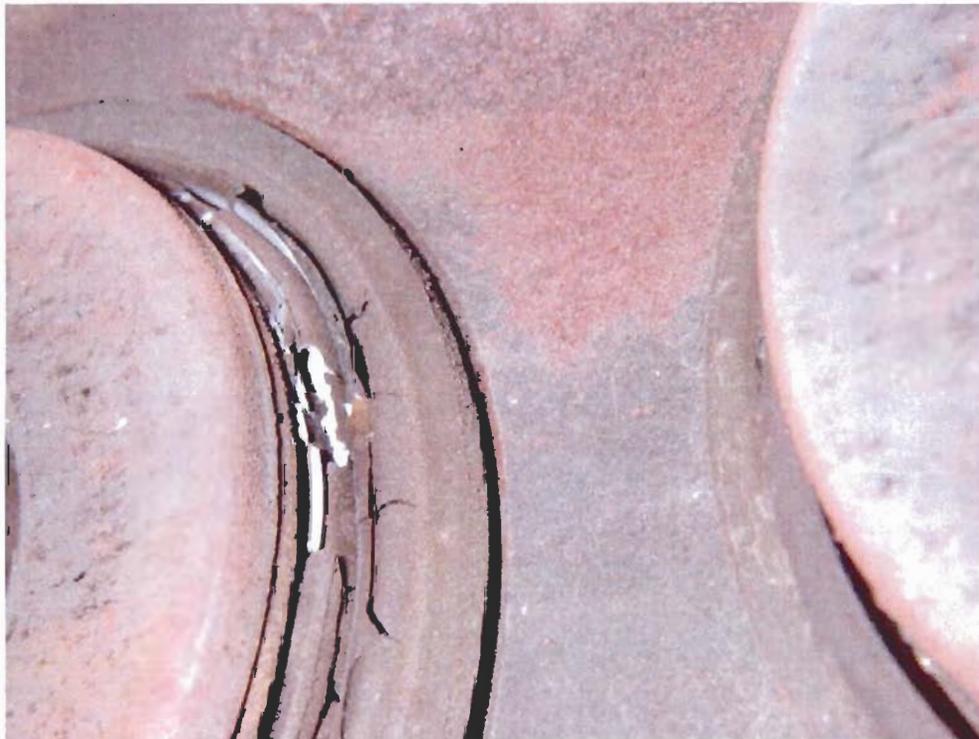
Figure 6 - After the Right Rear Caliper was Removed from the Slide Pins, the Damaged Boot on the Leading Piston was Visible

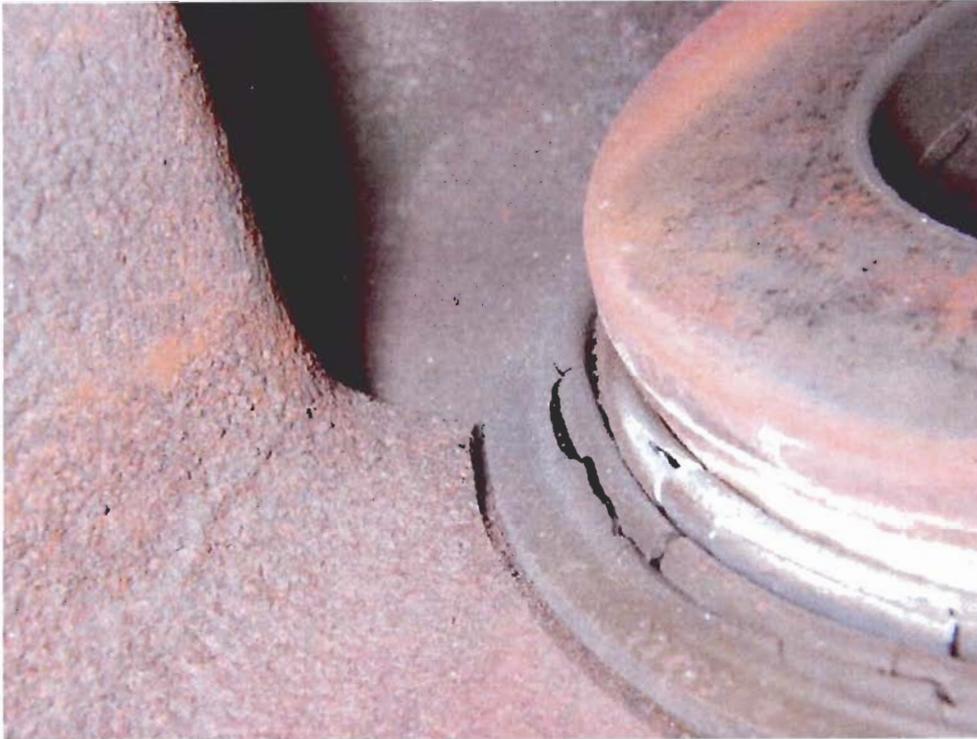
Figure 7 - The Trailing Piston Boot was also Damaged

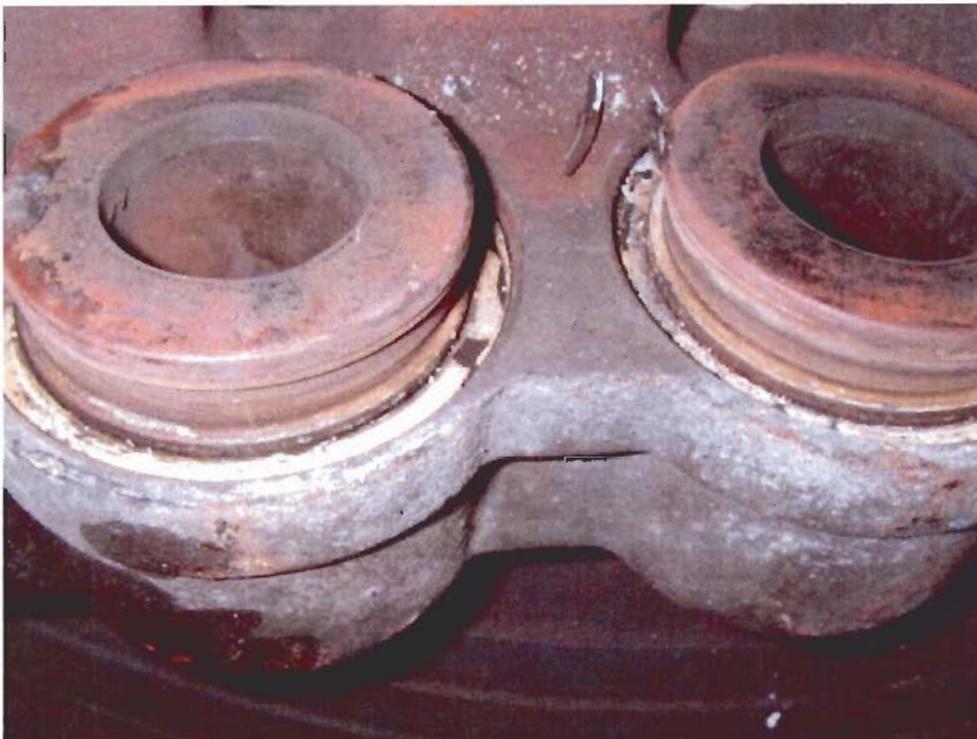
Figure 8 - After the Piston Boots were Removed from the Right Rear Caliper, the Undamaged Seal Lands were Visible
The white substance is the Lithium grease that is installed to help displace moisture from the seal land area.
