**ENGINEERING ANALYSIS EA92-041**

**GENERAL MOTORS PICKUP TRUCK DEFECT INVESTIGATION**

**ENGINEERING ANALYSIS REPORT AND  
INITIAL DECISION THAT THE SUBJECT VEHICLES  
CONTAIN A SAFETY-RELATED DEFECT**

**October 17, 1994**

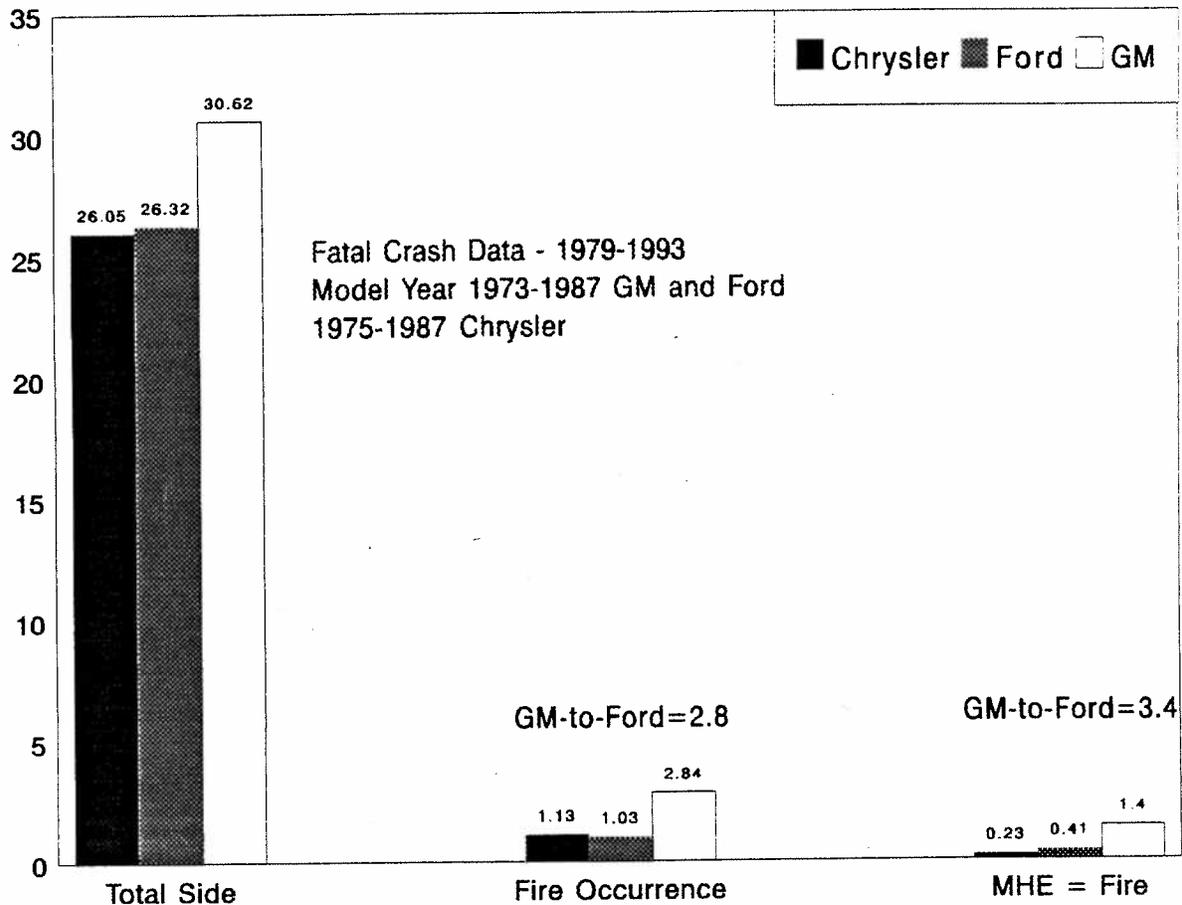
Figure 3. Side-Impact Occupant Fatalities per Million Registered Vehicle-Years

fatalities per million registered vehicle-years was 2.84 for GM, 1.03 for Ford, and 1.13 for Dodge. The ratio of the side-impact fire-related fatality rate for the GM pickup trucks to that of the Ford pickup trucks is 2.8 to 1. Finally, in those side-impact crashes in which fire was the MHE, comparative fatality rates were 1.40 for GM trucks, 0.41 for Ford trucks, and 0.23 for Dodge trucks. The difference in the side-impact MHE=fire occupant fatality rates between the GM and Ford trucks is 0.99 (1.40 - 0.41) occupant fatalities per million

registered vehicle-years. The ratio of GM to Ford rates for side-impact MHE=fire occupant fatalities is 3.4 to 1.<sup>8</sup>

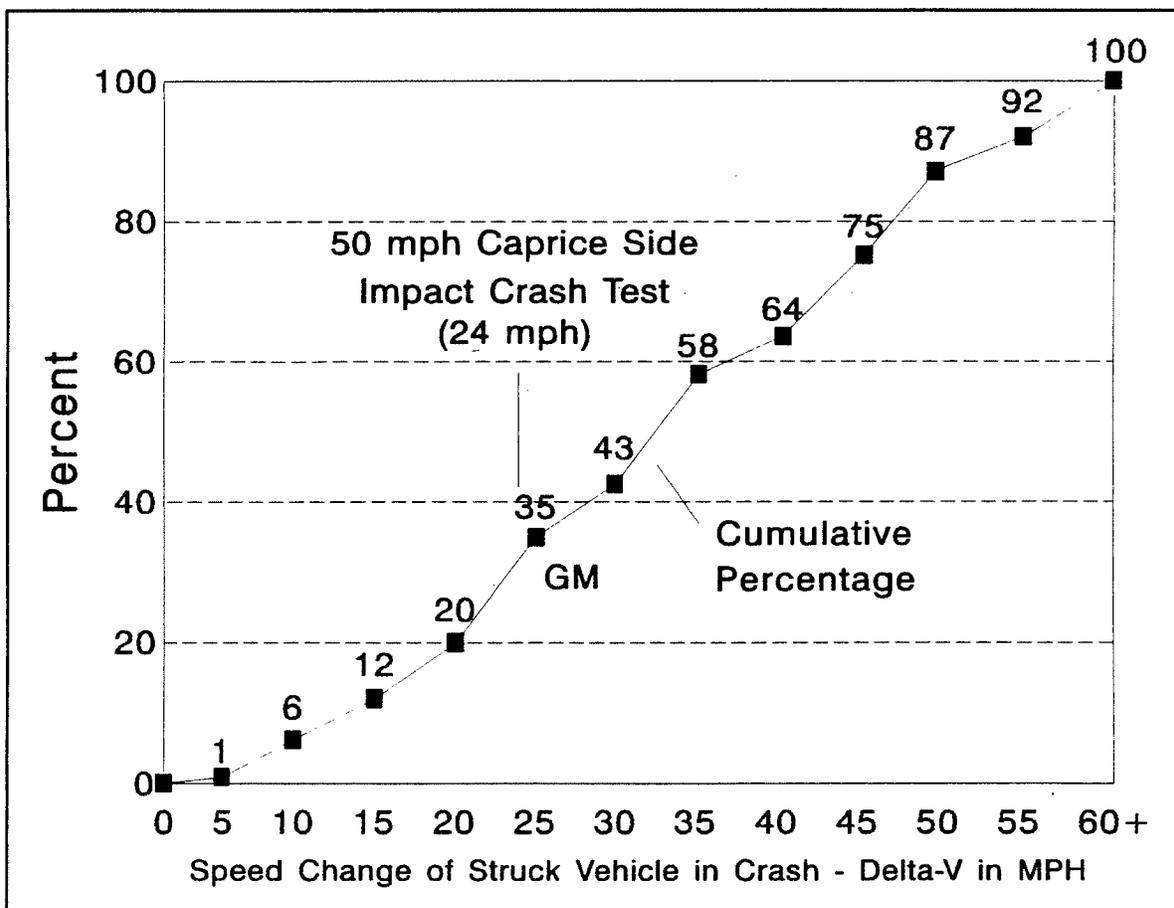
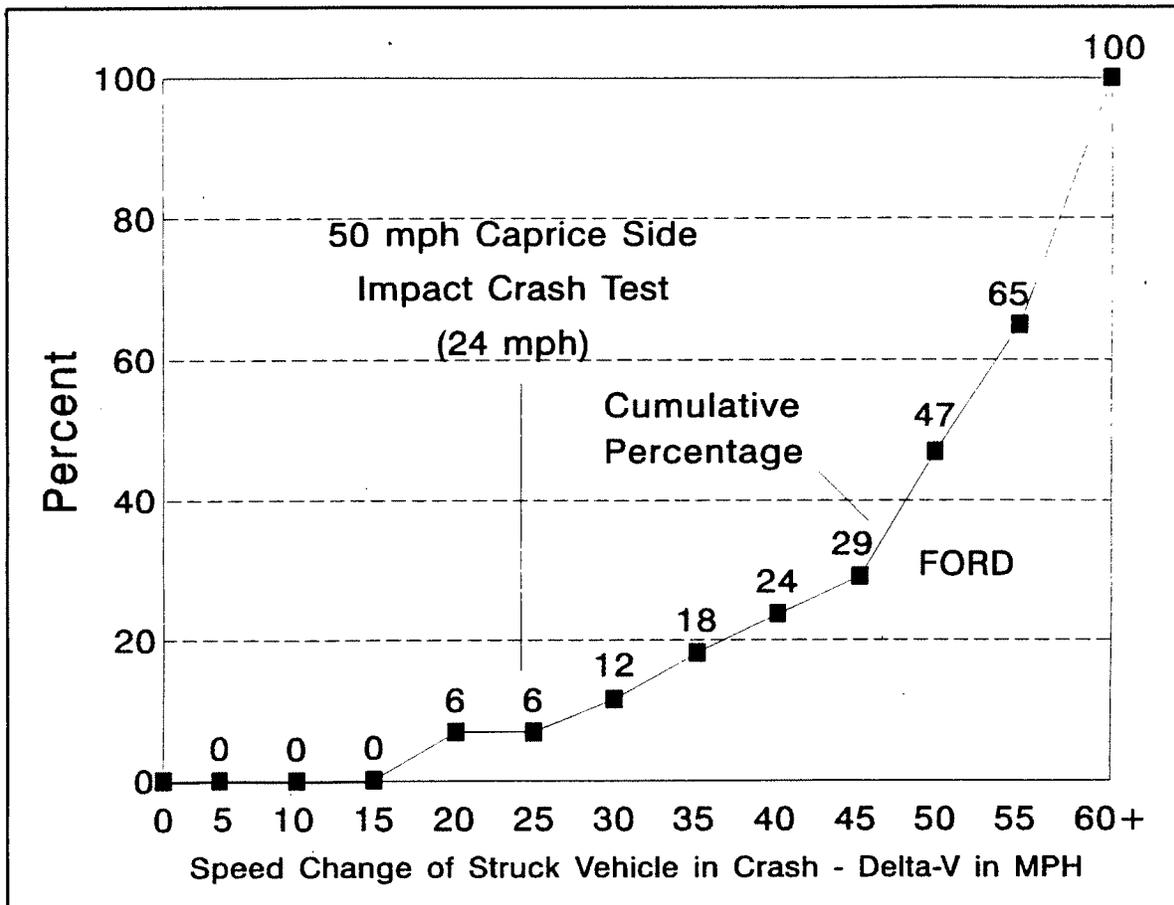
Figures 4 and 5 present the results of this analysis for GM and Ford pickups, respectively. The figures depict the percentage of fire-related, fatal side-impact crashes within five mph delta-V increments for each of these vehicles. Also shown is the 24 mph delta-V obtained in the ODI 50-mph crash test of a subject vehicle that resulted in a fuel tank leak. This indicates that a 50-mph crash is at the lower end of the range of crash severity necessary to cause a fire due to a fuel tank leak in both the subject vehicles and the Ford pickups; i.e., approximately 65 percent of the GM crashes and 94 percent of the Ford crashes analyzed by ODI had delta-V values above 24 mph.

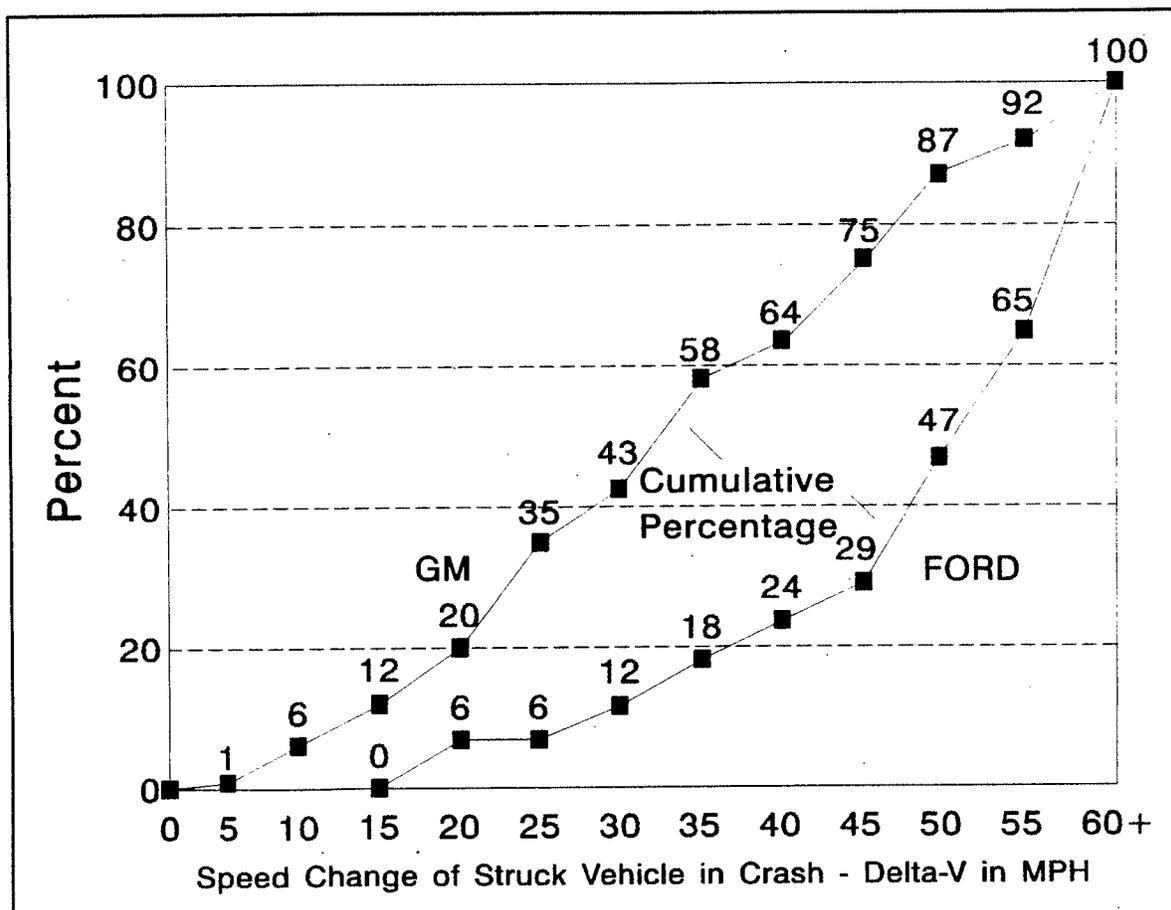
**Figure 6.** Percent of GM and Ford Pickup Truck Fatal Side Crashes with Fire, by Crash Severity (Delta-V in mph).

Figure 6 presents the GM and Ford data together. Because of the limited number of Ford crashes available for analysis, ODI recognizes that the graph of the Ford data may not be a precise reflection of the delta-V experienced by Ford pickups in fire-related fatal crashes. Nevertheless, ODI believes that these graphs provide a valid indication that, in general, the crash severity needed to cause a fire in a fatal side-impact crash involving a Ford pickup is greater than that needed to cause a fire in such a crash involving the subject vehicles.

These data indicate that the average crash severity for the GM truck in fatal side-impact crashes with fire is at a delta-V of 36 mph, while the Ford delta-V average is 55 mph. Thus, while fatal side-impact crashes with fire involving the subject vehicles occur at extremely high levels of crash severity, and at severity levels far in excess of that associated with a FMVSS No. 301 side-impact test, those severity levels are often below those required to create a post-crash fire in the Ford pickups.
