Add to file VOQ 10214732

Vehicle 2003 BMW 745

Stephen McHenry, Investigator, EA08-003

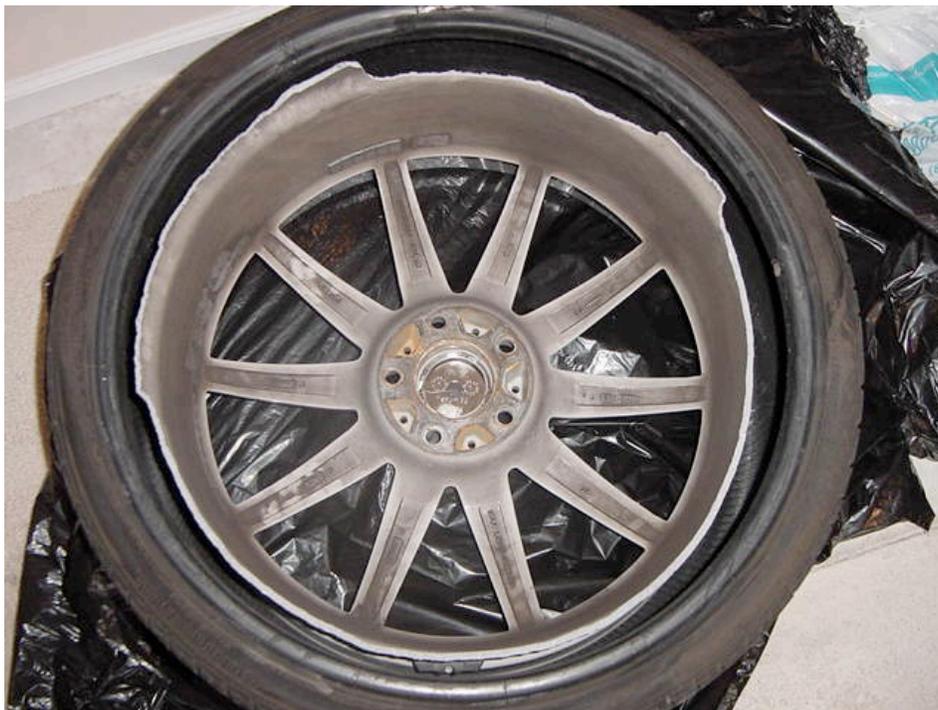
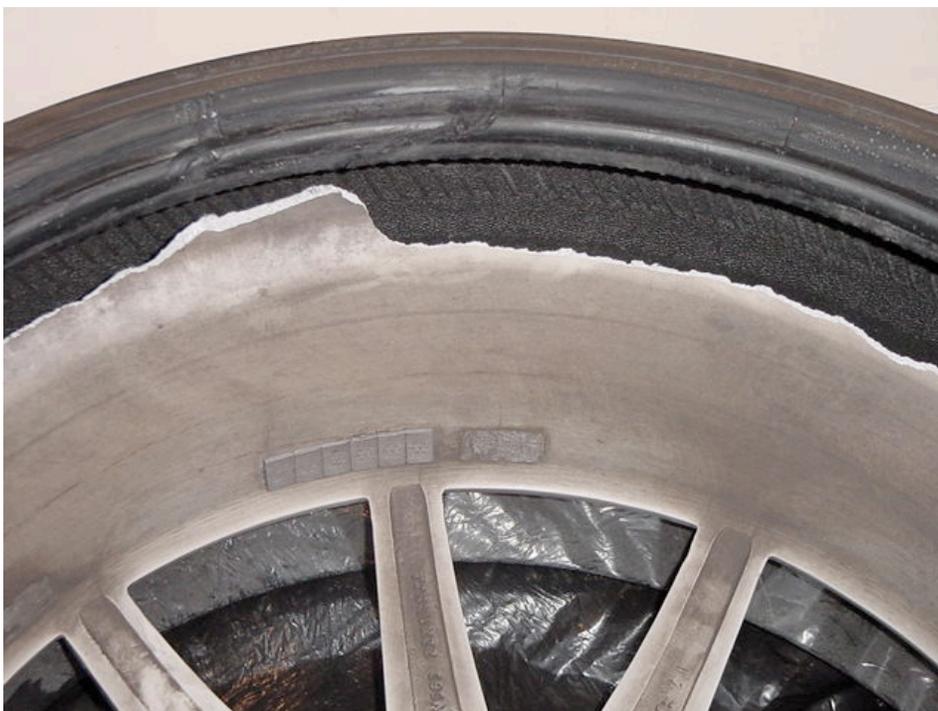
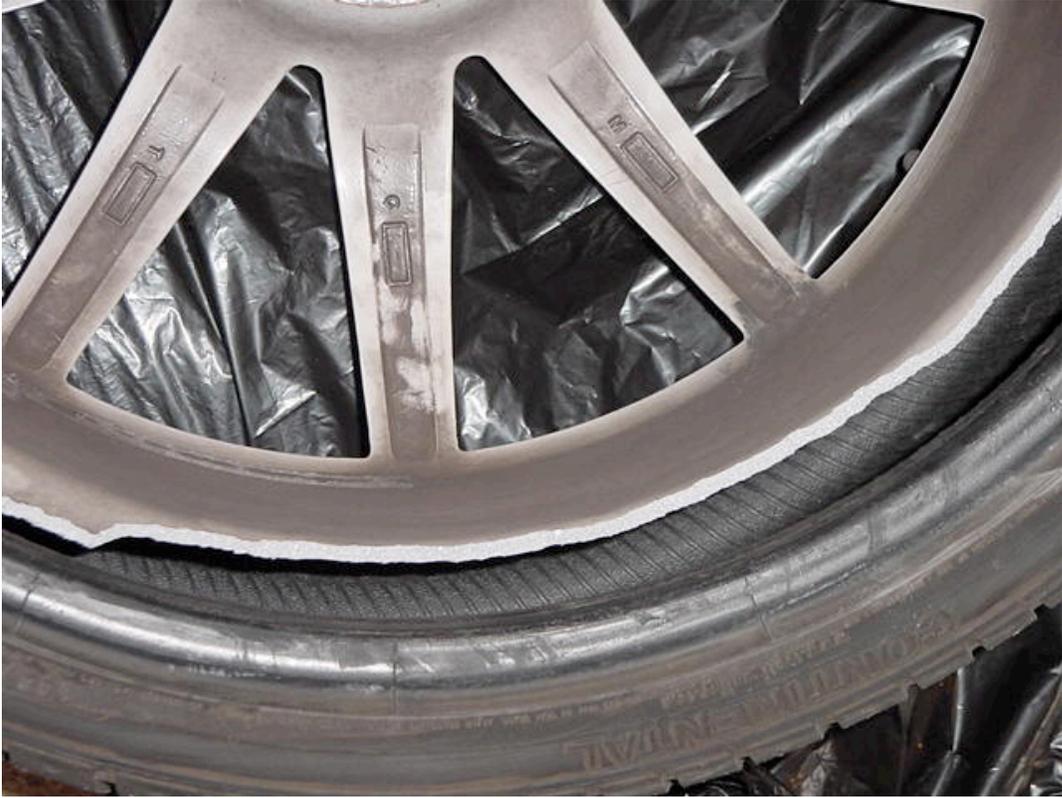
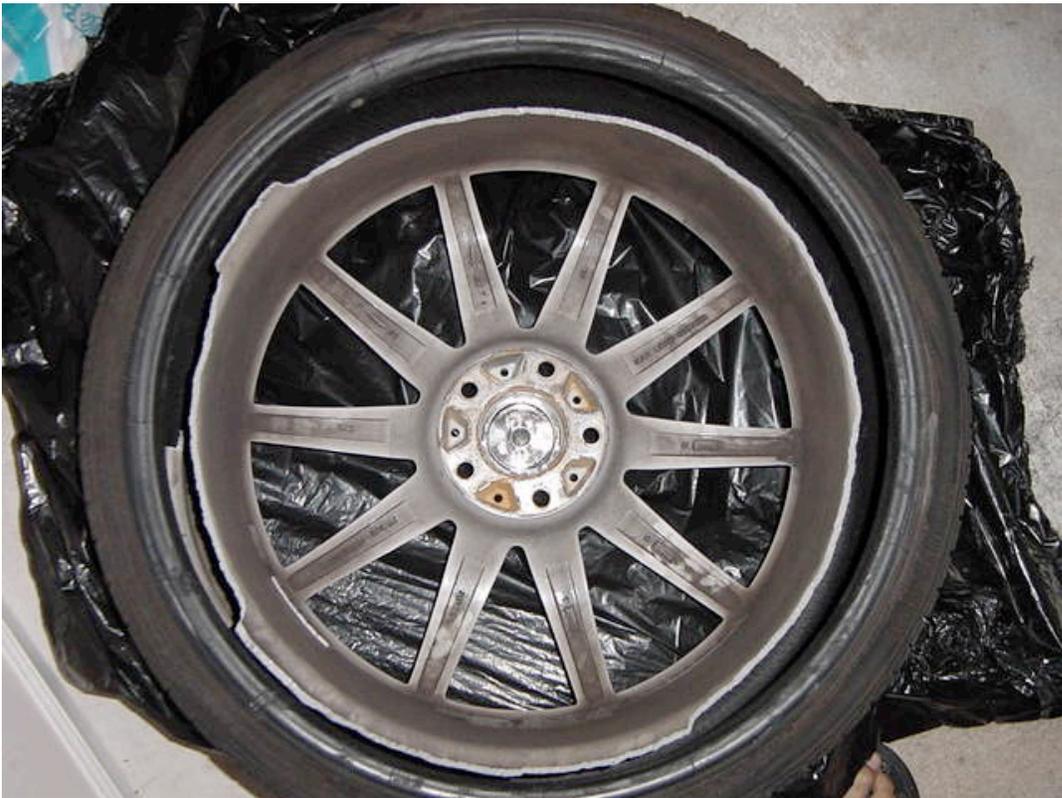
Right rear wheel failed, radial cracking;

Wheel had been installed in place for approximately 8 months and 9,000 miles;

Traveling approximately 65 mph when failure occurred;

No impact experienced with wheel before failure (e.g., potholes, curbs);

Pieces of rim flew off behind, could have contacted following traffic, luckily there was none;

Dent in RR shock caused from wheel shrapnel

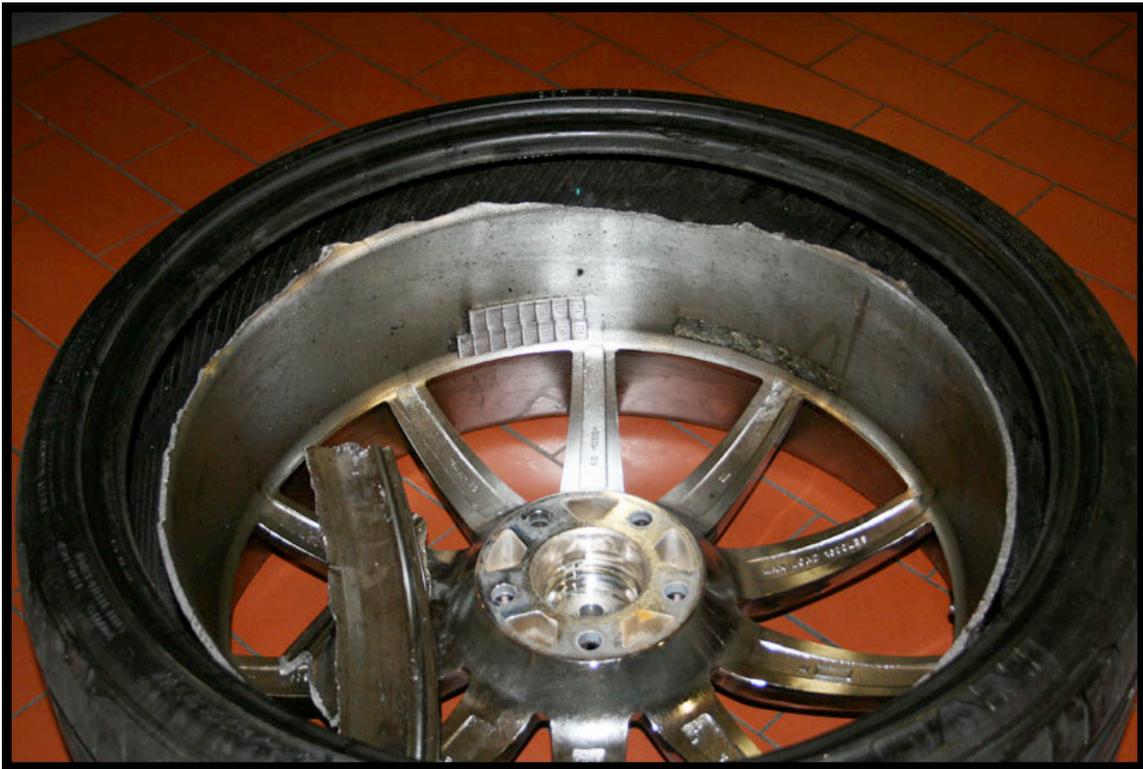
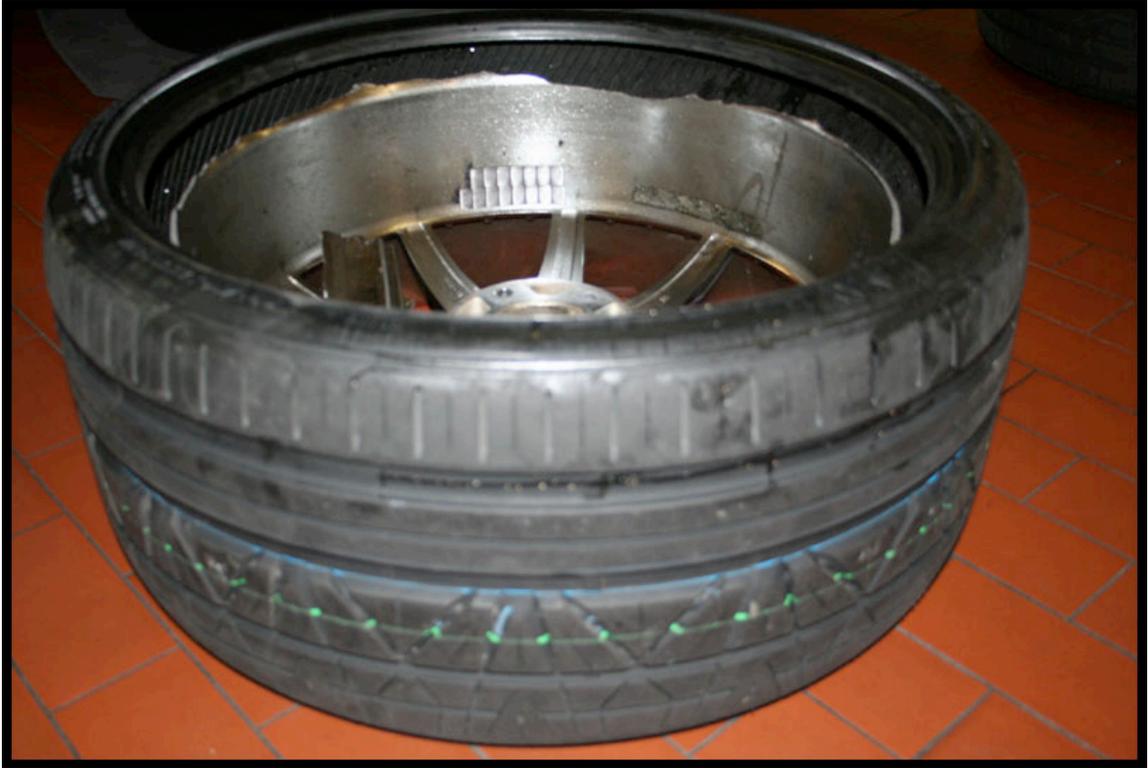
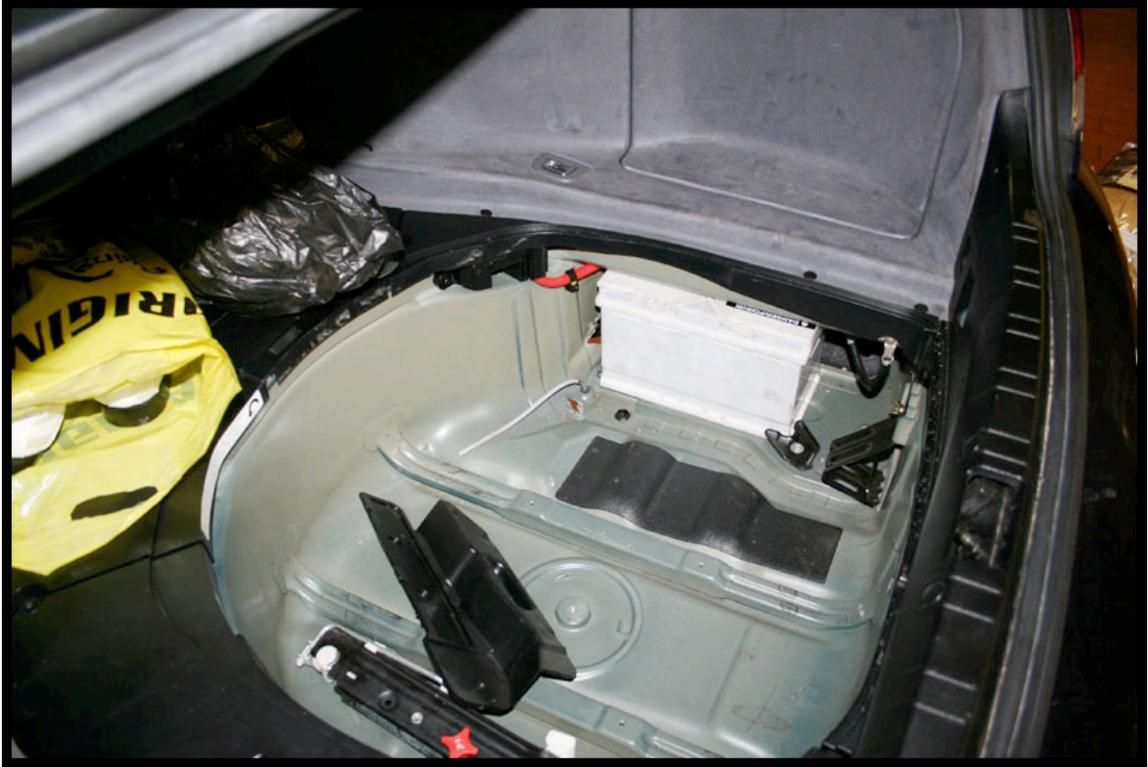
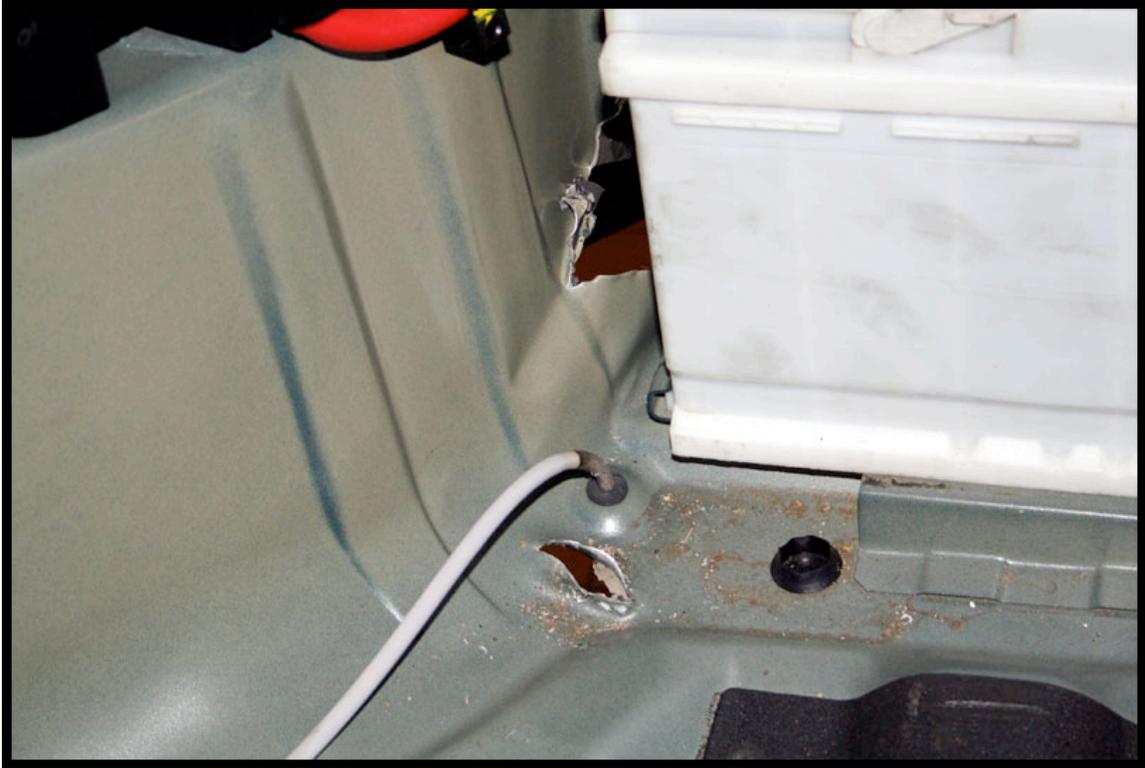
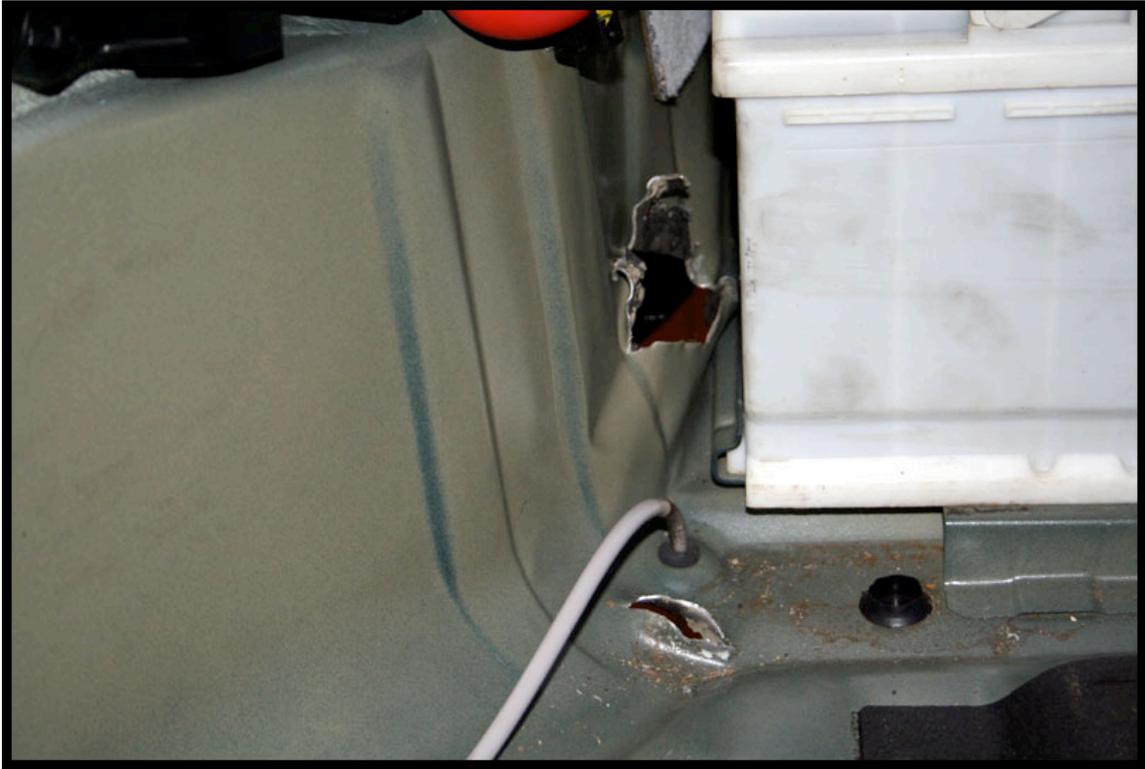
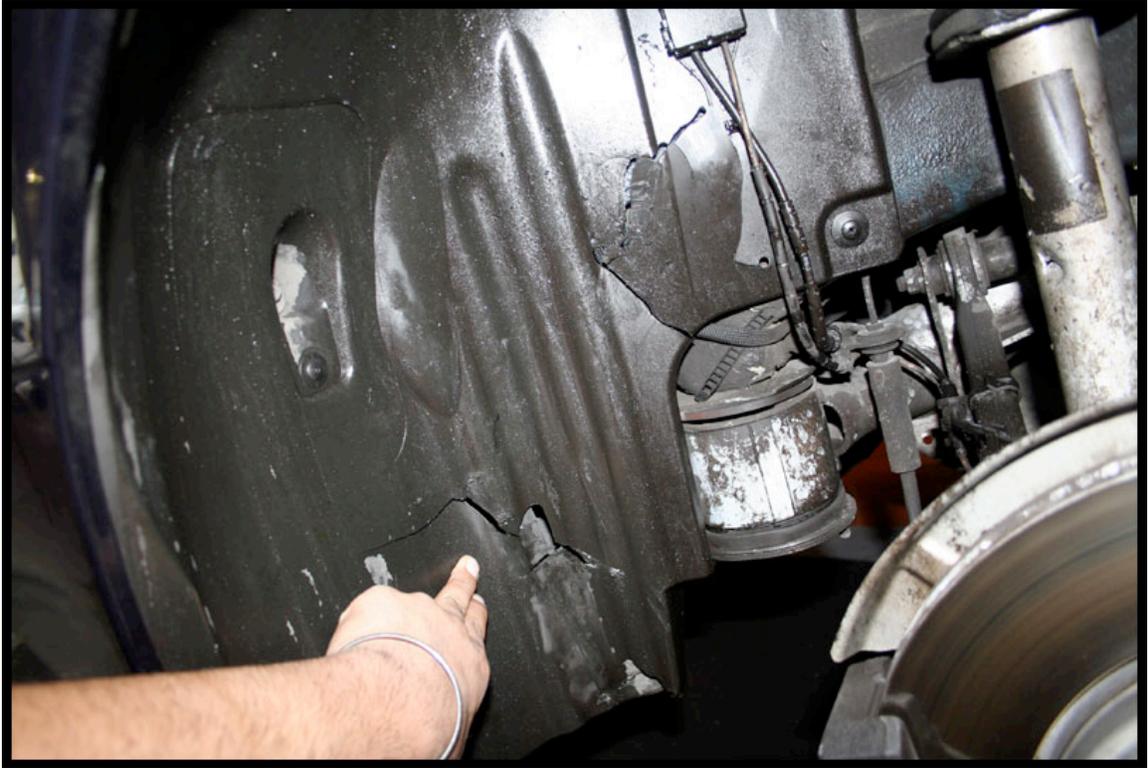
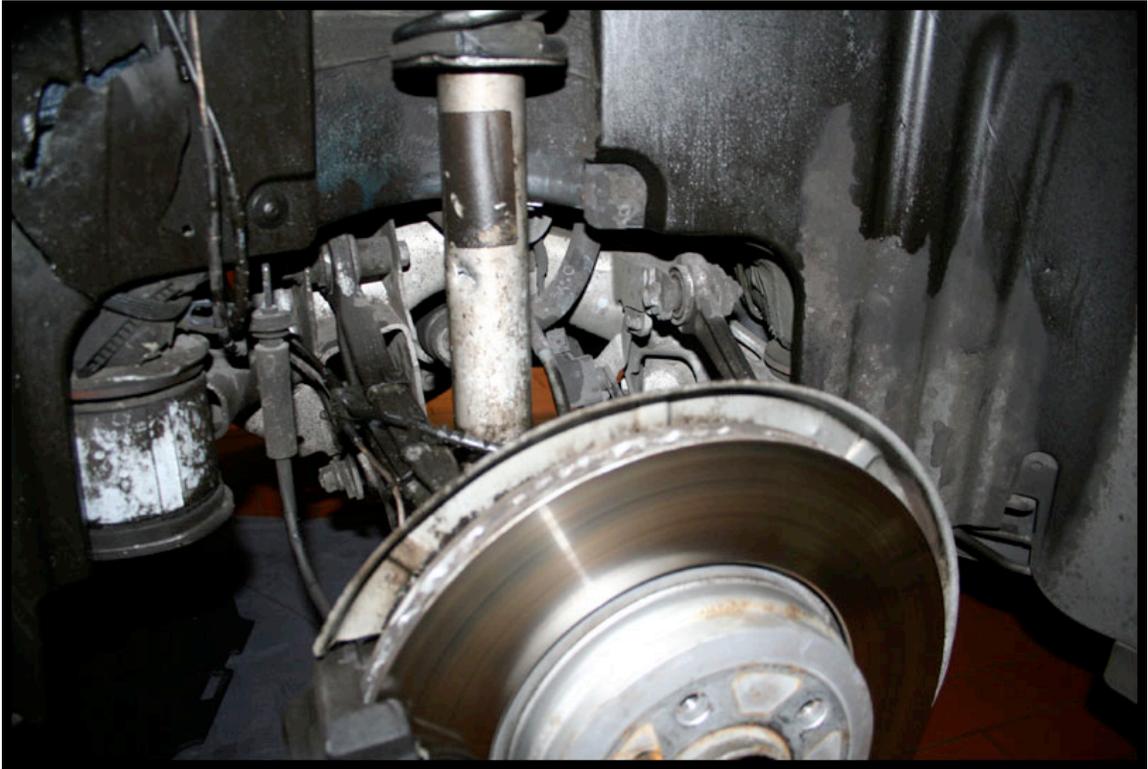
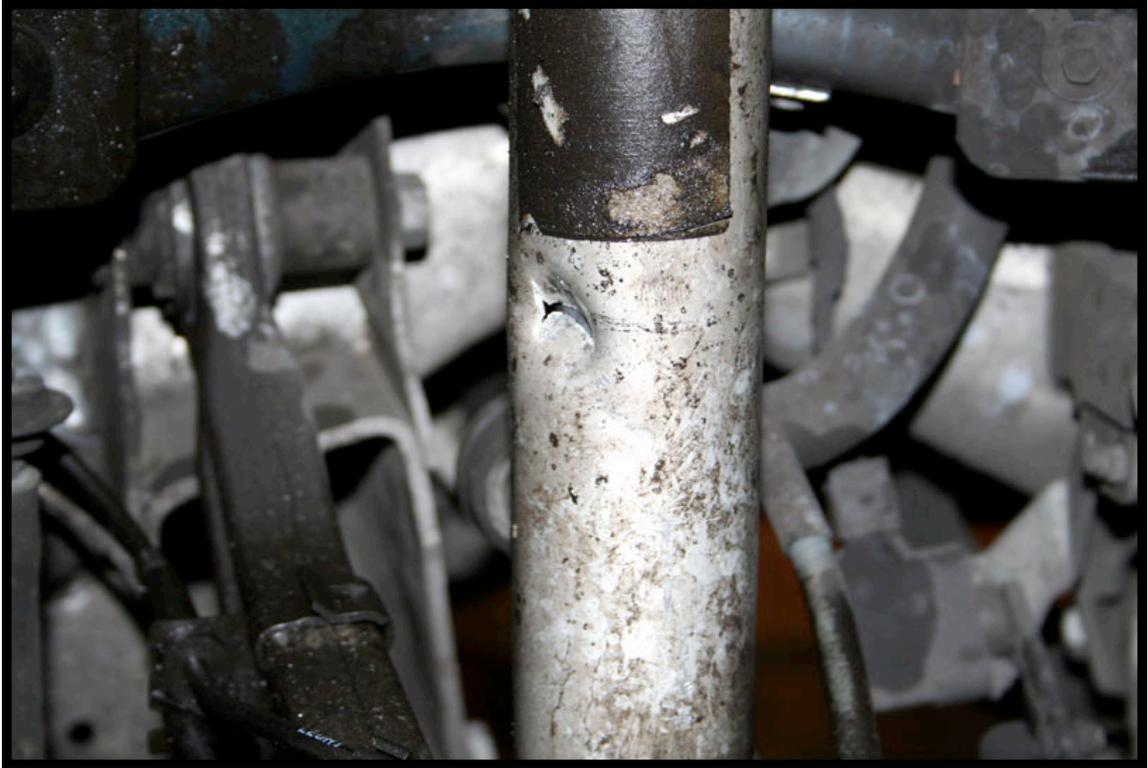
Right rear wheel failed, at approximately 75 mph at 1;00 a.m. on highway;
Wheel had been installed in place for approximately 2 weeks and 2,000 miles;
No impact experienced with wheel before failure (e.g., potholes, curbs);
Pieces of rim flew off, created a loss of control situation;
Shrapnel from wheel penetrated trunk compartment damaging battery;
Shrapnel also dented a shock absorber and cut a liquid-vapor separator in the fuel system
allowing raw fuel fumes to escape, but was not detected for another 700 miles of driving
due to location of damage;
Vehicle 2003 BMW 745

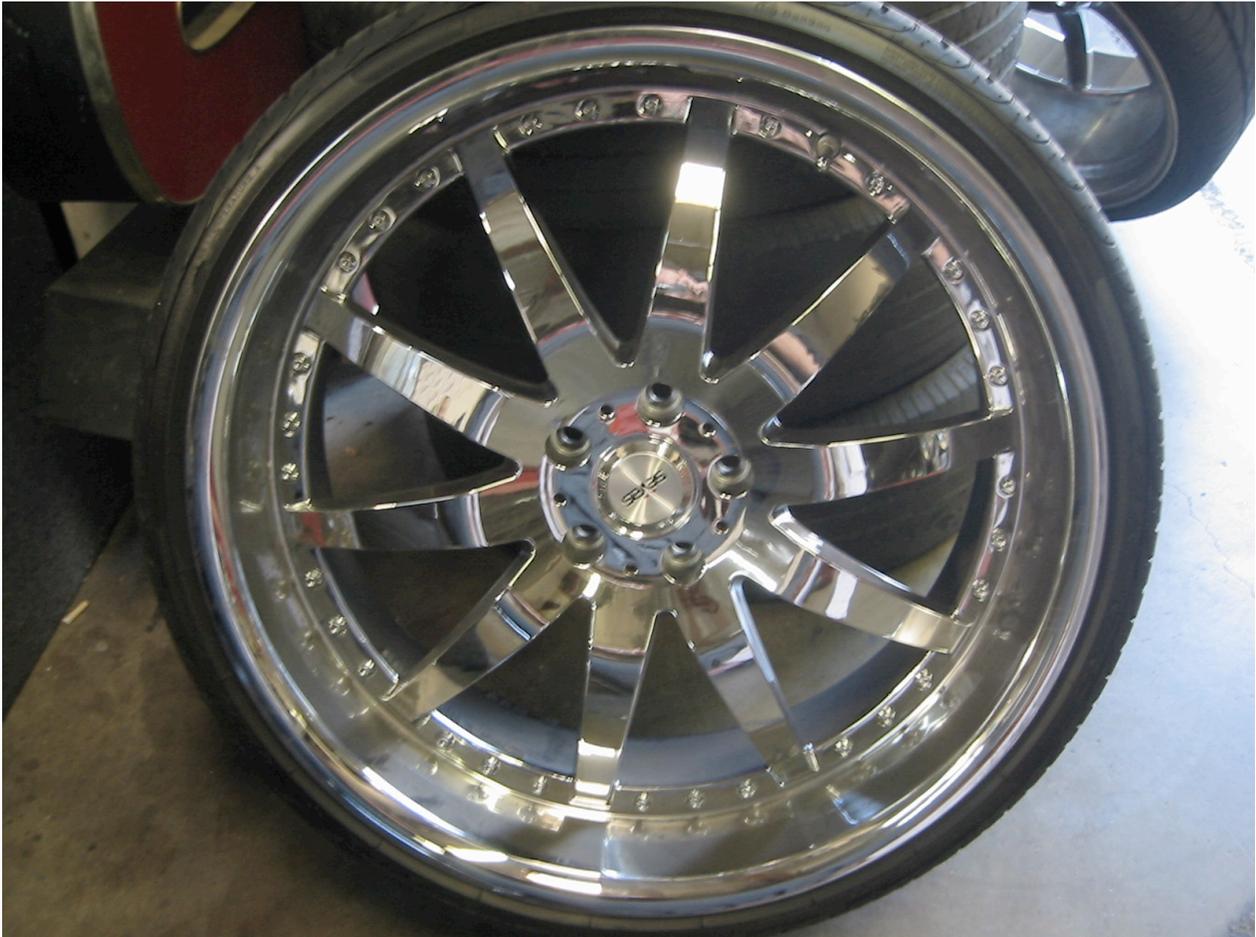
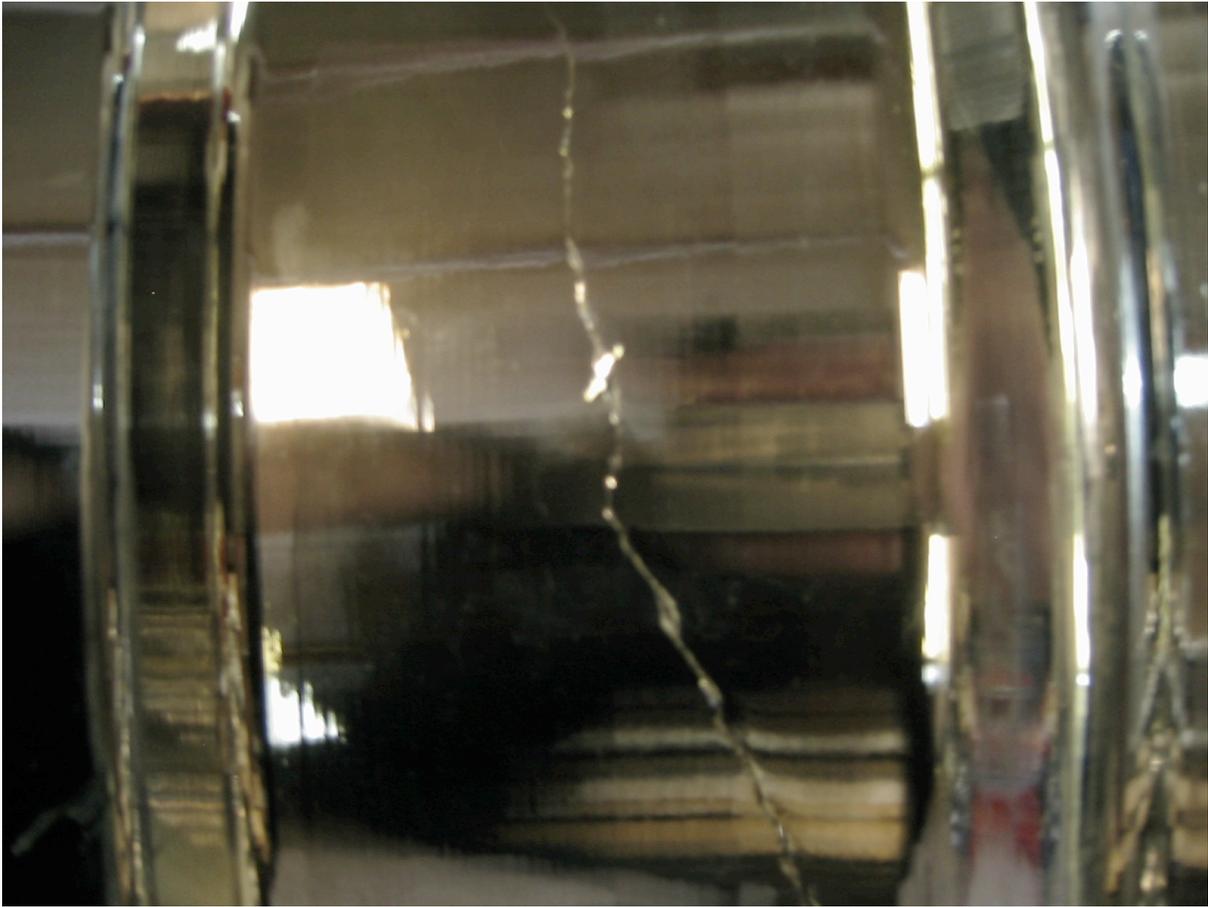
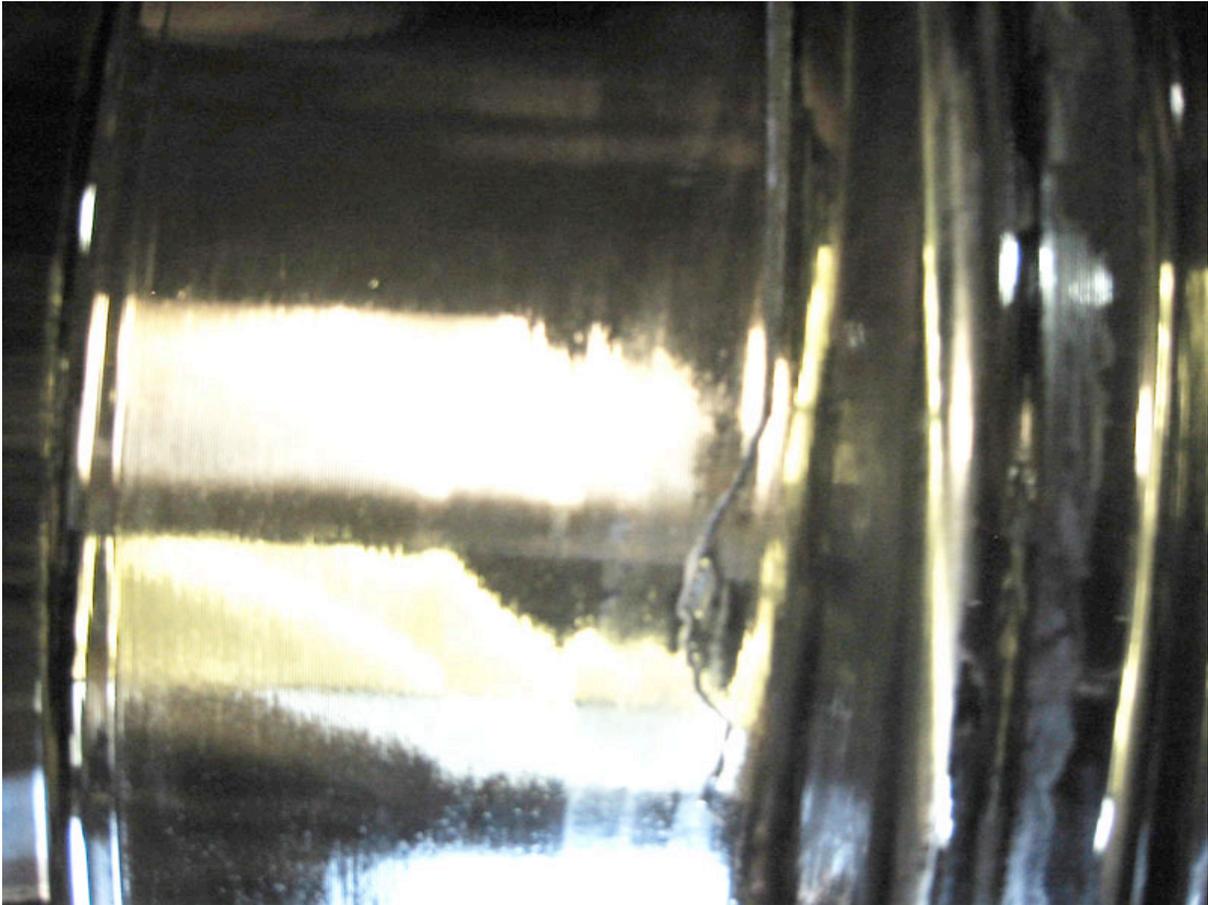
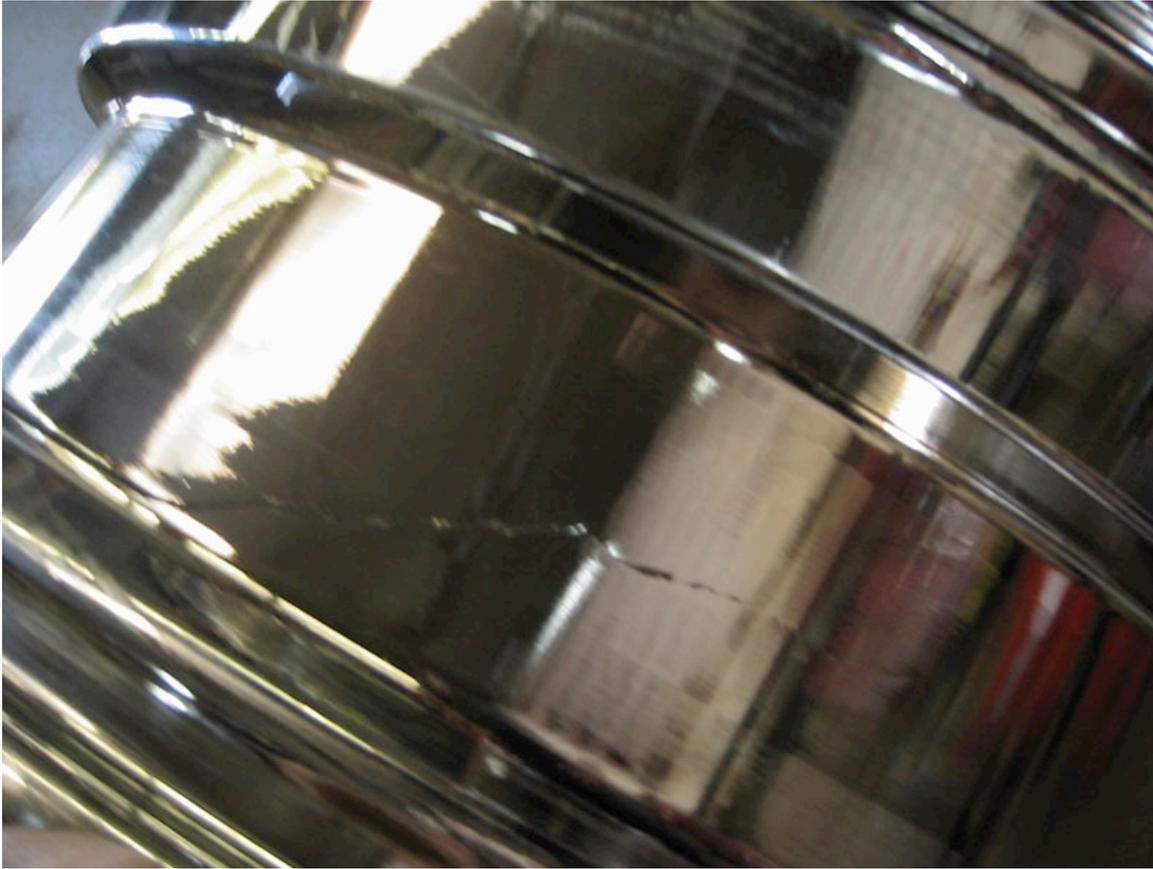
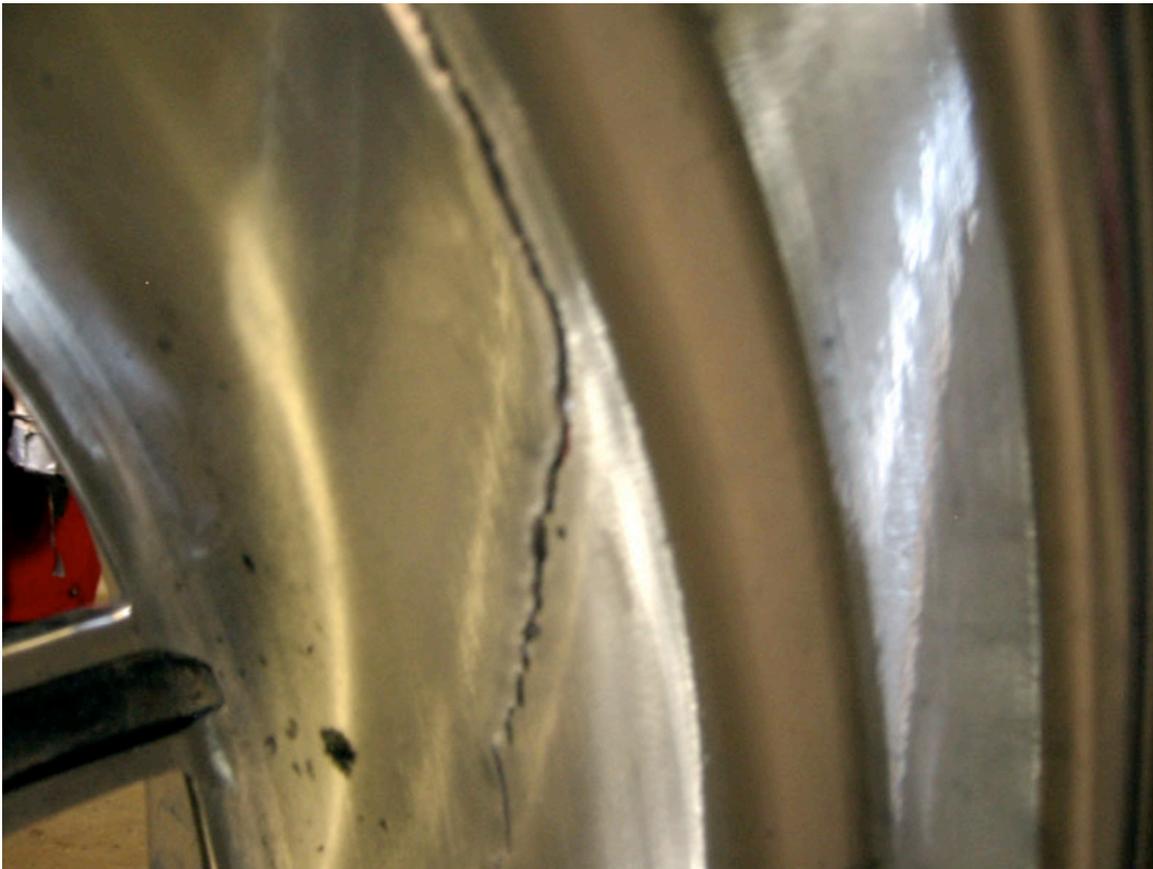
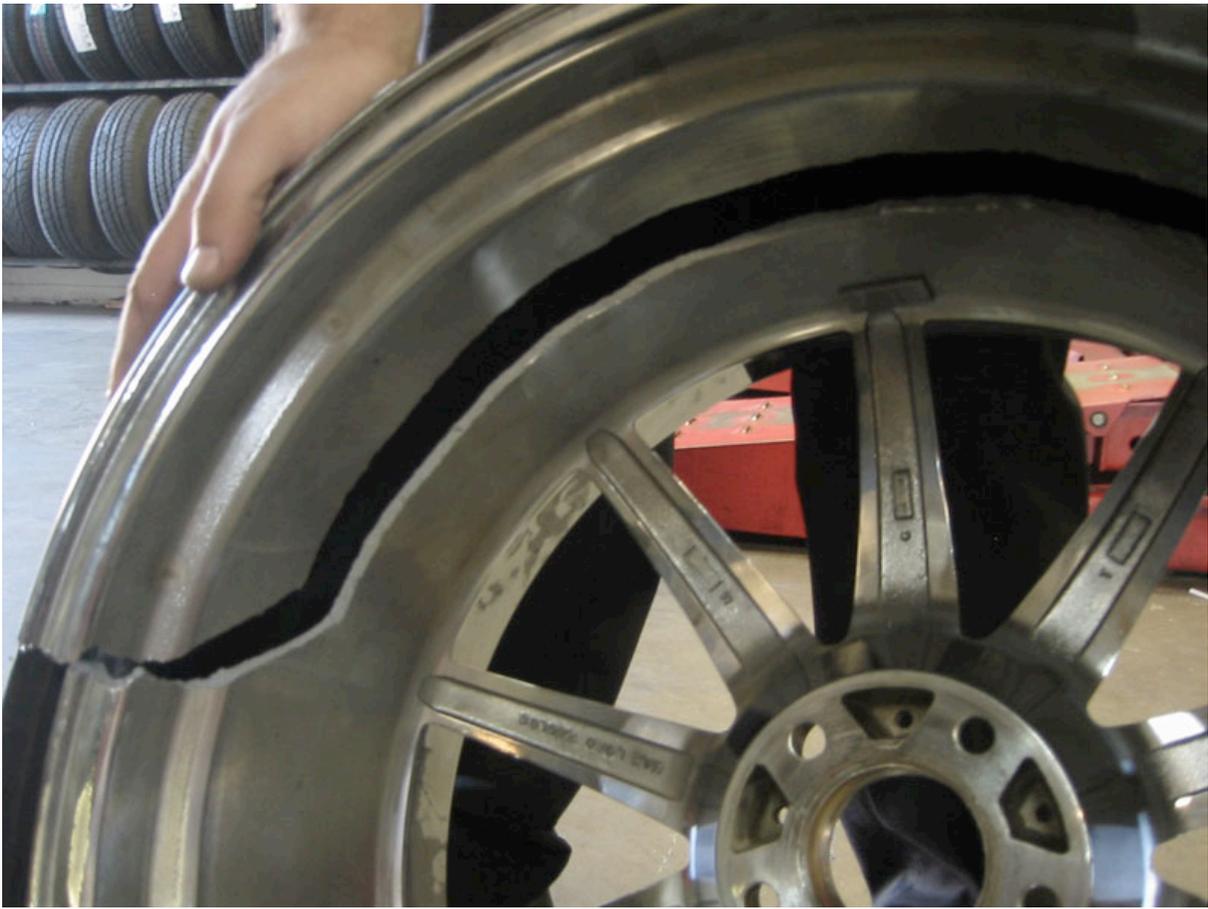
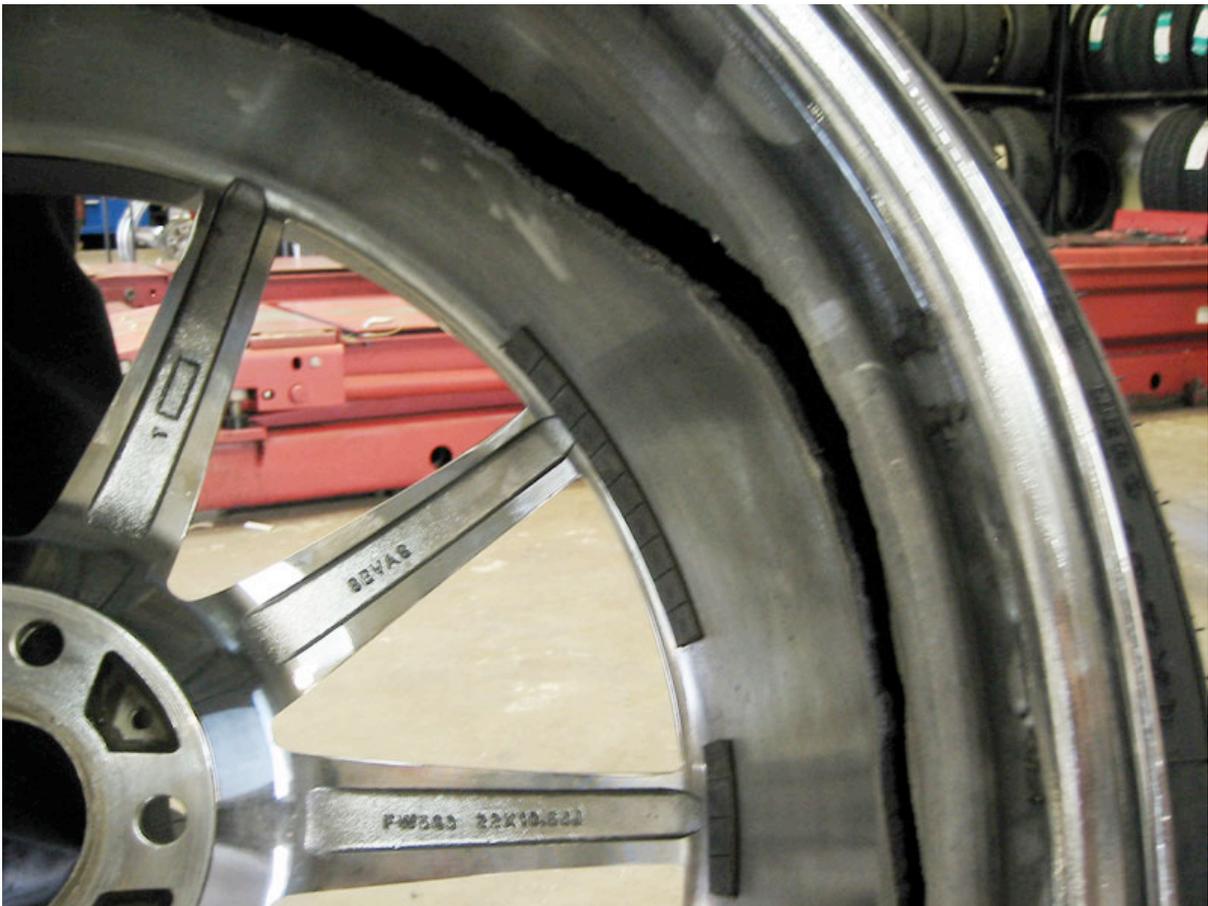
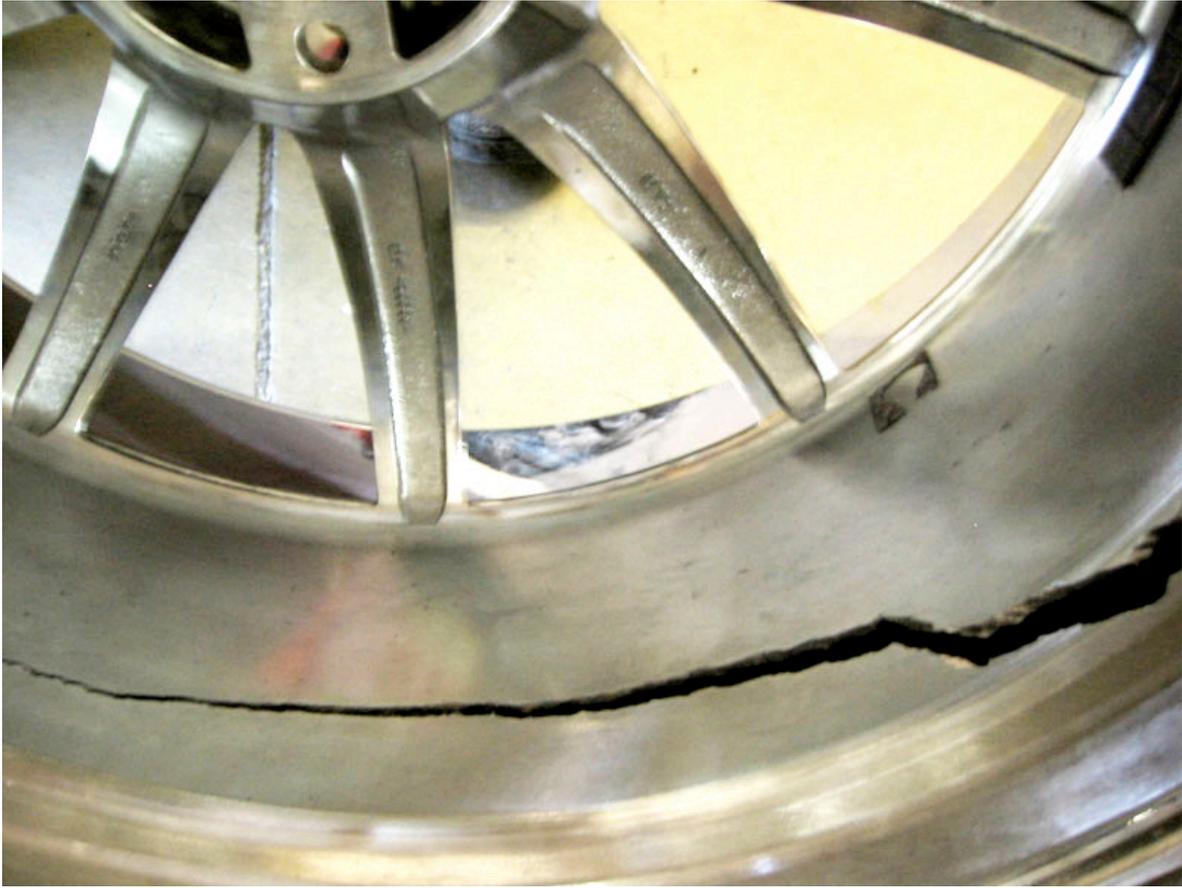
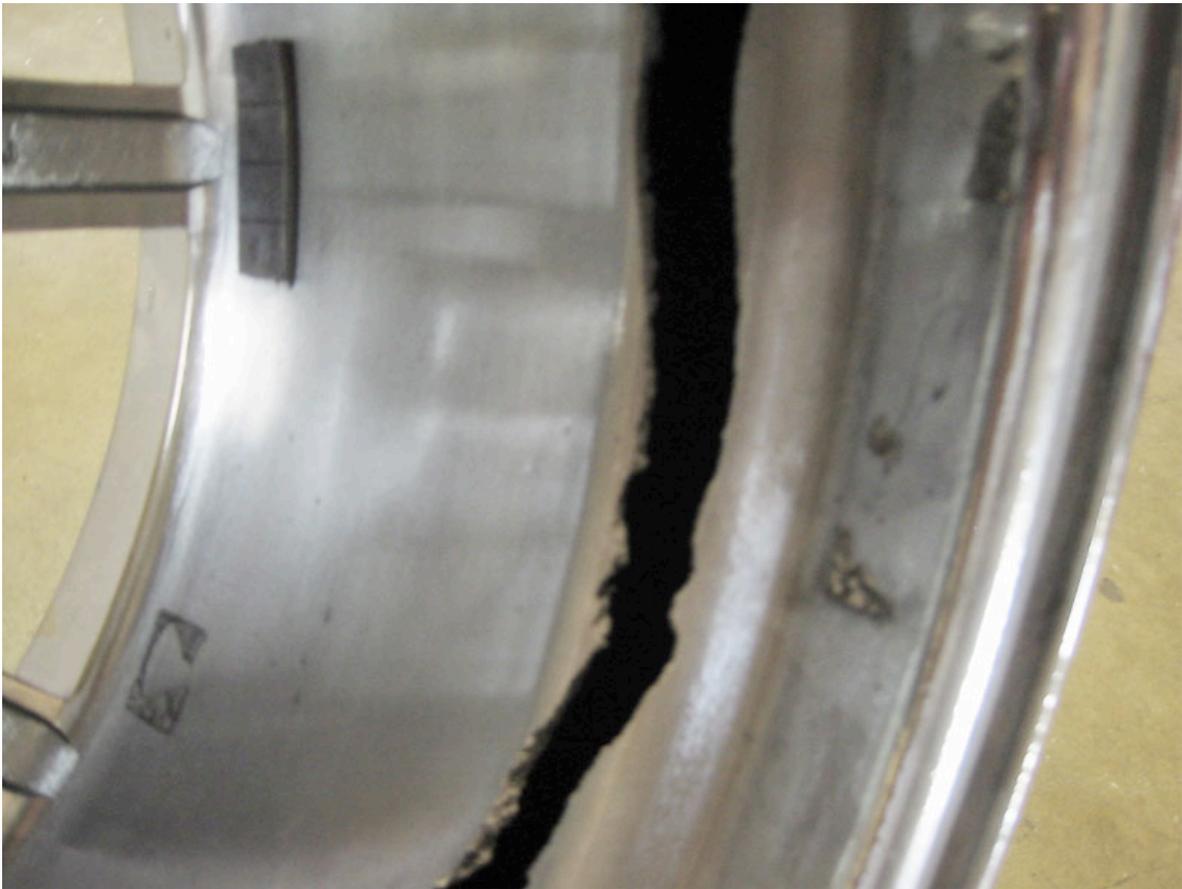
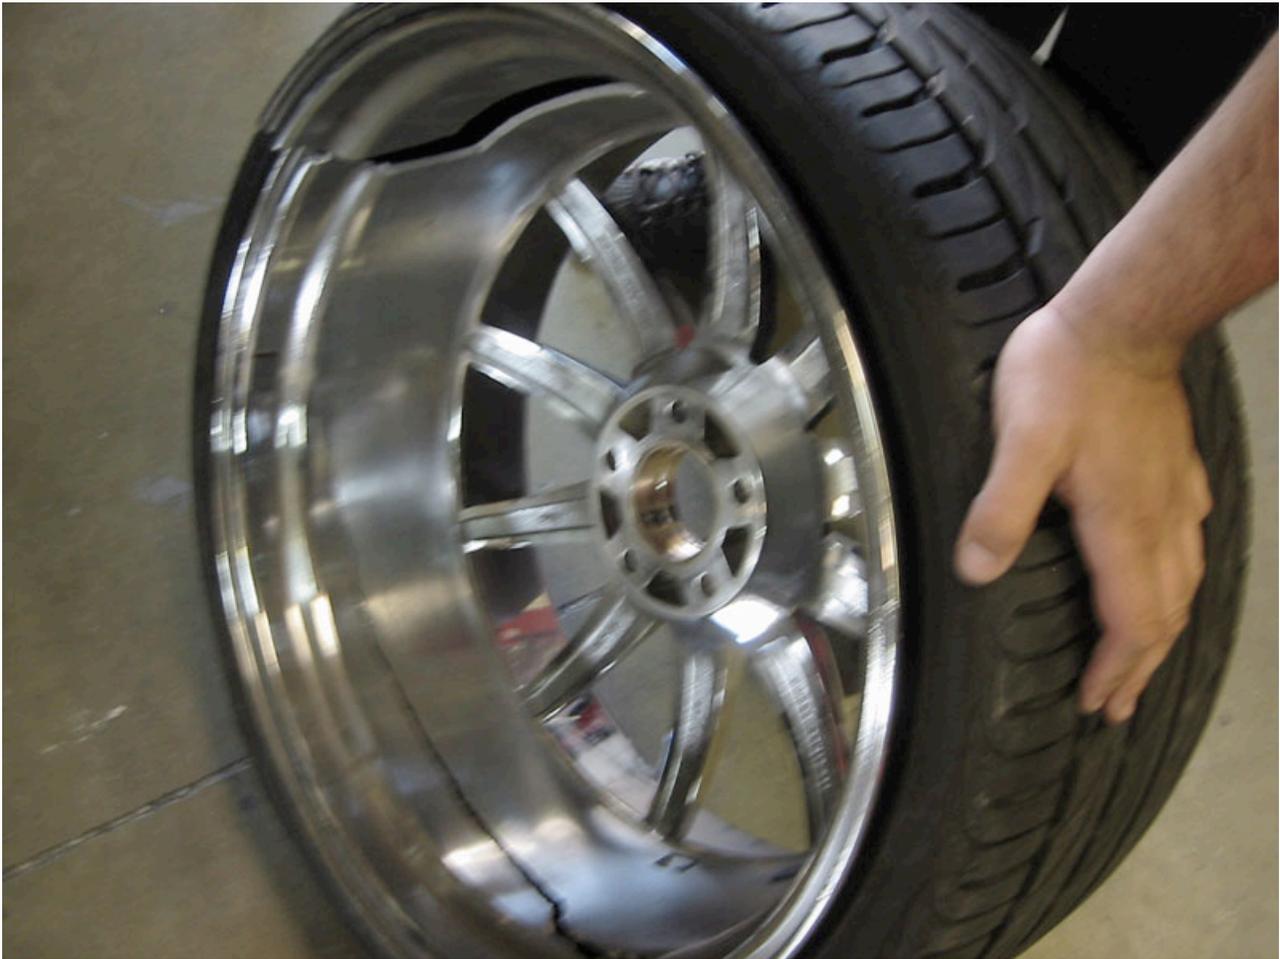
Left front and left rear cracked while driving 10 mph on city street;
No impact experienced with wheel before failure (e.g., potholes, curbs);
Prior to failure unresolved problems with vibration and balance;
Vehicle 2007 BMW 650
