Re: Recall No. 07V-486 Supplemental Information

MODEL: 2002~2008 KLR™ 650 (KL650-A16/L, A17/L, A18/L, A19/L,
KL650A6F/L, KL650A7F/L, KL650E8/L)

TITLE: MUFFLER MOUNTING BOLTS TORQUE

RECALL

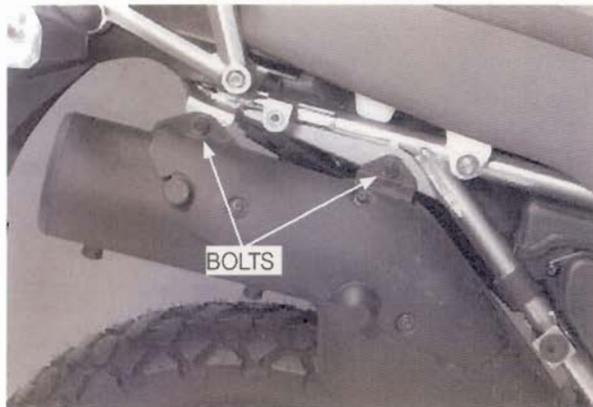
Muffler Mounting Bolts

On some eligible units, insufficient tightening torque of the muffler mounting bolts could allow the bolts to loosen. If the bolts loosen completely, it is possible for the muffler to separate from the motorcycle and create the potential for a crash resulting in injury or death.

- Remove the right side cover to expose the muffler.

- Tighten two muffler mounting bolts

**Muffler mounting bolt: 25 N-m
(2.5 kgf-m, 18.5 ft-lb)**

- Re-install right side cover.
