# TOYOTA CUSTOMER SERVICES

Volume: XIV  
Number: TC07-022  
Date: 12/14/2007  
 Action  
 Retain  
 Information

SUBJECT: SAFETY RECALL (SPECIAL SERVICE CAMPAIGN) – 70G  
(2007 MODEL YEAR TUNDRA 4WD REAR PROPELLER SHAFT)

**Special Service Campaign 70G  
2007 Model Year Tundra 4WD Rear Propeller Shaft  
SAFETY RECALL NOTICE**

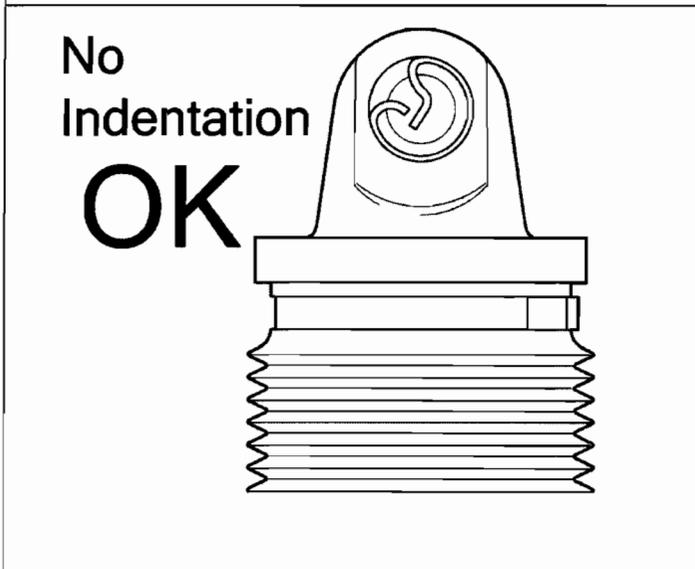
**INSPECTION PASSED**

- If **NO INDENTATION** is left, the joint is OK.
- Paint the sanded area with the paint marker.

- There may be a slight scratch or smudge left on the good joint.
- Multiple coats of paint may be required to properly cover the tested area.

- No repairs are necessary. The campaign is complete. Return the vehicle to the customer.

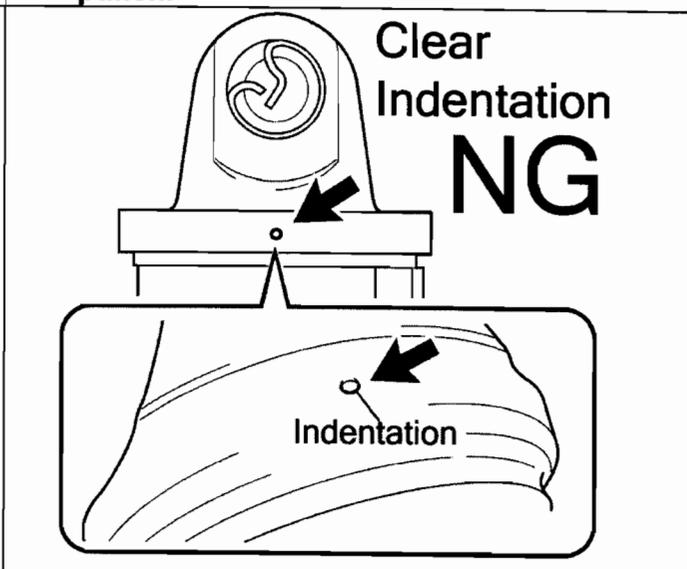
**INSPECTION FAILED**

There will be a clear indentation about the size of the center punch tip if the propeller shaft needs to be replaced.

If an **INDENTATION** is left, replace the rear propeller shaft. Proceed to the **SUPPLEMENT** section.
