SUBJECT: **Safety Recall 05S28 - Supplement #12:** 1992-2004 Multiple Vehicle Lines -
Speed Control System Modification

Safety Recall 05S28 - Supplement #12
1992-2004 Multiple Vehicle Lines
Speed Control System Modification

1992-2004 MULTIPLE VEHICLE LINES — SPEED CONTROL SYSTEM MODIFICATION

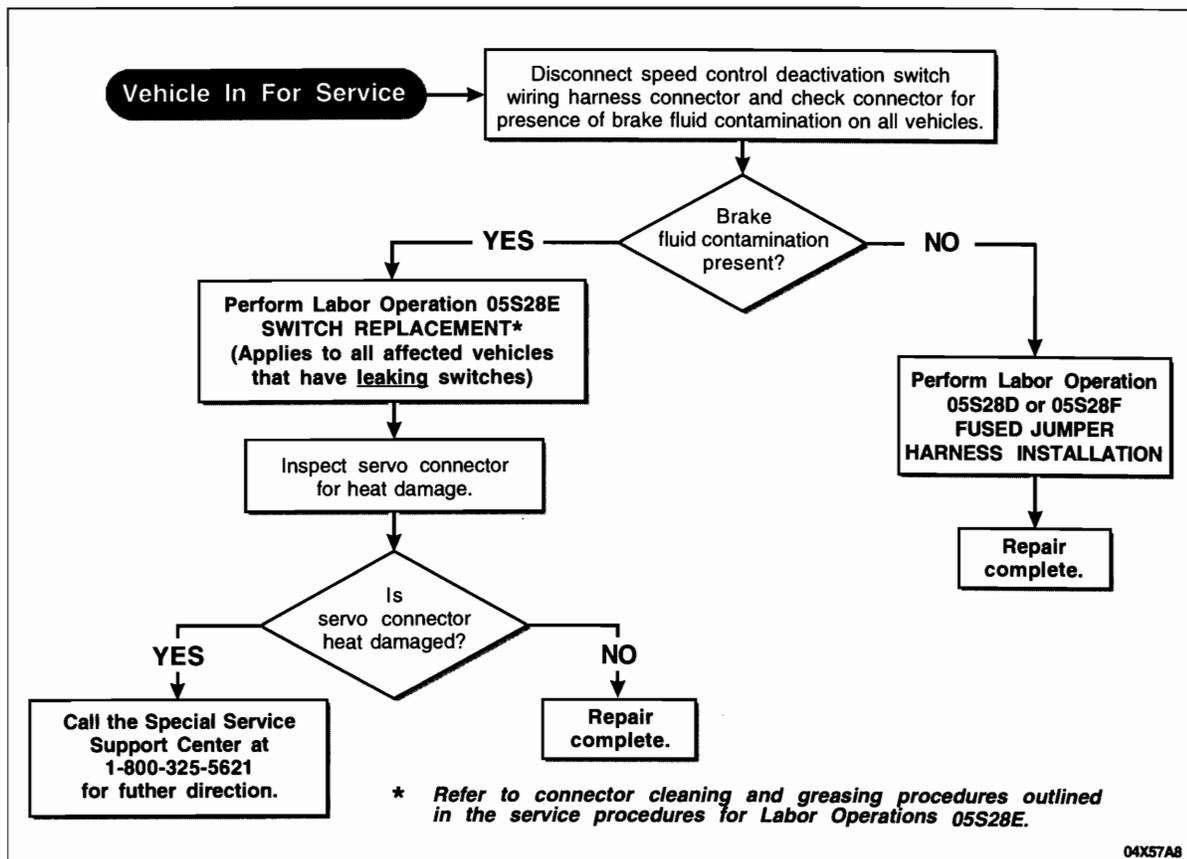
FIGURE 1

REPAIR FLOW CHART – PERMANENT REPAIR

1. Prior to performing each repair, the speed control deactivation switch harness connector must be carefully inspected for the presence of any brake fluid (evidence of a leaking switch).
2. If brake fluid is present:
 - a. the speed control deactivation switch harness electrical connector and the servo connector are blown dry of any trace of brake fluid (05S28E only).
 - b. electrical grease II (XG-15-A) is applied by the technician to the servo vehicle harness connector and the deactivation switch vehicle harness connector.

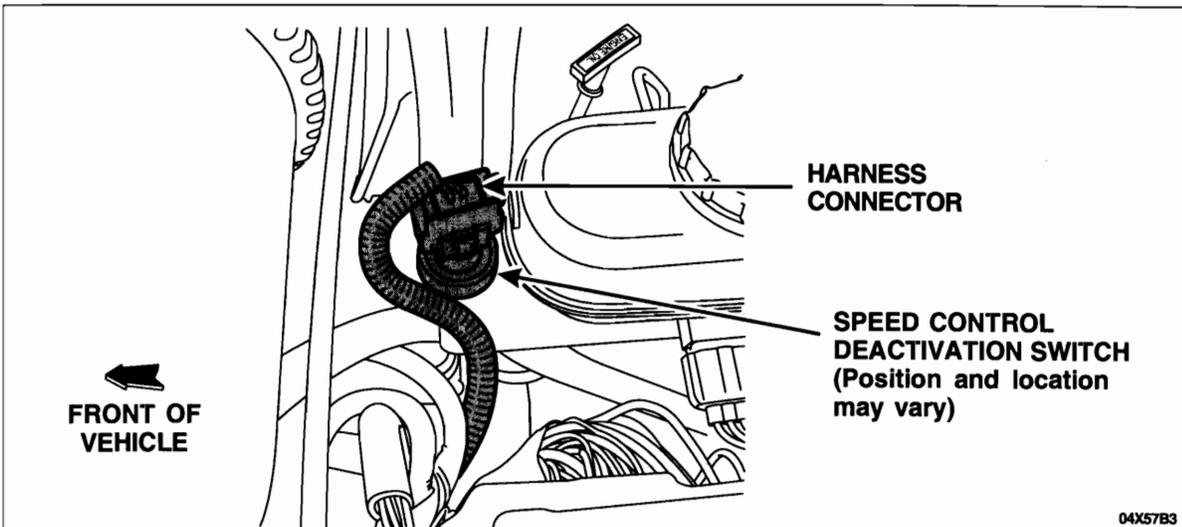
FIGURE 2

2. If necessary (E-150/250/350), lift the vehicle and disconnect the speed control deactivation switch and inspect the harness connector for the presence of brake fluid. See Figure 2.
 - If no brake fluid is present:
 - install the fused jumper harness (Labor Operation D or F).
 - If brake fluid is present, proceed to Labor Operation E.

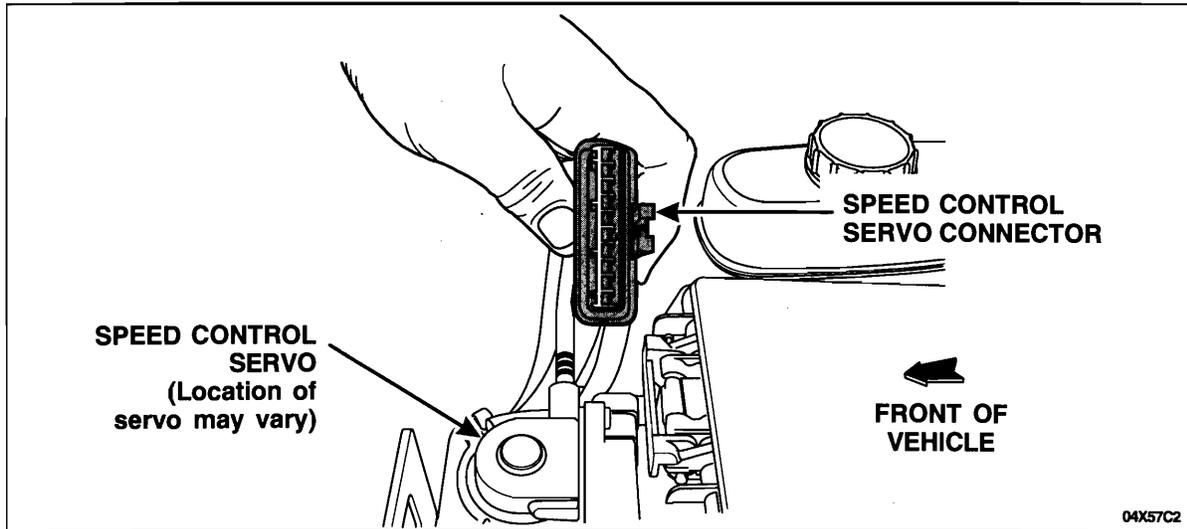
FIGURE 7

6. Disconnect the speed control servo and inspect the vehicle harness connector for heat damage. See Figure 7.
 - If no heat damage is found at the speed control servo connector (even if there is presence of brake fluid in the connector), proceed to next step.
 - If the speed control servo connector is heat damaged, call the Special Service Support Center at 1-800-325-5621 for further instructions.
