SUBJECT: DEMONSTRATION / DELIVERY HOLD: Safety Recall 06S47:
Certain 2006, Low Cab Forward Vehicles
Injection Pressure Regulator (IPR) Heat Shield Replacement and Connector Inspection

Safety Recall 06S47
Certain 2006, Low Cab Forward Vehicles
Injection Pressure Regulator (IPR) Heat Shield Replacement and Connector Inspection

CERTAIN 2006 MODEL YEAR LOW CAB FORWARD (LCF) VEHICLES — INJECTION PRESSURE REGULATOR (IPR) INSPECTION AND REPAIR

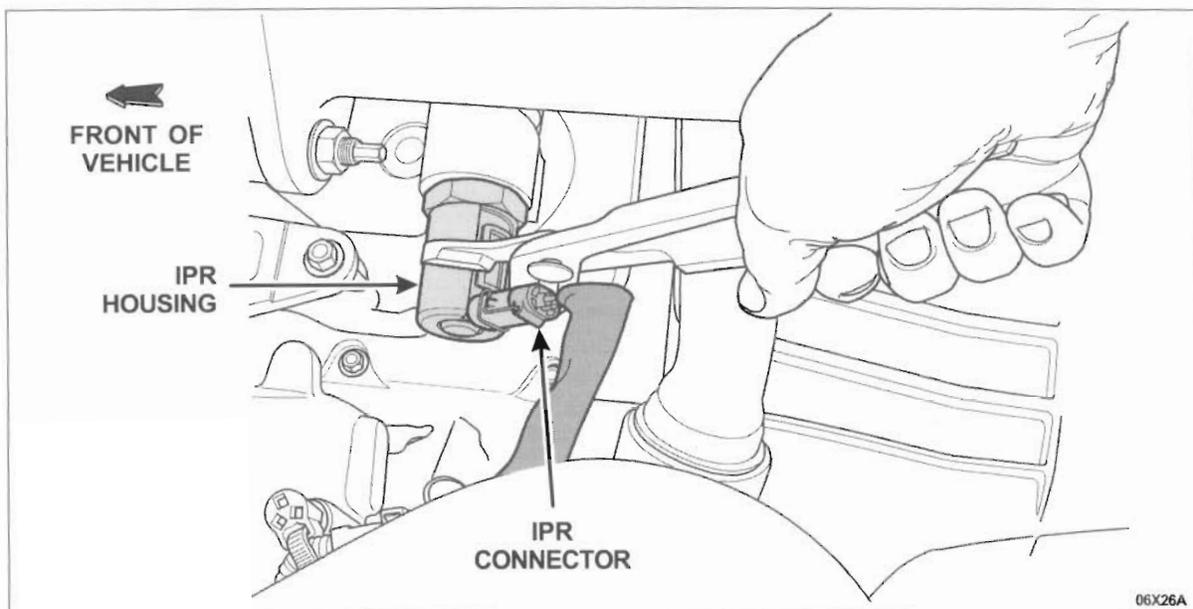
FIGURE 1

NOTE: The IPR valve may be found with the connector pointing down. In this position inspection, application of electrical grease and reconnecting the harness connector is difficult. To assist in this repair, it is advised that you rotate the IPR housing using suitable pliers and orient the connector so it is pointing in a direction that allows you to be able to see inside the connector. DO NOT ATTEMPT TO EITHER LOOSEN OR TIGHTEN THE IPR TO RE-ORIENT THE HOUSING. THE HOUSING WILL ROTATE SEPARATELY FROM THE VALVE. Use care when rotating the housing to avoid damaging the inner plastic housing. Do not crush the outer housing. See Figure 1.

After performing the necessary repairs, it is essential that the connector be re-oriented so it points straight down. This will help prevent water from entering the connector.

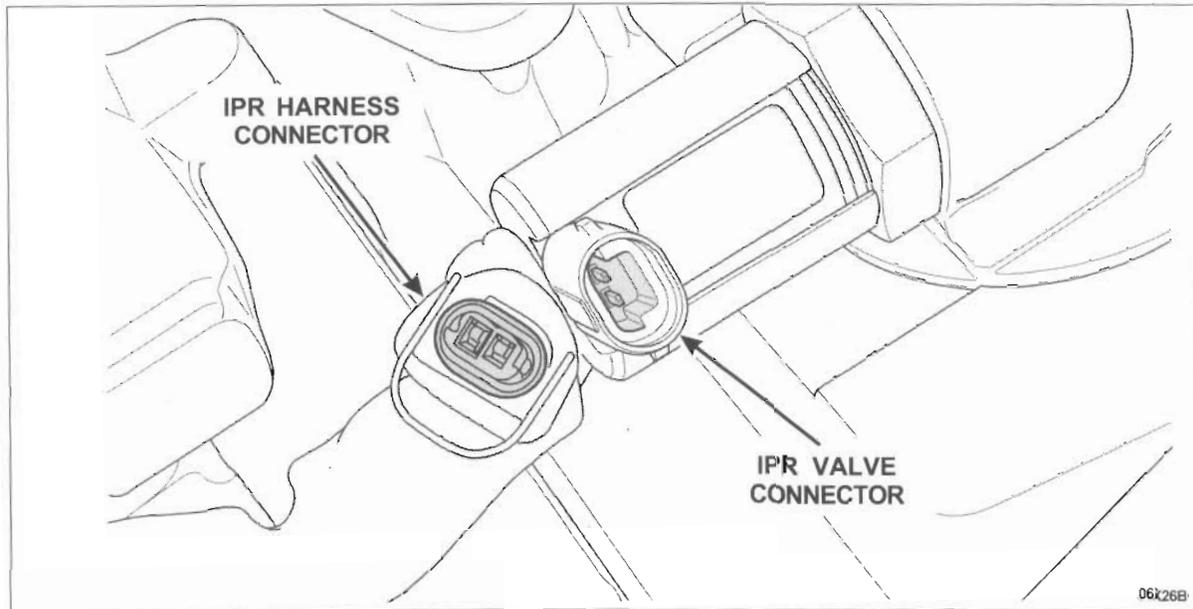
FIGURE 2

1. Disconnect the IPR electrical connector and inspect the harness connector and the IPR valve connector for the presence of corrosion. See Figure 2.
 - If the connector is free of corrosion, proceed to Step 2.
 - If the **harness** connector shows signs of corrosion, proceed to Harness Pigtail Replacement in this Attachment III.
 - If the **IPR valve** connector shows signs of corrosion, contact the Special Service Support Center at 1-800-325-5621 for further instructions.
