**Re: Defect Information Report – Supplemental Report No. 1  
07V-530, FL-514, Holland Simplex Fifthwheel Lever Pivot Bolt**

## Subject: Holland Simplex Fifth Wheel Pivot Spacers

January 2008  
 FL514AB  
 NHTSA #07V-530  
 REVISED NOTICE

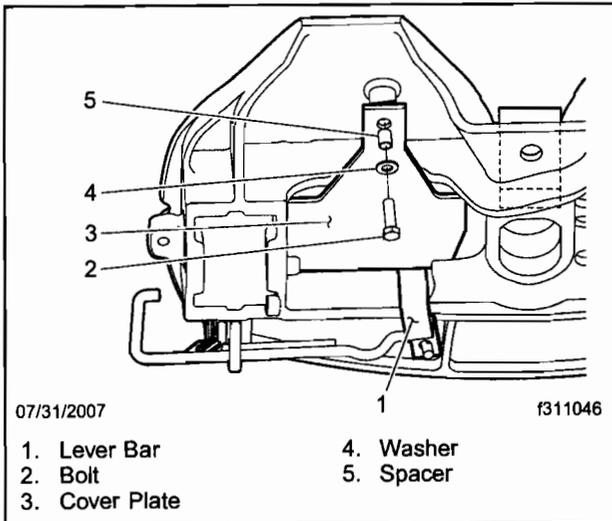
**Fig. 1, Fifth Wheel Components**

If a hex head bolt is present, proceed with the next step. See **Fig 1**.

- Remove the bolt and inspect to determine if it is the original pivot bolt with spacer sleeve or if it is a shoulder bolt and washer. See **Fig. 1** and **Fig. 5**.

If it is the original pivot bolt with spacer sleeve, the spacer may need to be dislodged using a 5/8-inch (16-mm) diameter rod. Remove and discard the bolt, spacer sleeve, and washer and proceed to step 8.

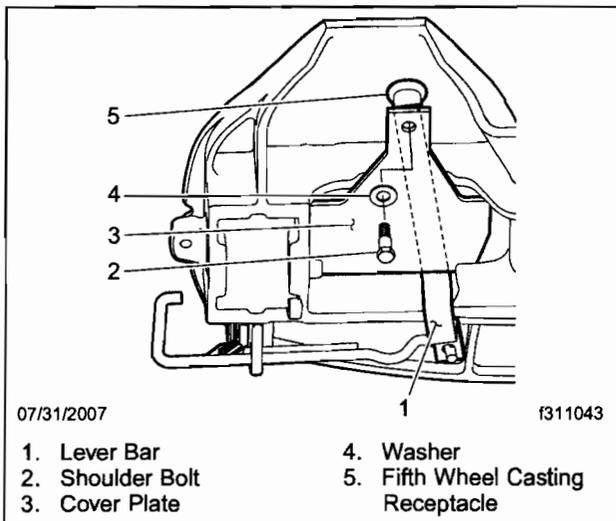
**Fig. 5, Fifth Wheel Components Including Replacement Parts**

If it is a shoulder bolt and washer, the correct bolt and washer are being used. Proceed to step 9.

- Install the new shoulder bolt and washer from the kit, or if the vehicle already contains the correct shoulder bolt, reinstall the existing shoulder bolt and washer ensuring that the bolt passes through the holes in the cover plate and lever bar and into the threaded fifth wheel casting receptacle. Then tighten the shoulder bolt until there is no more than 3/16 inch of free play in the component stack (washer, cover plate, and lever bar), and use a torque wrench to tighten the bolt to 80 lbf·ft (108 N·m). See **Fig. 5** and **Fig. 6**.

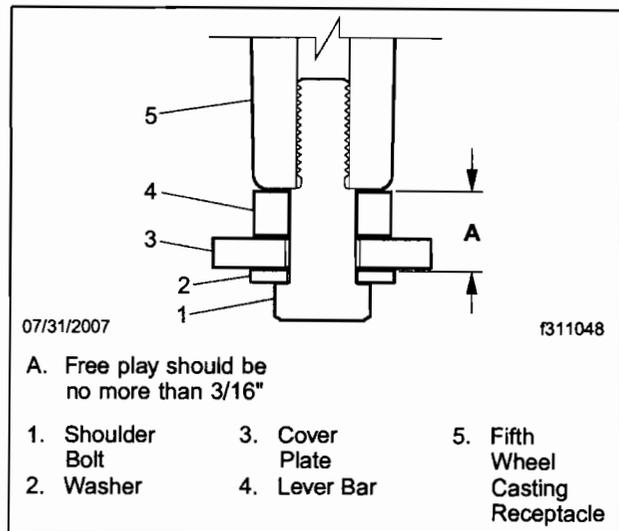
**Fig. 6, Component Stack**

NOTE: Free play is the allowed vertical movement of components between the bolt and the fifth wheel casting receptacle.

A. Free play should be no more than 3/16"

10. Ensure that the lever bar and cover plate can move freely up and down the shoulder bolt. See **Fig. 6**.

If they cannot move freely, or there is more than 3/16 inch of free play, remove the shoulder bolt and washer and reinstall them as described in steps 8 and 9 of this procedure.
