**Re: Defect Information Report – Supplemental Report No. 3  
07V-306, FL-501, AAC Front Axle Steering Arm Bolts**

## Subject: AAC Front Axle Tie Rod and Steering Arm Fasteners

December 2007  
 FL501A  
 NHTSA #07V-306

Instruction Sheet #TBB 85490087

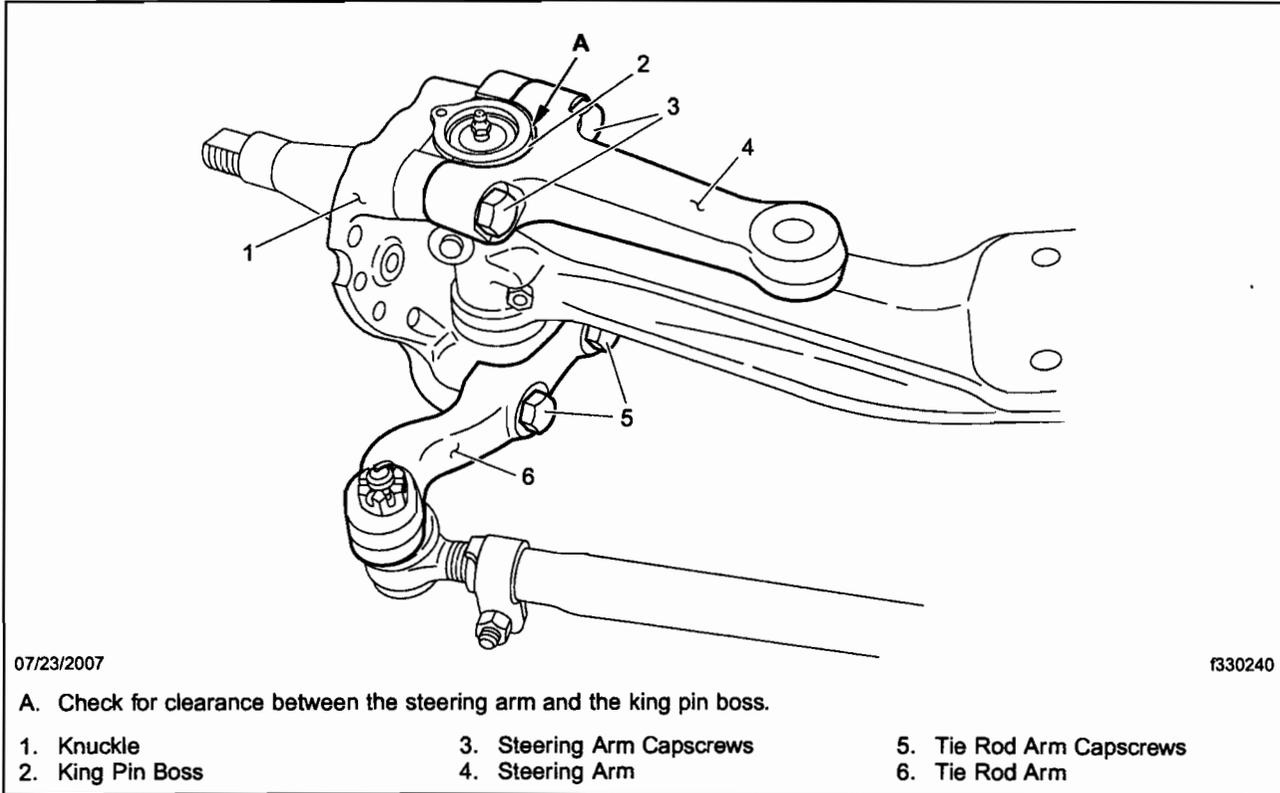
**Fig. 1, Steering Arm and Tie Rod Arm**

During front axle assembly, the fasteners that attach the steering arm or the tie rod arms to the spindle may have been over or under tightened. Incorrectly tightened fasteners may fatigue and fracture, resulting in a possible vehicle crash without prior warning.

1. Check the base label (Form WAR259) for a completion sticker for FL501 (WAR260) indicating this work has been done. The base label is usually located on the passenger-side door about 12 inches (30 cm) below the door latch on trucks, over the driver's window in school buses, on the front wall under the dash in motorhomes, or in the driver's area in step vans. If a completion sticker for FL501 is present, nothing more needs to be done. If no sticker is present, go to the next step.
2. Shut down the engine, and chock the front tires.
3. Using a 0.004 inch (0.1 mm) feeler gauge, check the clearance between the steering arm and the king pin boss. See Fig. 1.

1. Remove one of the capscrews that attaches the steering arm to the steering knuckle. See Fig. 1.
2. Check the capscrew threads to verify whether Loctite® or another thread locking compound was applied to them.

3. Apply Loctite 277 to the threads of a new M20 x 1.5 x 80 capscrew from the Recall kit.
4. Install the new steering arm capscrew and tighten it 425 lbf-ft (575 N-m).
5. Repeat steps 1 through 4 to replace the second capscrew.
6. Continue with the "Tie Rod Arm Capscrew Replacement" procedure in these Work Instructions.

1. Remove one of the capscrews that attaches the tie rod arm to the knuckle. See **Fig. 1**.
2. Check the capscrew threads to verify whether Loctite® or another thread locking compound was applied to them.

3. Apply Loctite 277 to the threads of a new M20 x 1.5 x 90 capscrew.
4. Install the new tie rod arm capscrew and tighten it 425 lbf-ft (575 N·m).
5. Repeat steps 1 through 4 until all four of the tie rod arm capscrews have been replaced.
6. Clean a spot on the base label (Form WAR259) and attach a completion sticker for Recall FL501 (Form WAR 260) to the base label.
7. Remove the chocks.

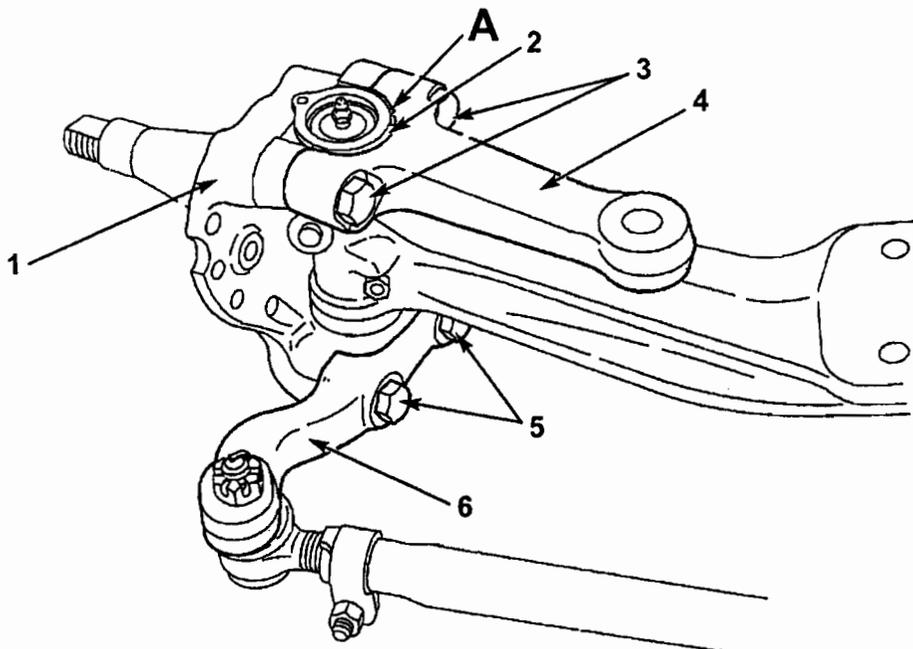
Figure 1

1. Shut down the engine, and chock the front tires.
2. Using a 0.004" (0.1 mm) feeler gauge, check the clearance between the steering arm and the king pin boss. **Figure 1**

### A. Check for clearance between the steering arm and the king pin boss.

1. Remove one of the capscrews that attaches the steering arm to the steering knuckle. **Figure 1**
2. Check the capscrew threads to verify whether Loctite® or another thread locking compound was applied to them.

3. Apply Loctite 277 to the threads of a new M20 x 1.5 x 80 capscrew from the Recall Kit.
4. Install the new steering arm capscrew and tighten it 425 ft/lbs. (575 N·m).
5. Repeat steps 1 through 4 to replace the second capscrew.
6. Continue with the "Tie Rod Arm Capscrew Replacement" procedure.

1. Remove one of the capscrews that attaches the tie rod arm to the knuckle. **Figure 1**
2. Check the capscrew threads to verify whether Loctite® or another thread locking compound was applied to them.

3. Apply Loctite 277 to the threads of a new M20 x 1.5 x 80 capscrew.
4. Install the new tie rod arm capscrew and tighten it 425 ft/lbs. (575 N·m).
5. Repeat steps 1 through 4 until all four of the tie rod arm capscrews have been replaced.
6. Remove the chocks.
