**Re: Defect Information Report – Supplemental Report No. 4
07V-306, FL-501, AAC Front Axle Steering Arm Bolts**

**Recall Notification
Subject: AAC Front Axle Tie Rod and Steering Arm Fasteners**

December 2007
FL501A
NHTSA #07V-306

Subject: RECALL 07V-306 – AAC Front Axle Tie Rod & Steering Arm Fasteners

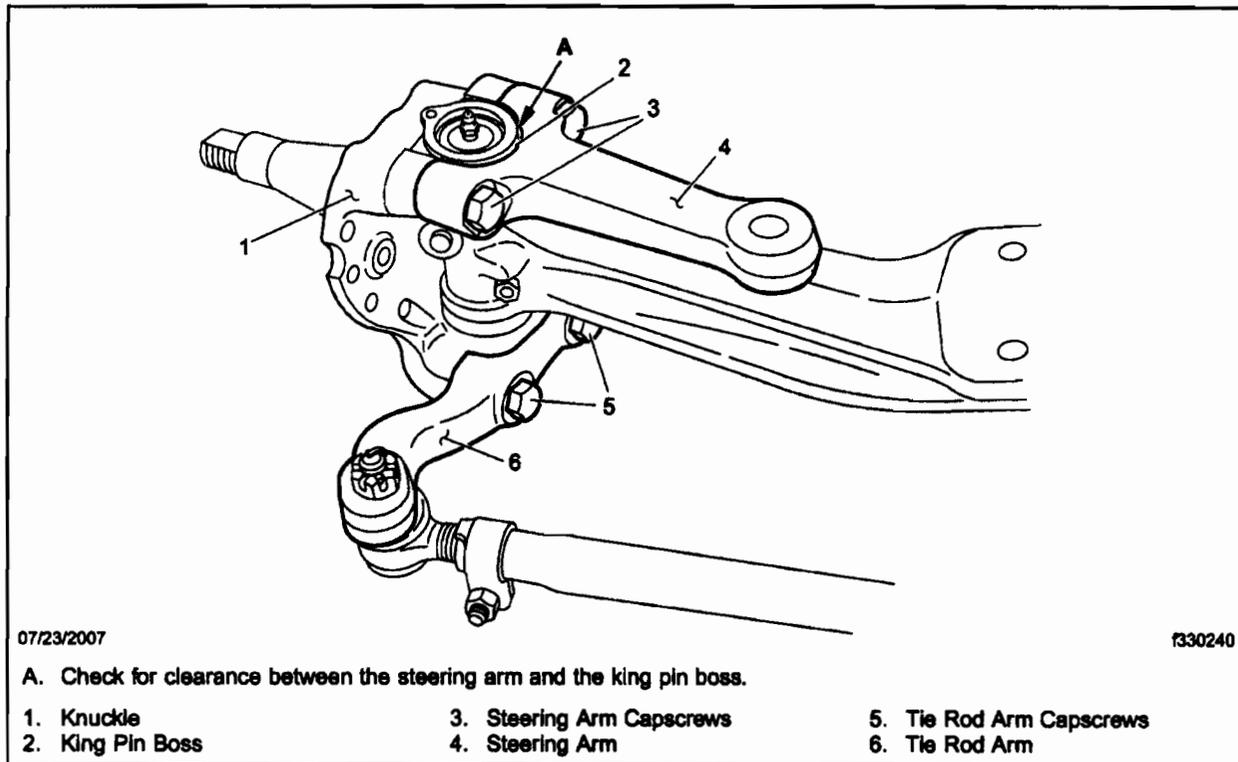
Fig. 1, Steering Arm and Tie Rod Arm

During front axle assembly, the fasteners that attach the steering arm or the tie rod arms to the spindle may have been over or under tightened. Incorrectly tightened fasteners may fatigue and fracture, resulting in a possible vehicle crash without prior warning.

1. Check the base label (Form WAR259) for a completion sticker for FL501 (WAR260) indicating this work has been done. The base label is usually located on the passenger-side door about 12 inches (30 cm) below the door latch on trucks, over the driver's window in school buses, on the front wall under the dash in motorhomes, or in the driver's area in step vans. If a completion sticker for FL501 is present, nothing more needs to be done. If no sticker is present, go to the next step.
2. Shut down the engine, and chock the front tires.
3. Using a 0.004 inch (0.1 mm) feeler gauge, check the clearance between the steering arm and the king pin boss. See Fig. 1.

1. Remove one of the capscrews that attaches the steering arm to the steering knuckle. See Fig. 1.
2. Check the capscrew threads to verify whether Loctite® or another thread locking compound was applied to them.

3. Apply Loctite 277 to the threads of a new M20 x 1.5 x 80 capscrew from the Recall kit.
4. Install the new steering arm capscrew and tighten it 425 lbf-ft (575 N-m).
5. Repeat steps 1 through 4 to replace the second capscrew.
6. Continue with the "Tie Rod Arm Capscrew Replacement" procedure in these Work Instructions.

1. Remove one of the capscrews that attaches the tie rod arm to the knuckle. See Fig. 1.
2. Check the capscrew threads to verify whether Loctite® or another thread locking compound was applied to them.

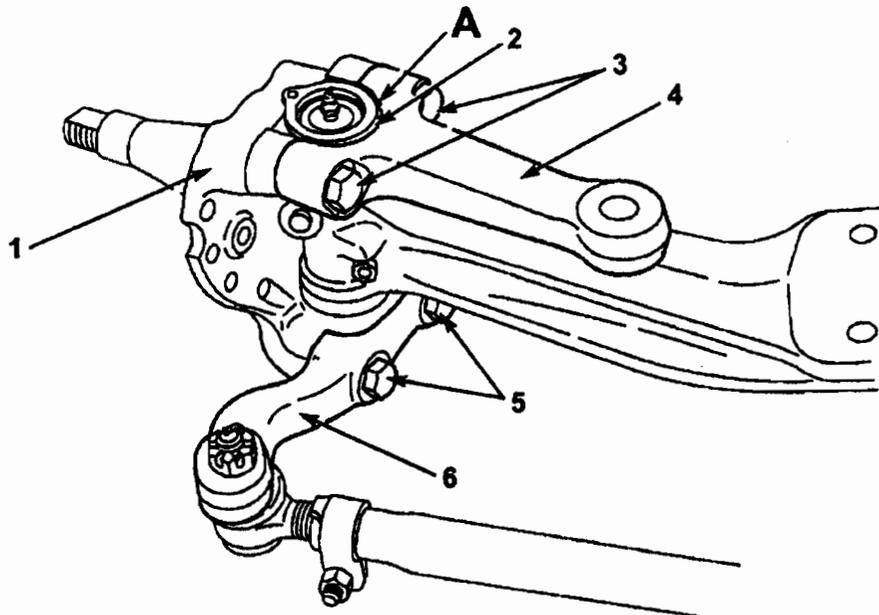
A. Check for clearance between the steering arm and the king pin boss.

If there is clearance, go to the "Steering Arm Capscrew Replacement" and "Tie Rod Arm Capscrew Replacement" procedures found on page two of this document.

If there is no clearance, the steering arm must be replaced. Go to the "Steering Arm Replacement" procedure found on page two of this document.
