**Re: Defect Information Report – Supplemental Report No. 4
07V-302, FL-504, Bendix SR-7 Spring Brake Control Valve Assembly Check Valves**

**April 2008
FL504
NHTSA #07V-302**

**Recall Notification
Subject: Bendix SR-7 Park Brake Valves**

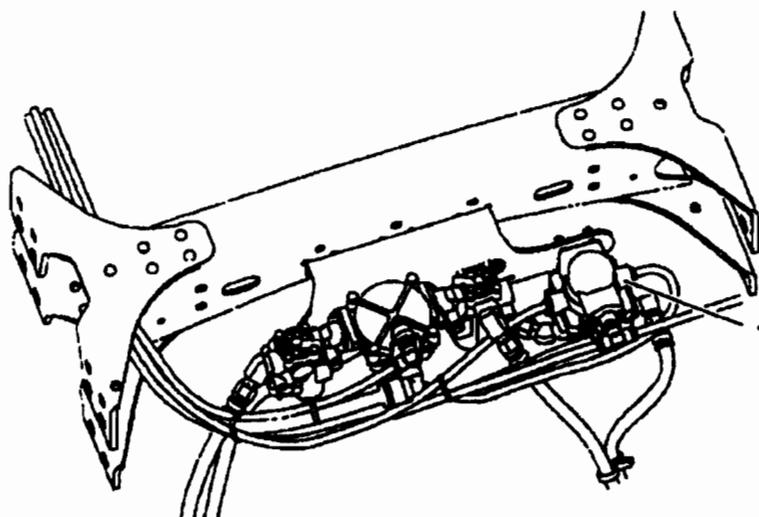
1. SR-7 Valve

Note: HDX units are not using Date Code on valve.

5. Install the valve and bracket onto the crossmember.
6. Connect all of the air lines.
7. Before returning the vehicle to service, perform the operating and leakage tests.

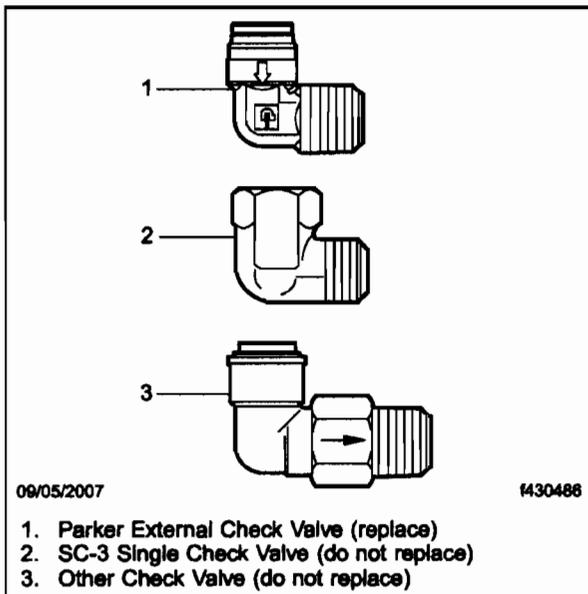
Fig. 1, External Check Valve Identification

If the brass retainer and internal components are not present and intact, both the Parker external check valve and the entire SR-7 valve must be replaced. First complete the "SR-7 Valve Replacement" below then continue with this procedure and install the external check valve kit.

8. Using pipe sealant, install the new Parker single check valve, from the kit. Be careful to orient it in the same position as the original.
9. Install the 1/2-inch o.d. supply line in the external single check valve supply port.

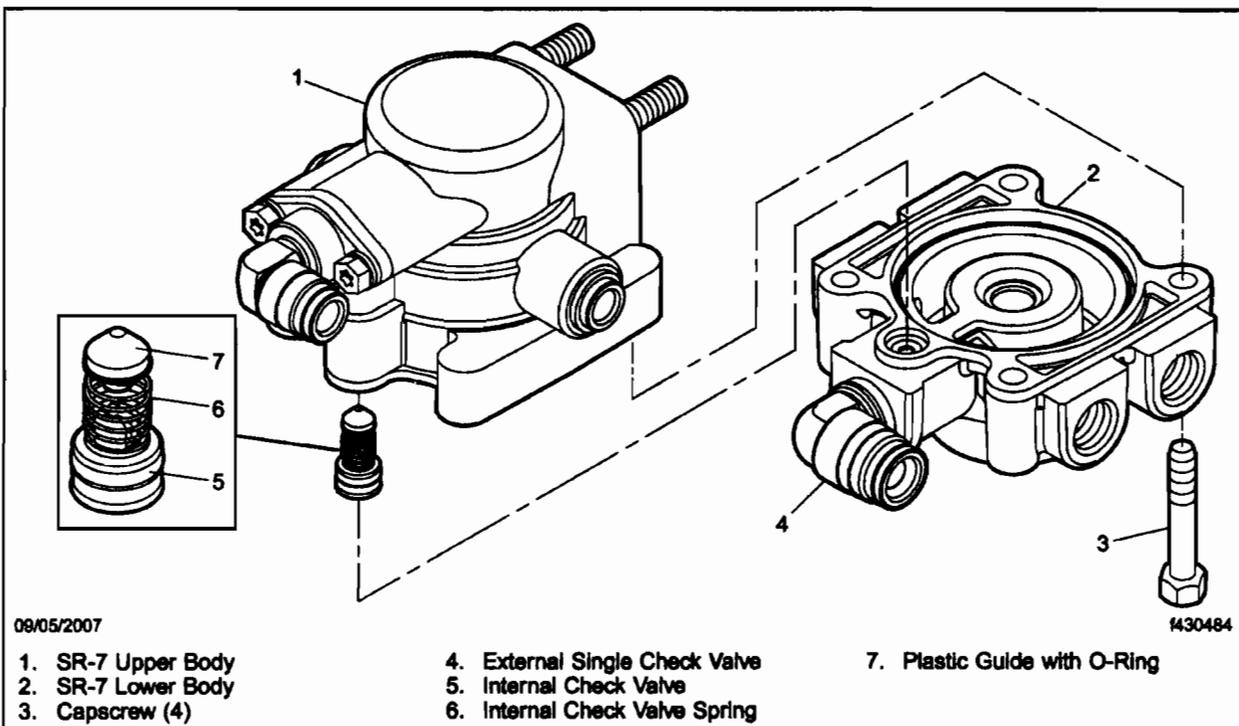
Fig. 3, Replacing the Internal Check Valve

NOTE: The check valve may stick to its seat in the upper body. Be sure that all of the components are removed before going to the next step.

4. From the valve bore, remove and discard the plastic guide, spring, and check valve.
5. Insert the replacement cartridge in the bore where the check valve, spring, and plastic guide were removed. Push the cartridge into position until it stops. A portion of the plastic guide in the cartridge will stick out. Do not force the cartridge further into the bore.

- Align the valve lower body with the upper body and push the body halves together. Install two of the four screws (finger tight only) into the lower body mounting holes closest to the supply port first. This will help with alignment.
- Insert the remaining two screws and tighten finger-tight. Tighten all four screws to 80 to 100 lbf-in (900 to 1140 N-cm).
- Reconnect any air lines that were disconnected.
- Secure the enclosed tie wrap on the valve or fitting in a conspicuous location to indicate that the Recall has been performed.
- Perform the "Operation and Leak Test" below.

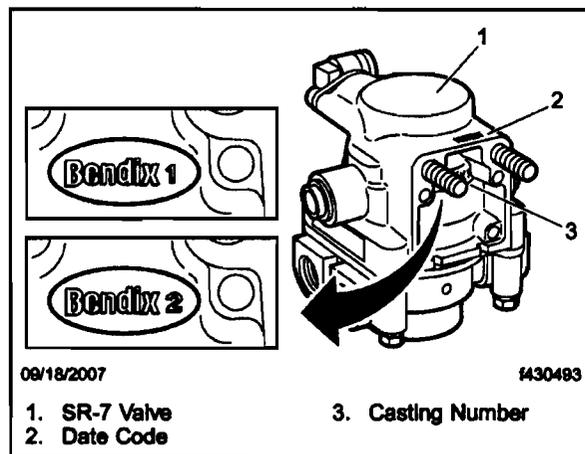
Fig. 4, Date Code and Casting Number Identification

- Locate the manufacturing date code on the top of the SR-7 valve. See Fig. 4 to determine its location.

If the date code is between April 1, 2006 (D0106) and May 24, 2006 (E2406), install the internal check valve kit. Go to the "Internal Check Valve Cartridge Replacement" procedure.

If the casting is "Bendix 2" and the vehicle is in FL504F, install the internal check valve cartridge kit; go to the "Internal Check Valve Cartridge Replacement" procedure. Next install the Parker external check valve kit; go to the "Parker Single Check Valve Inspection and Replacement" procedure starting with step 8.

If the casting is "Bendix 2" and the vehicle is in FL504G, install the internal check valve cartridge kit. Go to the "Internal Check Valve Cartridge Replacement" procedure.

If the casting is "Bendix 1" for both FL504F and FL504G, replace the SR-7 valve. Go to the "SR-7 Valve Replacement" procedure.
