## **IMPORTANT RECALL INFORMATION #71003**

**SUBJECT: RECALL CAMPAIGN #71003 – (RIVERSIDE, CA Plant only)  
2007 & 2008 BOUNDER AND PACE ARROW 38P MODEL –  
SLIDE OUT ROOM ELECTRICAL COMPONENT RELOCATION**

# Recall Bulletin 71003

**SUBJECT:**  
Relocating  
Electrical  
Components  
And Sealing  
Electrical  
Controls  
Compartment

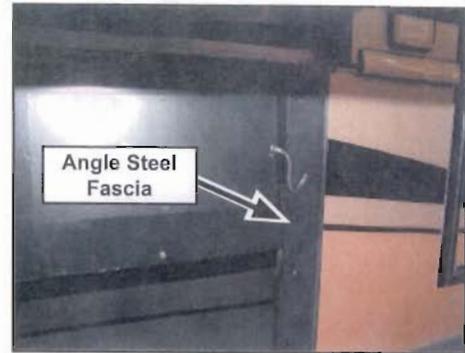
Figure 1

**NOTE:** The Battery Control Center and other electrical components will be visible after removing the sheet metal cover.

5. Label and then remove the battery cables from the Main chassis battery, located on the front of the bulkhead, and the Auxiliary batteries, located under the entry step. Remove the battery negative cable first, and then remove the positive cable.
6. Remove the screws from the angle steel fascia installed vertically on the forward edge of the Battery Control Center Compartment and along the entry door skirt. Retain angle steel fascia and screws for reassembly. See Figure 1.
7. Remove the screws from the perimeter of the sheet metal cover for the compartment containing the Battery Control Center. The sheet metal cover will need to be carefully pried from the installation location as sealant was applied during manufacturing. Retain the sheet metal cover and screws for reassembly.

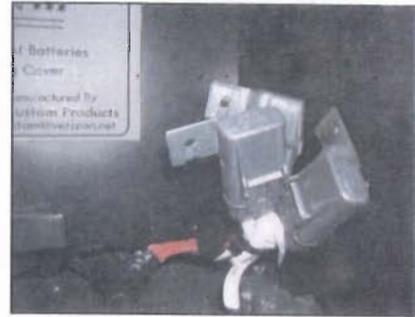
**Figure 3**  
In-line fuses need to be located off the floor of the compartment.

19. Locate the in-line fuses inside the compartment with the Battery Control Center:
  - A. If the in-line fuses are secured off the compartment floor, they do not need to be relocated; skip to Step 21. See Figures 3 and 4.
  - B. If the in-line fuses are located in a manner that they can make contact with the compartment floor, proceed to Step 20 to secure them above the compartment floor.

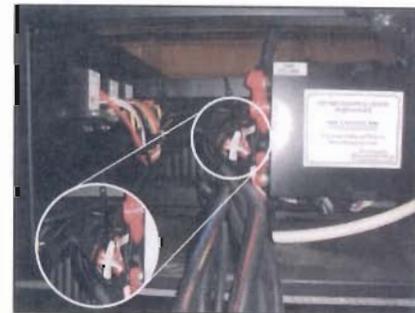
**Figure 4**  
In-line fuses secured off compartment floor with wire ties

20. If the in-line fuses were determined to need relocation in Step 19, use wire ties to bundle all fuses together. Relocate the fuses by one of the following methods:
  - A. Use a #8 X 1" Tek Screw to attach the mounting tab on one of the in-line fuses to a surface above the floor of the electrical compartment, making sure that all fuses will be elevated off the floor after installation. See Figure 3.
  - B. Use wire ties to secure the in-line fuses to the battery cables connected to the Battery Control Center, making certain that the fuses cannot make contact with the compartment floor. See Figure 4.
21. Verify that all electrical components are located above the compartment floor; correct as necessary. Proceed to the next section, "Sealing the Compartments".

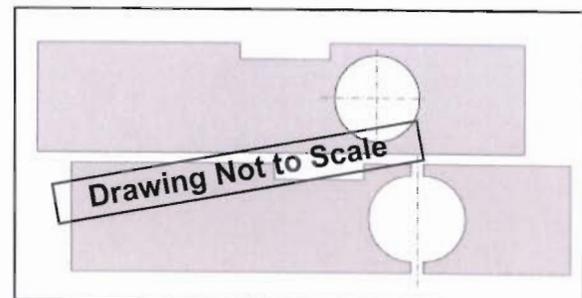
**FIGURE 5**  
Cut hole and notch as shown using measurements taken in Step 23, then cut Polyurethane Panel into two pieces using the vertical center-line of the hole.

24. Use a hole saw to cut a 4-inch diameter hole in the new piece of 8" x 22 1/4" Polyurethane Panel (BCC Housing Panel), for the wiring auto loom, according to the measurements recorded in Step 23. See Figures 5 and 6.
25. Use a jigsaw with a fine-tooth blade to cut a notch for the PACO Beam Rivet Bracket. Cut along the vertical center-line of the 4-inch diameter hole to separate the BCC Housing Panel into two pieces. See Figures 5 and 6.

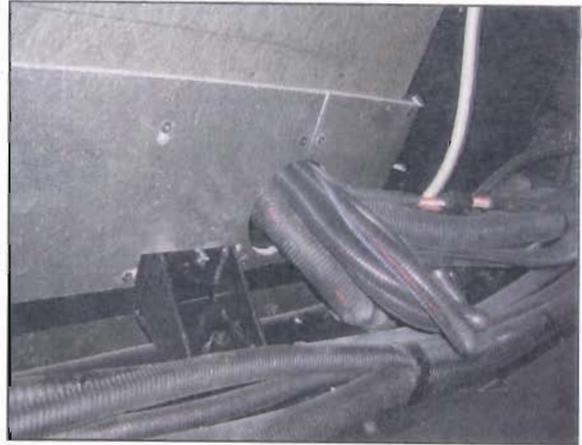
**FIGURE 6**  
Install the two pieces of Polyurethane material so that the wire harness passes through the hole cut in Step 24.

**NOTE:** The two pieces of BCC Housing Panel will be aligned back together at the cut seam surrounding the wiring harness auto loom, as shown in Figure 6.

26. Fit the two pieces of BCC Housing Panel up against the wire bundle so that the wires exit the hole formed by the two pieces. The two pieces, when positioned properly, will enclose the gap between the Battery Control Center Compartment floor and the PACO Beam. Trim the BCC Housing Panel to fit as needed. See Figure 6.
27. Secure the BCC Housing Panel to the PACO Beam and the tube steel of the compartment using #12-14 X 1" Tek Screws spaced 6"-8" apart. See Figure 6.

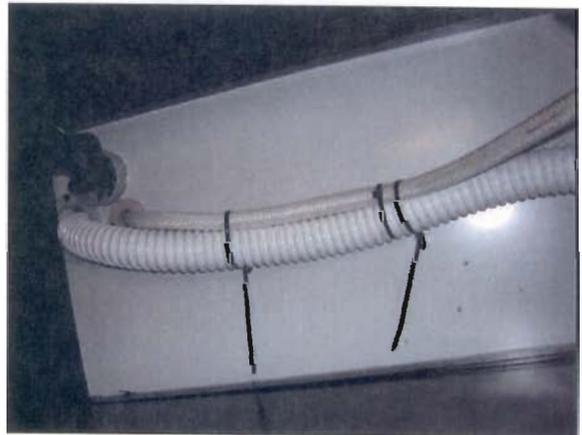
**FIGURE 7**  
Secure water lines to underside of floor inside water fill compartment

28. Working from below, secure water and vent lines for the water fill against the underside of the floor using wire ties and #8 x 1" tek screws. Position water hoses to avoid a water trap. See Figure 7.

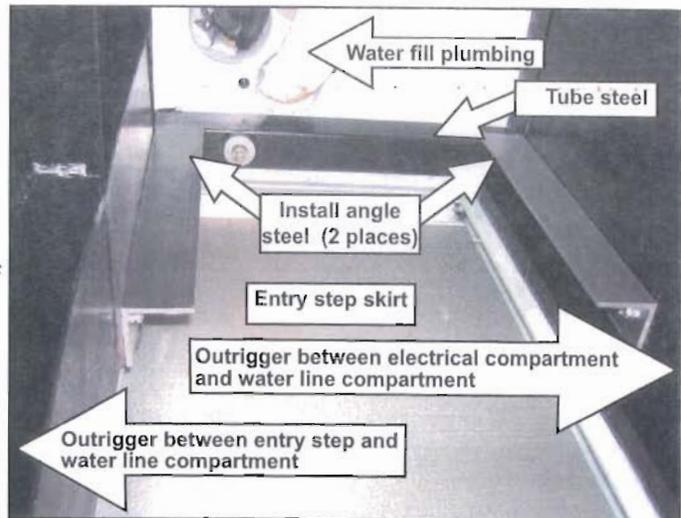
**FIGURE 8**

Fasten angle steel to left and right side of compartment behind entry step skirt. Edge of new angle steel should be flush with existing tube steel.

29. Position a 12" length of angle steel vertically onto the outrigger on one side of the water line compartment, directly below the tube steel framing behind the entry step skirt, as shown in Figure 8. Fasten with two #12-14 x 1" Tek Screws. Fasten a second piece of angle steel onto the outrigger on the opposite side of this compartment.

**NOTE:** One side of each of the two pieces of angle steel should be flush with the inner surface of the tube steel after installation. See Figure 8.

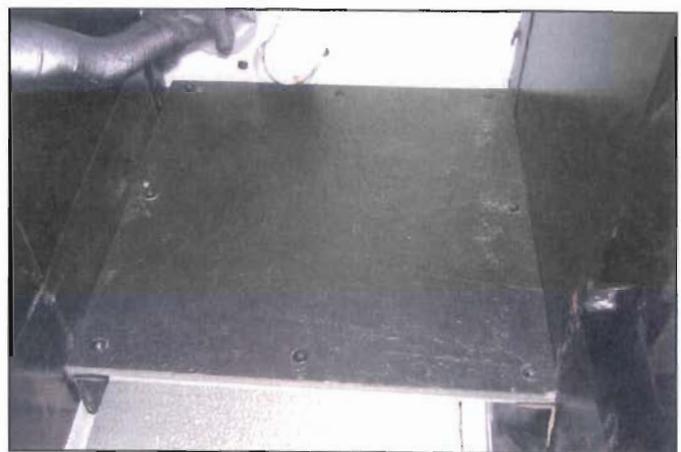
**FIGURE 9**

Fasten Inner Skirt Panel to both pieces of newly-installed angle steel.

30. Position a new 11" x 12" piece of Polyurethane Panel (Inner Skirt Panel) over the two pieces of angle steel installed in Step 29. Fasten onto both pieces of angle steel and onto the tube steel running across the top of the water line compartment. See Figure 9.
31. Apply Sikaflex sealant to all seams and edges of the newly installed Inner Skirt Panel.
32. Position a 4" length of angle steel horizontally, aligned with the bottom of the outrigger nearest the entry step. Fasten to the outrigger using #12-14 x 1" Tek Screws. See Figure 10.
33. Position a 26 3/4" length of angle steel horizontally, aligned with the bottom of the outrigger nearest the Battery Control Center Compartment, and the bottom flange of the PACO beam. Fasten to the outrigger using #12-14 x 1" Tek Screws. Refer to Figure 10.

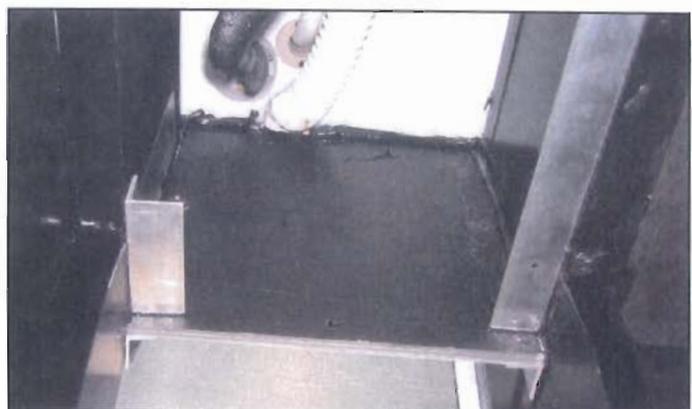
**FIGURE 10**

Fasten 4" and 26 3/4" lengths of angle steel to align with bottom of outriggers as shown.

**NOTE:** The longer piece of angle steel should span the distance between the Inner Skirt Panel installed in Step 30 and the PACO beam.

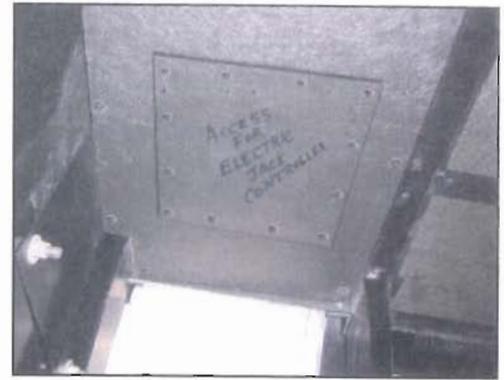
**FIGURE 11**  
Water fill compartment panel (shown after installation)

34. Measure and cut a notch in a new 13" x 26 3/4" Polyurethane Panel (Water Fill Compartment Bottom Panel) to fit around the outrigger nearest the entry step. This panel will later be installed parallel with the motor home floor and reach from the bottom flange of the PACO beam to the Inner Skirt Panel installed in Step 30. The panel will also cover the angle steel installed in Step 33, and the bottom of the outrigger nearest the entry step. See Figure 11.

38. Center the Service Panel over the opening cut in the Water Fill Compartment Bottom Panel that was fabricated in Steps 34-35. Fasten using #12-14 x 1" Tek Screws at pre-drilled locations.

**NOTE:** Be certain the Service Panel will be accessible after installation of the Water Fill Compartment Bottom Panel. Refer to Figure 11.

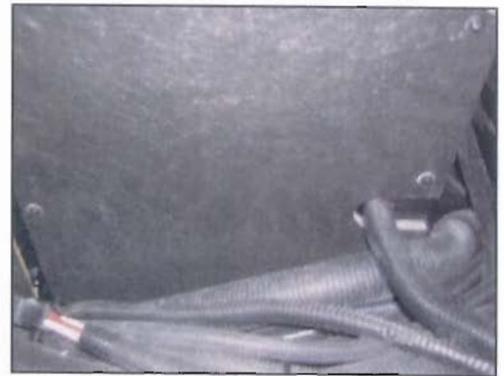
**FIGURE 12**  
Cut openings for wire harnesses in Water Fill Compartment Bottom as necessary.
