DET-08-057

08V-251  
(4 Pages)

Subject: Part 573 Defect Information Report  
MY 2006 – 2007 Isuzu NPR/NQR and GMC/Chevrolet W3500/4500 with Diesel Engine  
Fuel Supply Pump

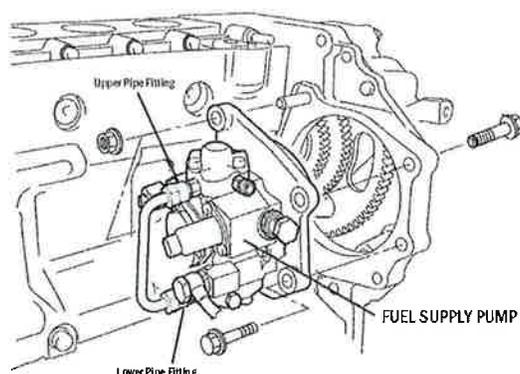
Summary: Diesel fuel may seep or leak from the fuel pipe at the upper or lower fuel port on the diesel fuel supply pump.

The diesel fuel supply pump has a fuel pipe that connects the upper and lower fuel ports on the pump.

The design of the fuel pipe was changed by the fuel pump supplier beginning with June 2006 production. At that time, the pipe's outer diameter was changed from Ø8 mm to Ø6.35 mm. Because the outer diameter of the pipe changed, the end shape of the pipe also apparently had to be changed due to manufacturability of the end. Isuzu has since learned that this new end shape was more sensitive to assembly variation than the previous design.

It was found that during the pump assembly process, when the upper or lower port was tightened to the proper torque first (without any hand tightening process to both ports) the fuel pipe slightly shifted, which in turn caused a gap between the fuel pipe and pump body at the other fuel port. When the other port was tightened in this condition, the pipe end was subject to being misaligned into the port causing a deformation to the fuel pipe sealing surface or fuel port sealing surface. In the instances where such misalignment occurred, the port would not seal correctly and diesel fuel seepage or leakage could occur.

In the corrected assembly process, when the fuel pipe is assembled with hand tightening at both ports prior to proper torque being applied, the pipe's sealing surface is properly aligned and seated in the fuel supply pump port.

All vehicles will be inspected for the reported condition. If no seepage or leakage is detected, the fuel pipe fittings will be tightened to the improved torque specification of 30 N-m. If seepage or leakage is detected, the fuel supply pump will be replaced with a new one.
