DET-08-057a
Revised

**08V-251
AMENDED**

Subject: Part 573 Defect Information Report
MY 2006 – 2007 Isuzu NPR/NQR/NRR and GMC/Chevrolet W3500/W4500/W5500
with Diesel Engine Fuel Supply Pump

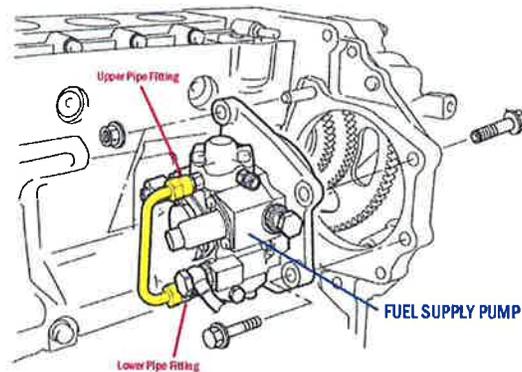
The diesel fuel supply pump has a fuel pipe that connects the upper and lower fuel ports on the pump.

The design of the fuel pipe was changed by the fuel pump supplier beginning with June 2006 production. At that time, the pipe's outer diameter was changed from Ø8 mm to Ø6.35 mm. Because the outer diameter of the pipe changed, the end shape of the pipe also apparently had to be changed due to manufacturability of the end. Isuzu has since learned that this new end shape was more sensitive to assembly variation than the previous design.

It was found that during the pump assembly process, when the upper or lower port was tightened to the proper torque first (without any hand tightening process to both ports) the fuel pipe slightly shifted, which in turn caused a gap between the fuel pipe and pump body at the other fuel port. When the other port was tightened in this condition, the pipe end was subject to being misaligned into the port causing a deformation to the fuel pipe sealing surface or fuel port sealing surface. In the instances where such misalignment occurred, the port would not seal correctly and diesel fuel seepage or leakage could occur.

In the corrected assembly process, when the fuel pipe is assembled with hand tightening at both ports prior to proper torque being applied, the pipe's sealing surface is properly aligned and seated in the fuel supply pump port.

All vehicles will be inspected for the reported condition. If no seepage or leakage is detected, the fuel pipe fittings will be tightened to the improved torque specification of 30 N-m. If seepage or leakage is detected, the fuel supply pump will be replaced with a new one.
