Safety Recall Circular

Code: **24M9/R7**

**Subject: 2008 Passat and Passat Wagon Equipped
With 2.0L FSI ULEV II Engine and
2009 Tiguan Equipped With 2.0L FSI ULEV II Engine
Inspect and Update ECM Software, If Necessary**

REVISED

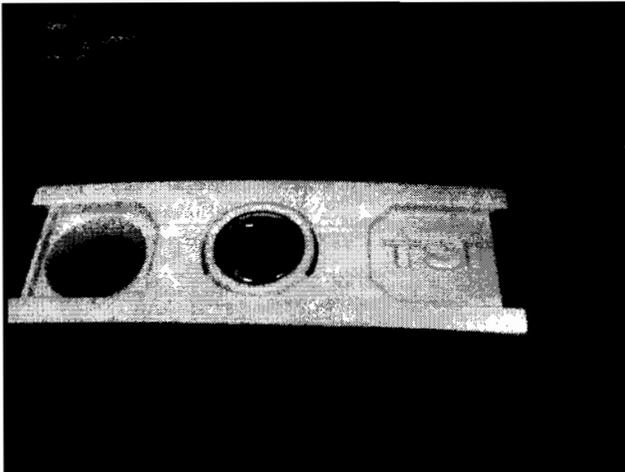
● Note: Affected Tiguan vehicles may have an engine cover that states "TSI" (photo). To ensure vehicle is affected, check VIN in ElsaWeb
