# Campaign Service

BULLETIN NUMBER:  
CB08-J-001

### SUPPLY PUMP CONNECTING PIPE FUEL LEAK SAFETY RECALL CAMPAIGN 08V-251

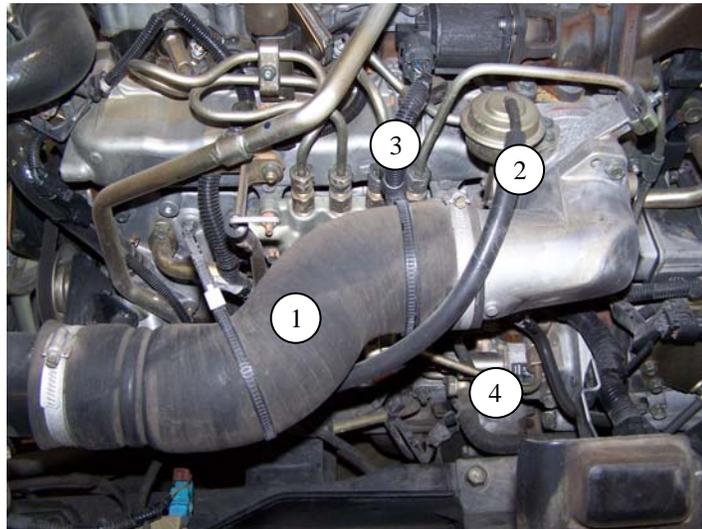
Figure 1

1. Tilt up the cab. Insert the lock pin. (**For Crew Cab Model**-Remove the driver's seat cushion and inspection panel to access the engine compartment.)
2. Remove the intake duct for access. See figure 1.

14. Install intake duct. Be sure to secure EGR valve harness and Throttle Valve vacuum hose into retaining clips. See figure 1.

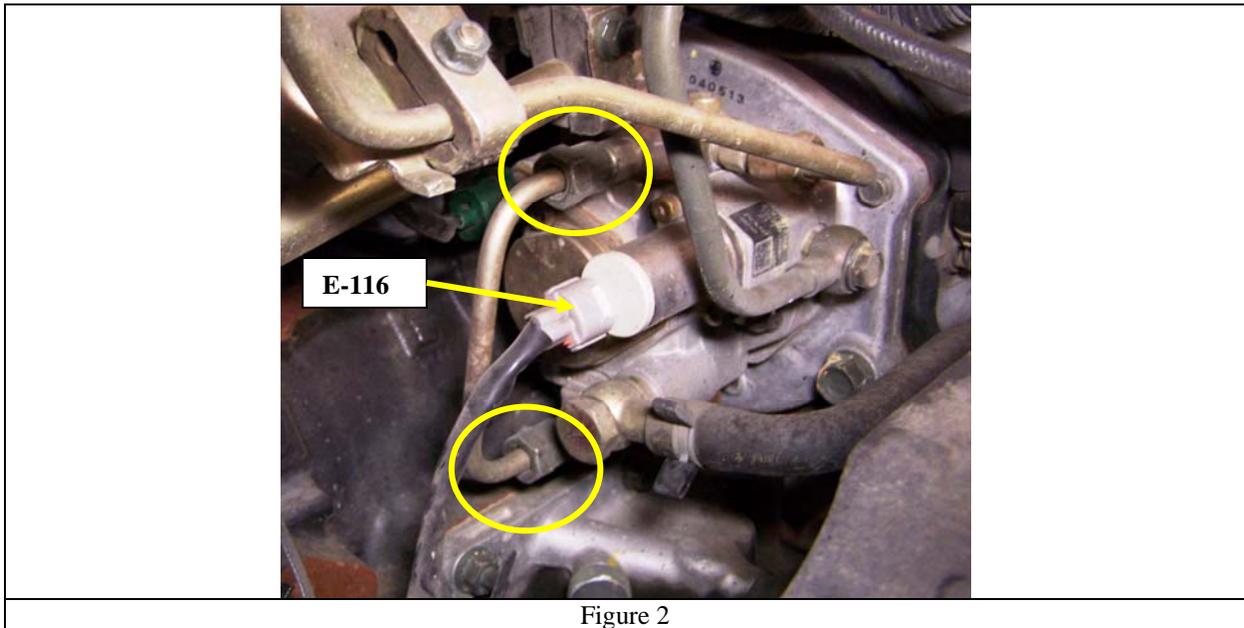
Figure 2

Some 2006 and 2007 Isuzu NPR/NQR/NRR and GMC/Chevrolet W3500/4500/5500 trucks with diesel engine manufactured between June 2006 and March 2007 may seep or leak diesel fuel from the fuel pipe at the upper or lower fuel port on the diesel fuel supply pump. Fuel leakage in the presence of an ignition source presents a risk of fire.

3. Inspect connecting pipe fittings for leaking fuel. See figure 2

4. If no leak is found, go to step 5. If a leak is found, replace the supply pump as outlined in the appropriate service manual. After replacing the supply pump go to “Applying the Campaign Label”.
5. Disconnect the Throttle Valve vacuum hose. See figure 1.
6. Remove shield mounting bolts and lower the shield for required clearance. See figure 3. (Three mounting bolts)

9. Using the special tool 3300FN pipe socket, tighten both connecting pipe fittings to 22 lb-ft (30Nm). The torque wrench operation angle should not be greater than 30 degrees. If the operation angle of the special tool is too wide, the tool may interfere with and scratch the pipe. To prevent accidental scratches, apply vinyl tape to the tool. Repeat tightening, alternating sides, until reaching the specified torque.
