FL614

NHTSA #11V-514

SECOND REVISED INTERIM RECALL BULLETIN

Subject: Rack and Pinion Steering Pinion Bearings

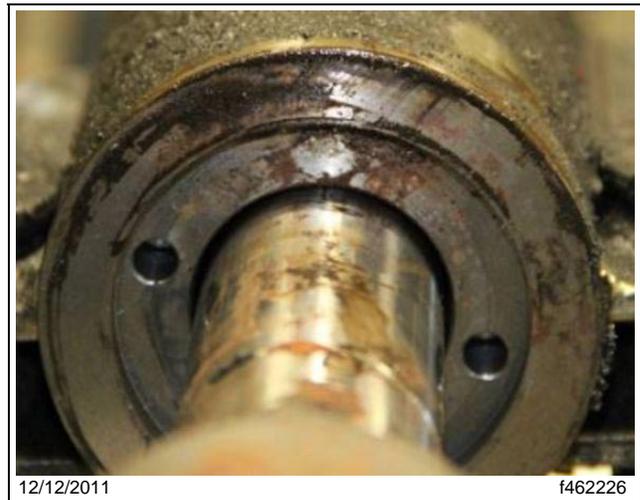
Fig. 2, Acceptable—Passenger-Side Rack Guide

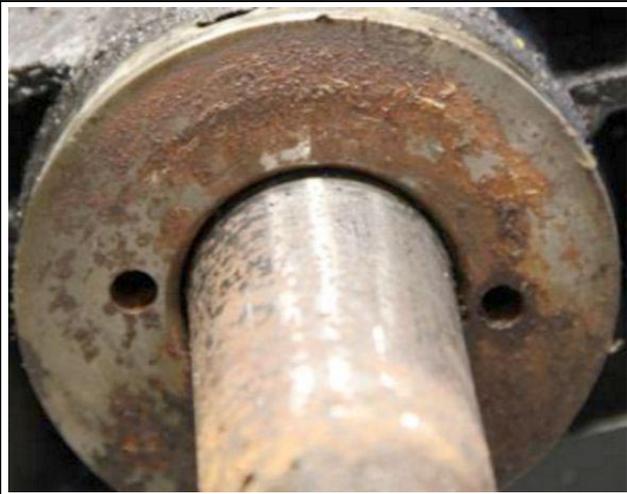
Fig. 3, Excessive Corrosion—Passenger-Side Rack Guide

7. On each side of the vehicle, pull the large ends of the bellows outboard as far as possible and inspect the gear housing and inner tie rod components, as follows. If any component in the following substeps has excessive corrosion, secure the bellows on the gear, then replace the rack and pinion gear. See the heading below, **Rack and Pinion Steering Gear Replacement**, for gear replacement instructions.

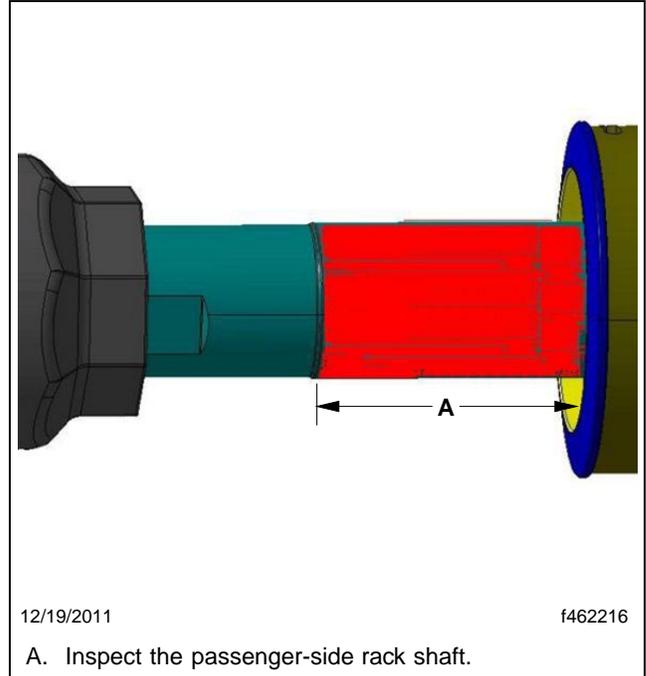
Fig. 4, Passenger-Side Rack Shaft

A. Inspect the passenger-side rack shaft.

- 7.2 Clean the passenger-side rack shaft between the tube and the shaft diameter change (as shown in **Fig. 4**). See **Fig. 5** for an example of corrosion.

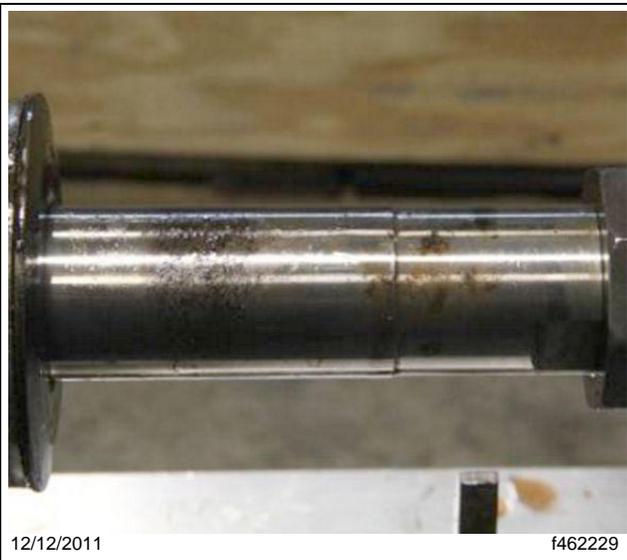
Fig. 5, Excessive Corrosion—Passenger-Side Rack Shaft

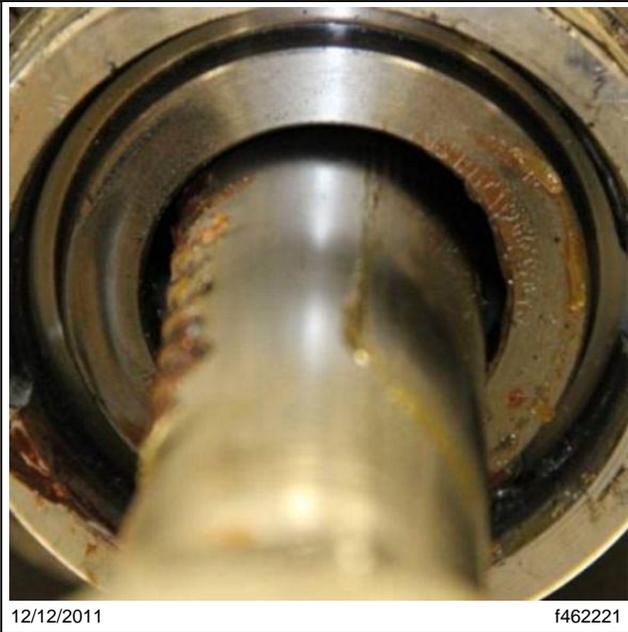
Fig. 7, Acceptable—Driver-Side Stop Ring

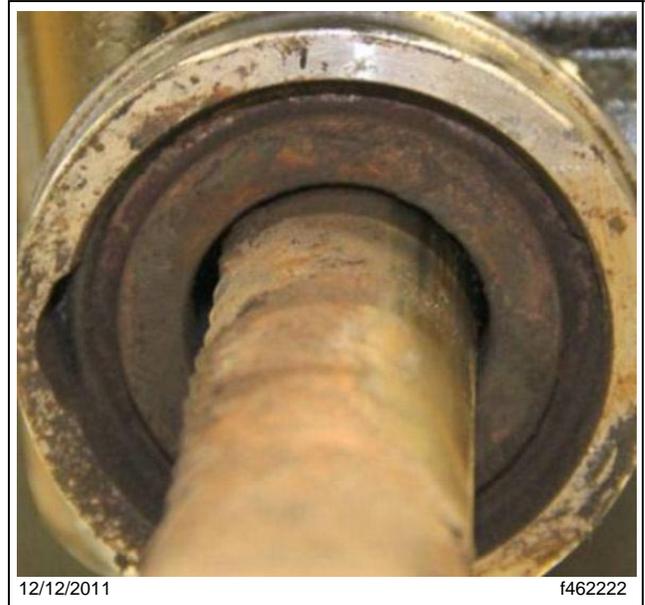
Fig. 8, Excessive Corrosion—Driver-Side Stop Ring

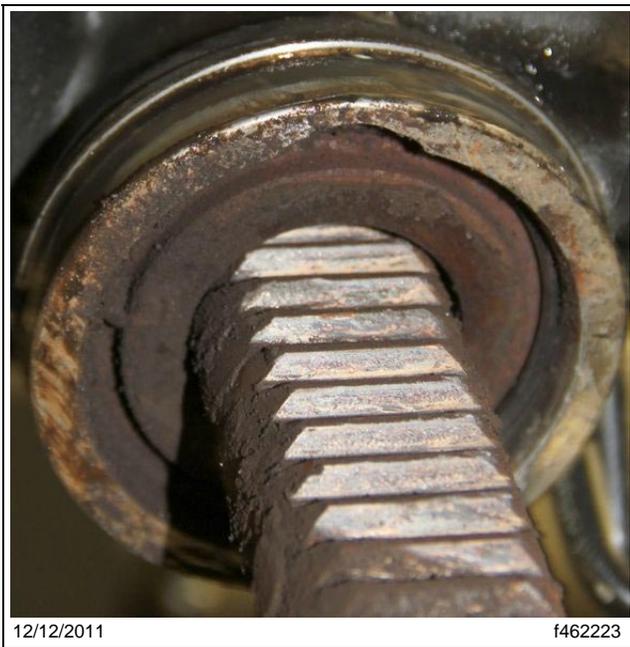
Fig. 9, Excessive Corrosion—Driver-Side Stop Ring

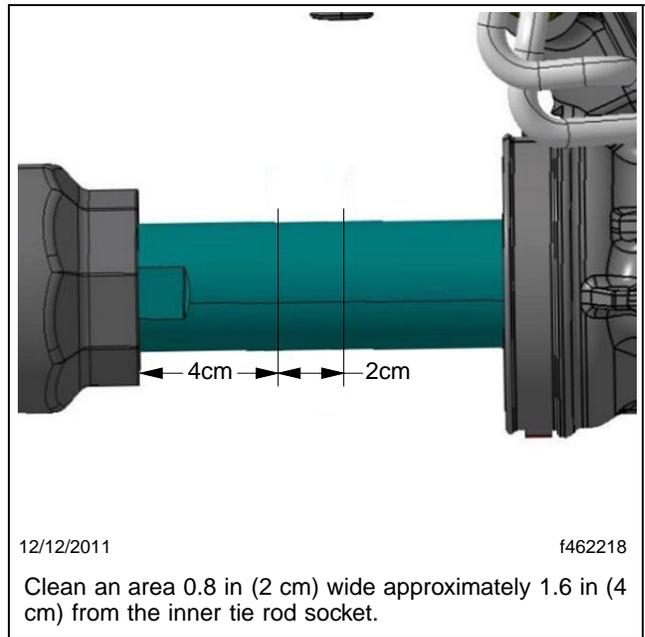
Fig. 10, Driver-Side Rack Shaft, Aft Side
Clean an area 0.8 in (2 cm) wide approximately 1.6 in (4 cm) from the inner tie rod socket.

- 7.4 Clean an area 0.8 in (2 cm) wide on the aft side of the driver-side rack shaft (opposite the teeth), as shown in **Fig. 10**. See **Fig. 11** and **Fig. 12** for examples of acceptable and unacceptable levels of corrosion.

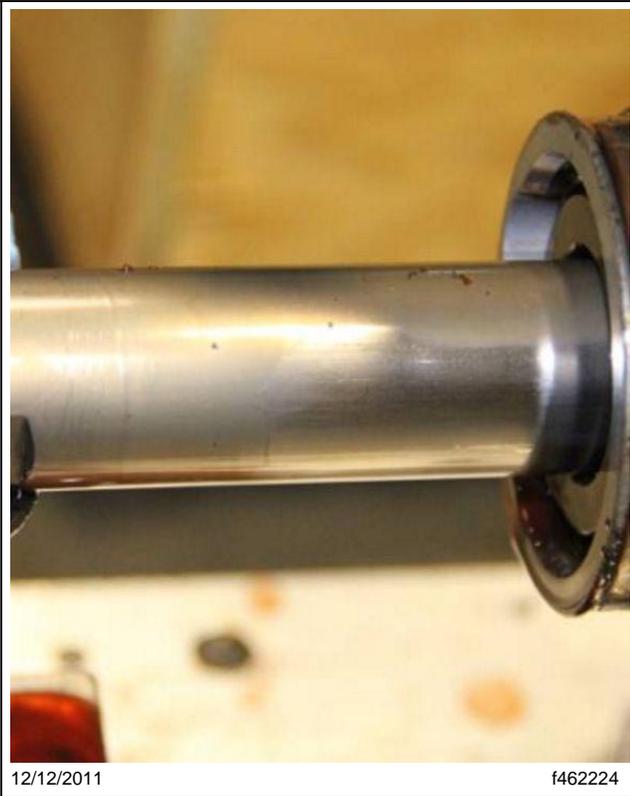
Fig. 11, Acceptable—Driver-Side Rack Shaft

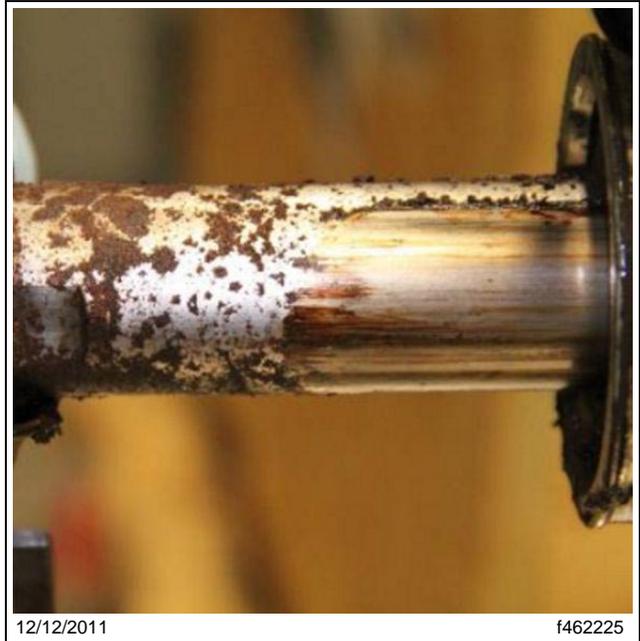
Fig. 12, Excessive Corrosion—Driver-Side Rack Shaft

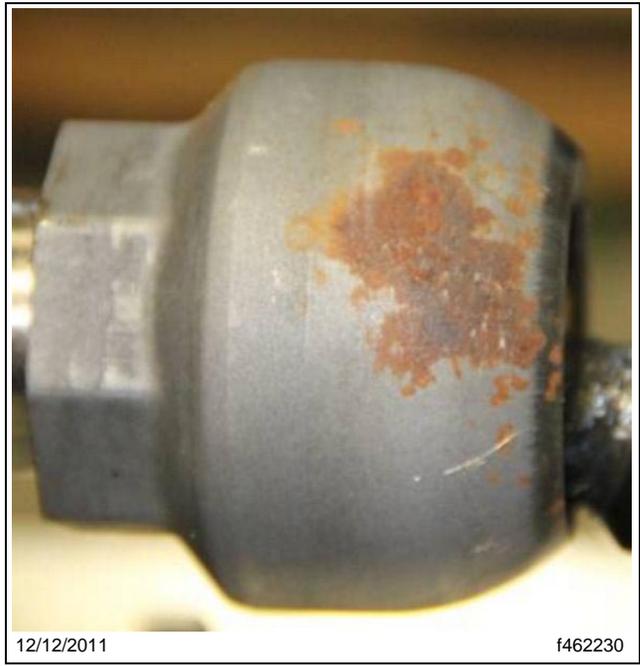
Fig. 14, Acceptable—Inner Tie Rod Socket

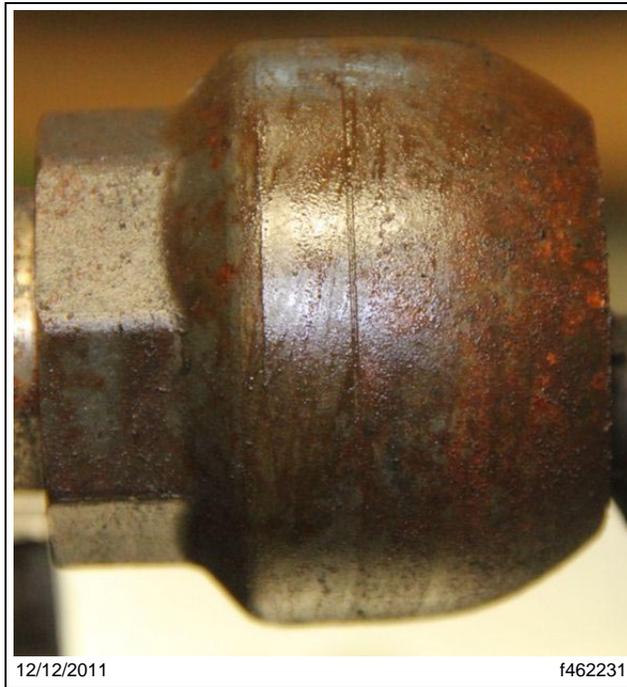
12/12/2011 f462231
Fig. 15, Excessive Corrosion—Inner Tie Rod Socket

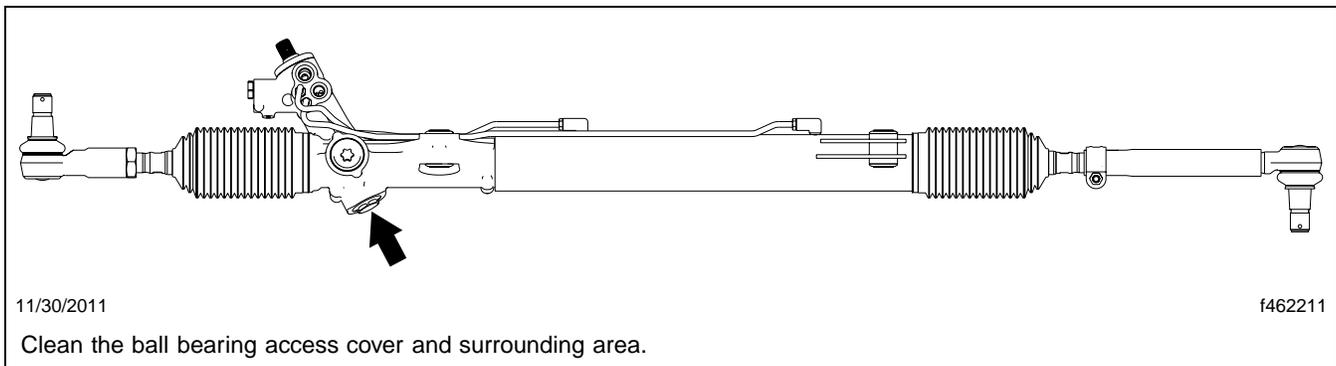
11/30/2011 f462211
Clean the ball bearing access cover and surrounding area.
Fig. 16, Ball Bearing Access Cover Location

8. Use brake cleaner to loosen debris and dirt build-up from the ball bearing access cover and surrounding areas, then wipe the area with a cloth. See **Fig. 16**. For hard to remove dirt, spray brake cleaner on the access cover and allow it to sit for a short time before wiping the dirt away.

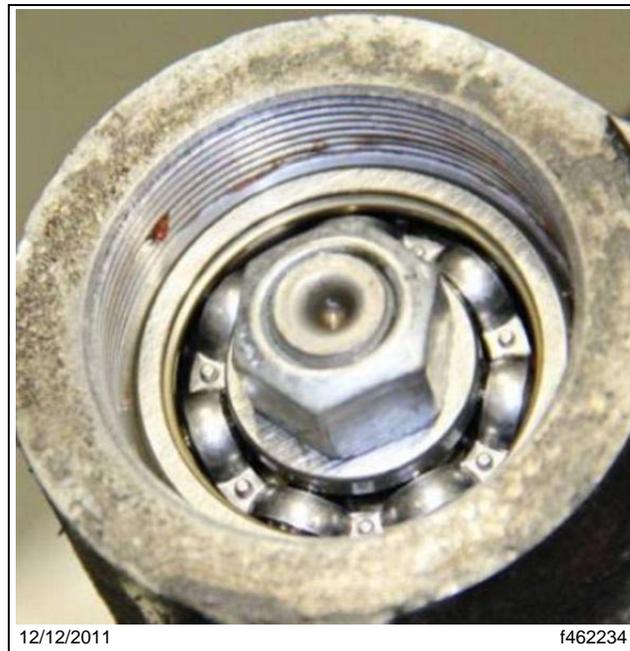
Fig. 17, Acceptable—Ball Bearing and Hexnut

11. Inspect the bearing access cover and ball bearing for corrosion. If any corrosion is found, install the bearing access cover back on the gear, then replace the rack and pinion gear. See the heading below, **Rack and Pinion Steering Gear Replacement**, for gear replacement instructions.
12. Complete the steps below under the following heading, **Greasing the Ball Bearing**.

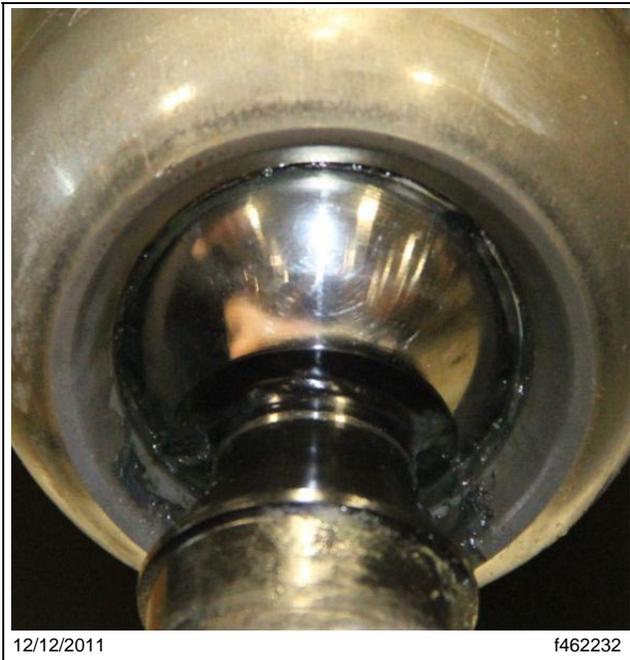
Fig. 23, Acceptable—Inner Tie Rod Ball Stud

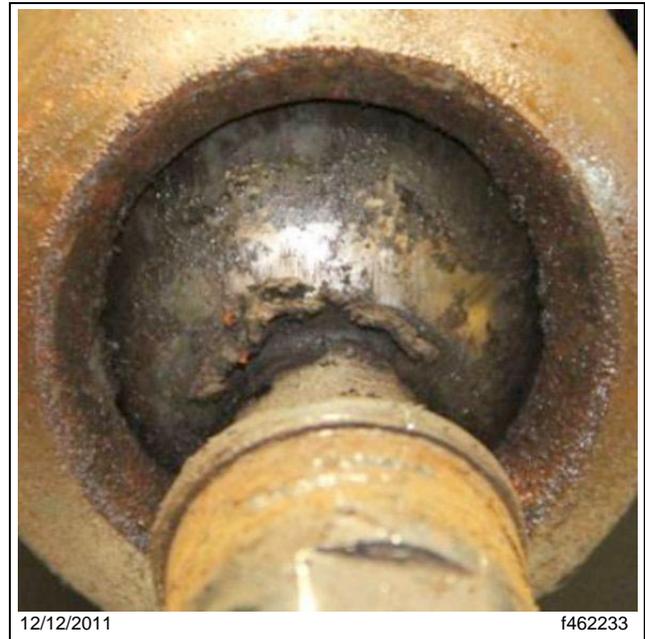
Fig. 24, Excessive Corrosion—Inner Tie Rod Ball Stud

If excessive corrosion is present, see the heading below, **Rack and Pinion Steering Gear Replacement**, for gear replacement instructions. If excessive corrosion is not present, proceed to the next step.
