Reference: NHTSA Identification Number 12V-197

## **Safety Recall M10 / NHTSA 12V-197 ABS/ESC Wiring**

**2011 – 2012 (LD) Dodge Charger**

**(LX) Chrysler 300**

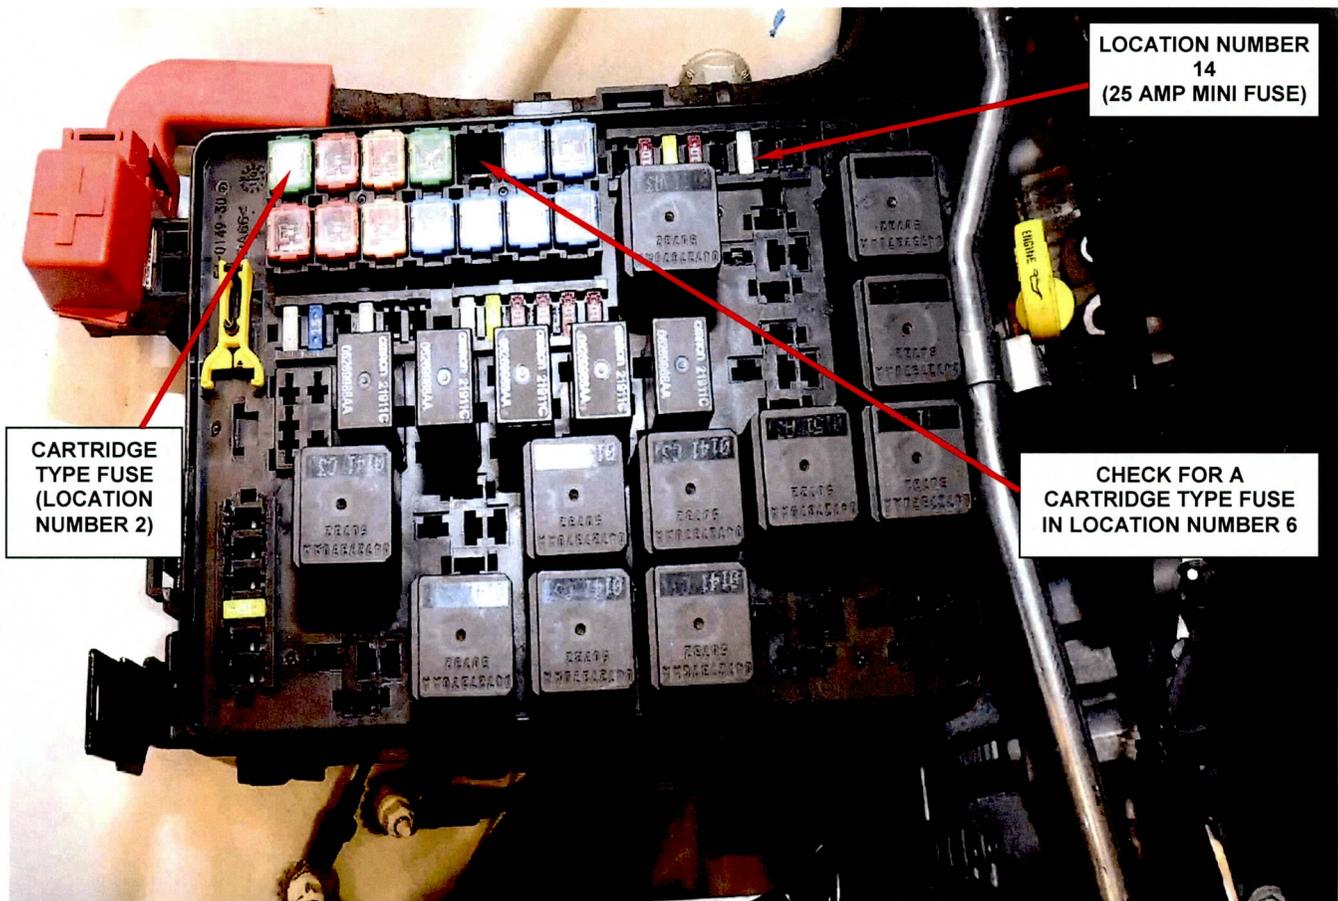
Figure 1 – PDC Cartridge Fuse Location

1. Remove the Power Distribution Center (PDC) cover.
2. Check for the presence of a 25 amp cartridge fuse (Figure 1) in PDC location number 6:
  - If PDC location number 6 **has** a 25 amp cartridge fuse, a **fuse upgrade is not required**. No further action is required. Install the PDC cover, close the hood and return the vehicle to the customer.
  - If PDC location number 6 **does not have** a 25 amp cartridge fuse, a **fuse upgrade is required**. Continue with Step 3 of this procedure.

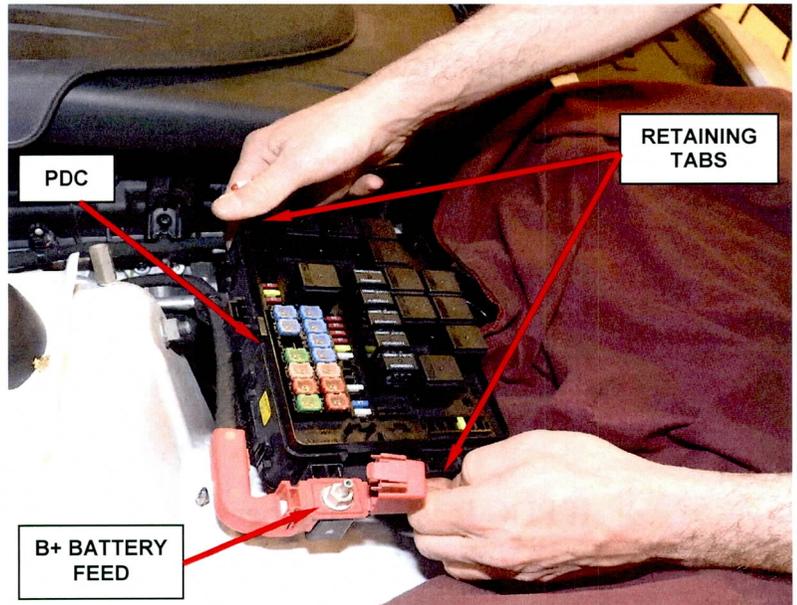
**Figure 2 – PDC Retaining Tabs**

3. Disengage the retaining tabs that secures the PDC to the mounting bracket (Figure 2).
4. Disconnect the main B+ battery feed wire on the PDC (Figure 2).
5. Remove and save the PDC mounting bracket.
6. Turn the PDC over to expose the bottom side of the PDC.
7. Carefully open the PDC bottom cover (Figure 3).

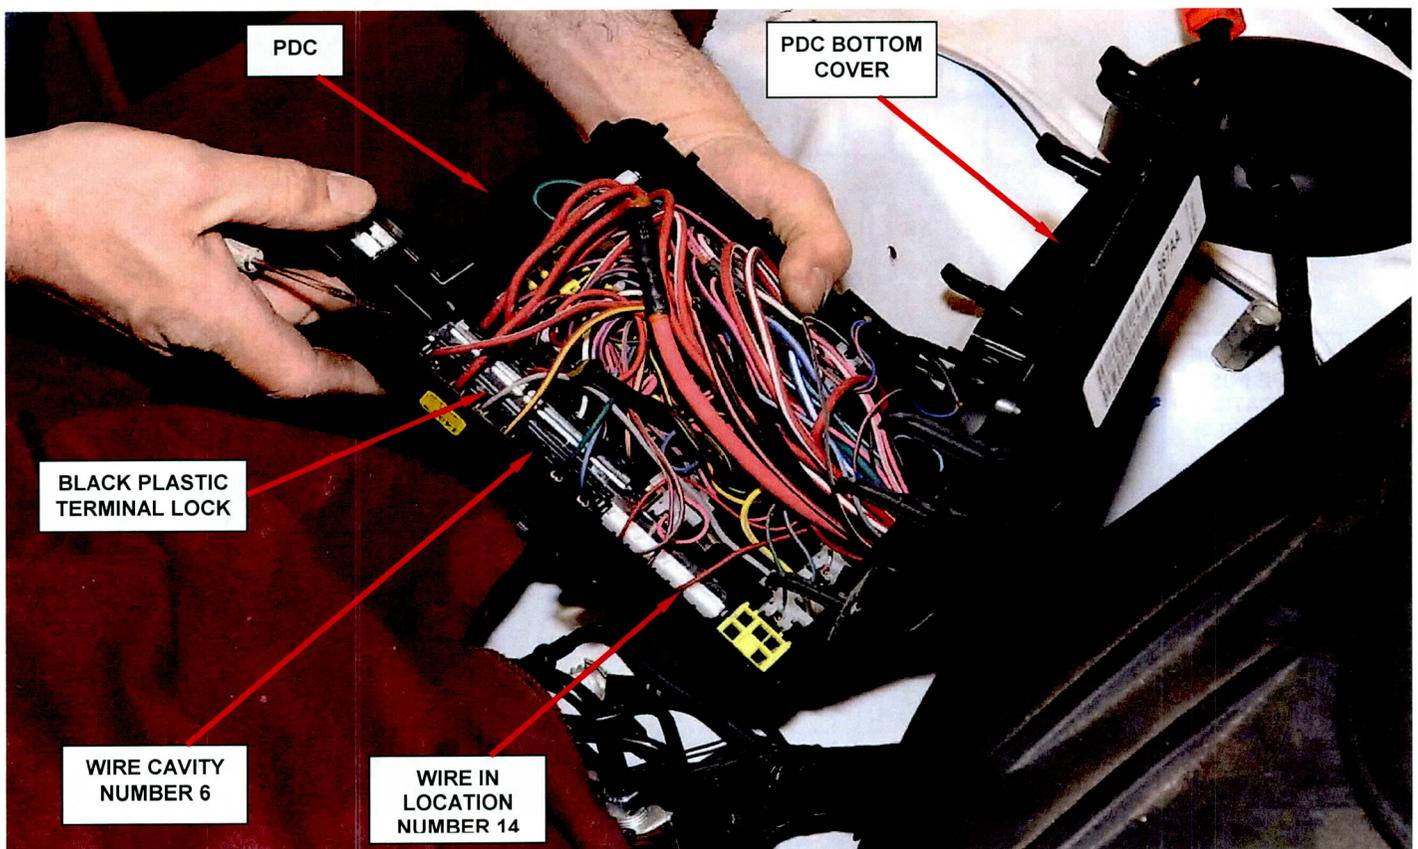
**Figure 3 – Terminal Black Plastic Lock**

8. Using a small pick tool, remove and discard the black plastic terminal lock (Figure 3).

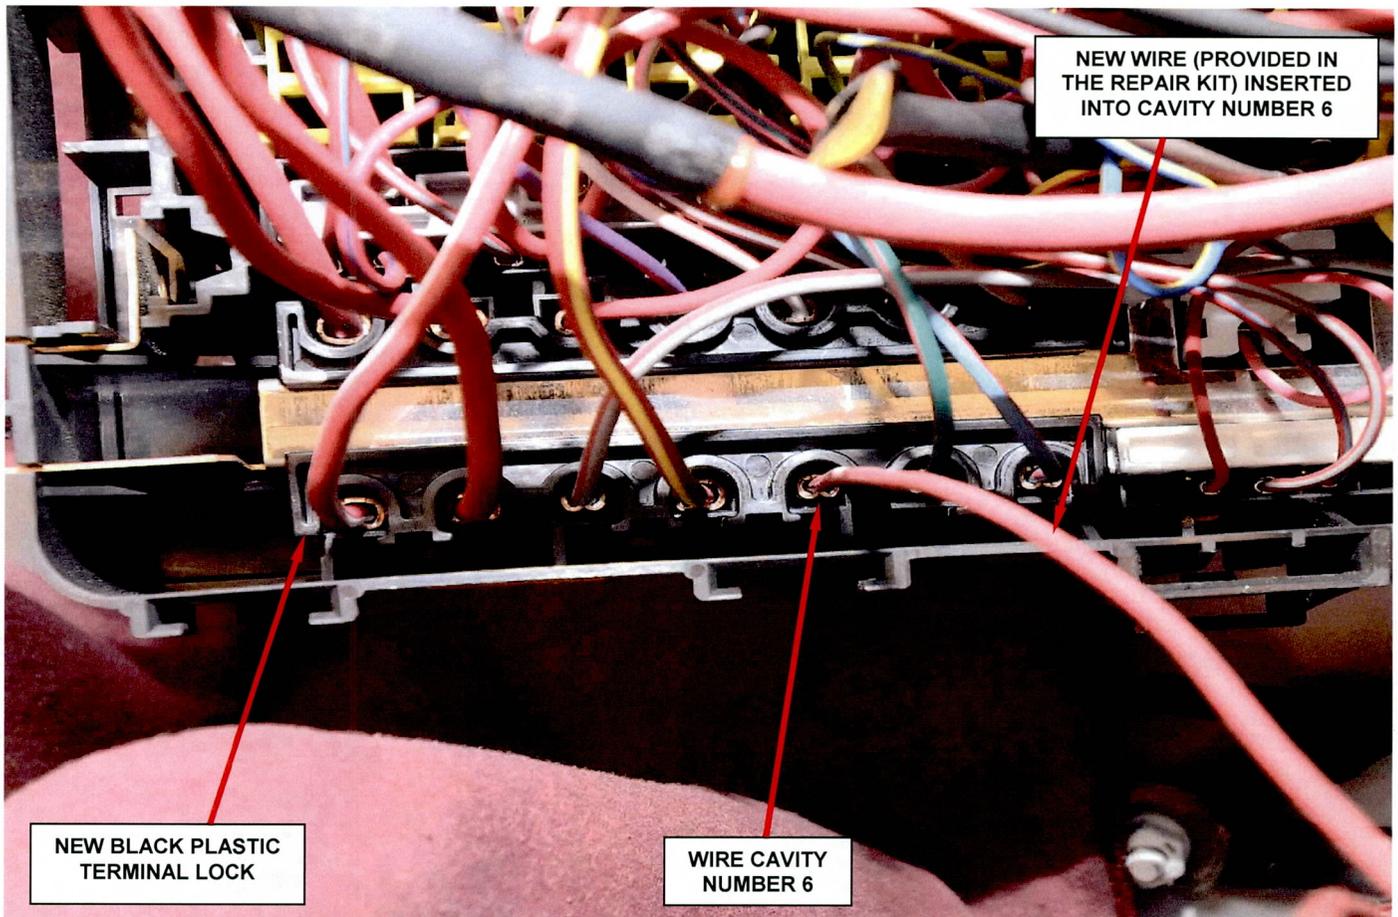
**Figure 4 – Cavity Number 6**

9. Insert the blade terminal provided in the repair kit into cavity number 6 of the PDC (Figure 4).

10. Install the new black plastic terminal lock provided in the repair kit (Figure 4).

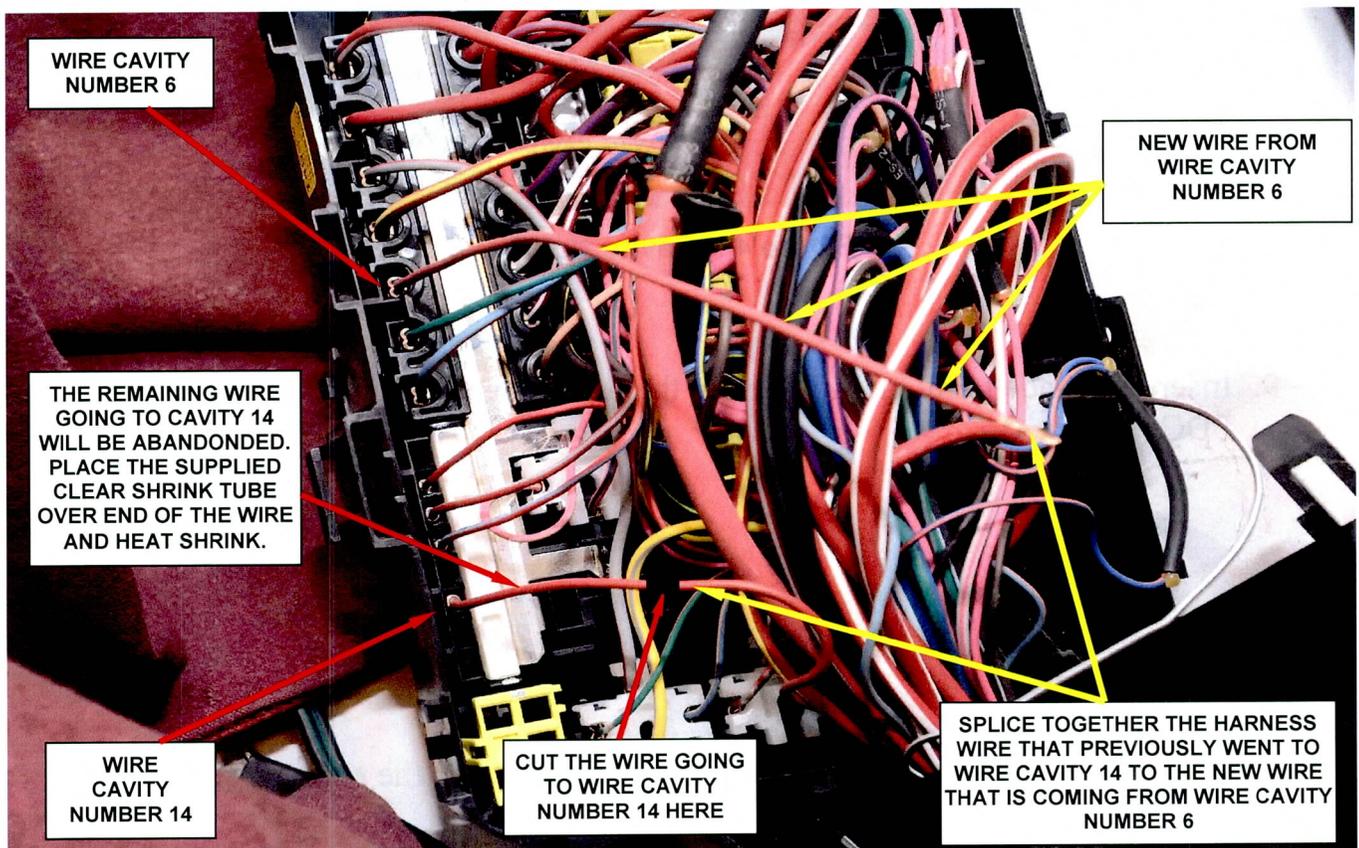
**Figure 5 – Cavity Number 14 Wire**

11. Locate the red wire located in cavity 14 (Figure 5). Place a mark on the wire approximately 35 mm up from the blade terminal.
12. Cut the wire at the mark made in Step 11.
13. Place the clear shrink tube provided in the repair kit over the remaining wire in cavity 14 of the PDC. Apply heat to the shrink tube to seal the end of the wire (Figure 5).
14. Strip approximately 10 -15 mm of insulation from the end of the remaining cut wire.
15. Place the black shrink tube provided in the repair kit over the remaining cut wire.

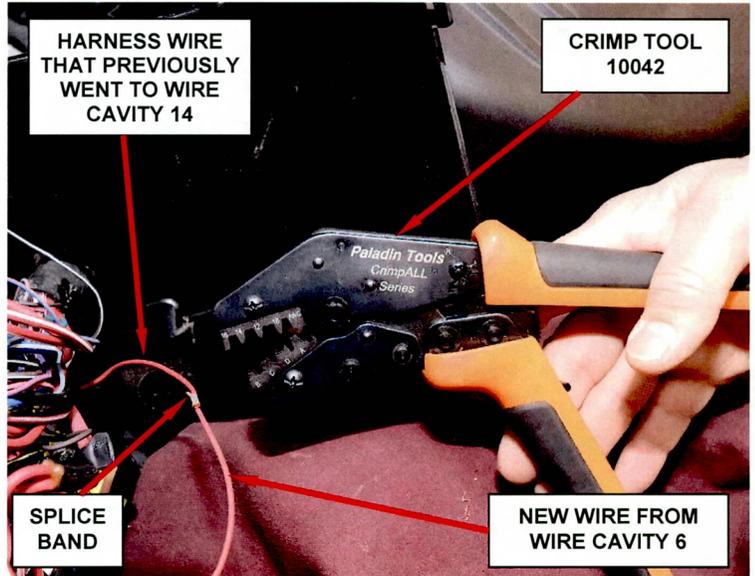
**Figure 6 – Install Splice Band Clamp**

16. Using the supplied splice band clamp and crimp tool 10042, crimp the wire that had the insulation stripped in Step 14 to the wire that was added in Step 9 (Figure 6).

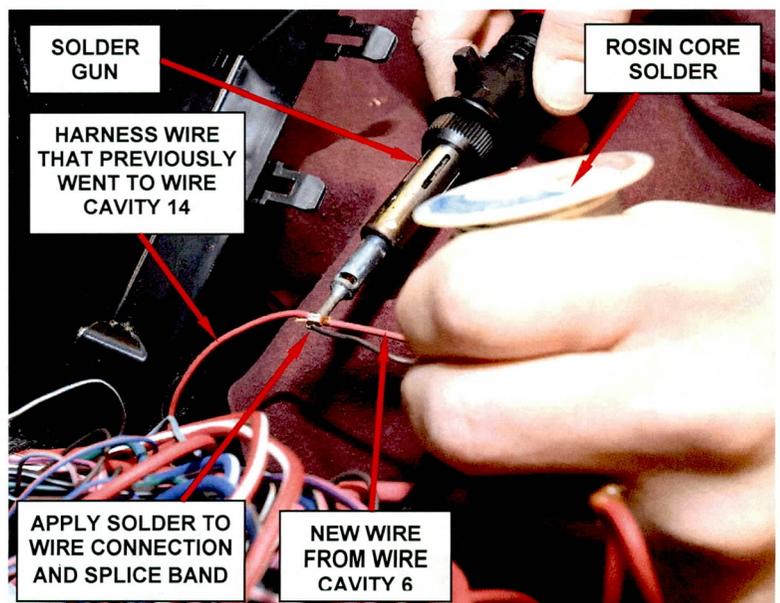
**Figure 7 – Solder Wire**

17. Solder the crimp installed in Step 16 with rosin core solder (Figure 7).

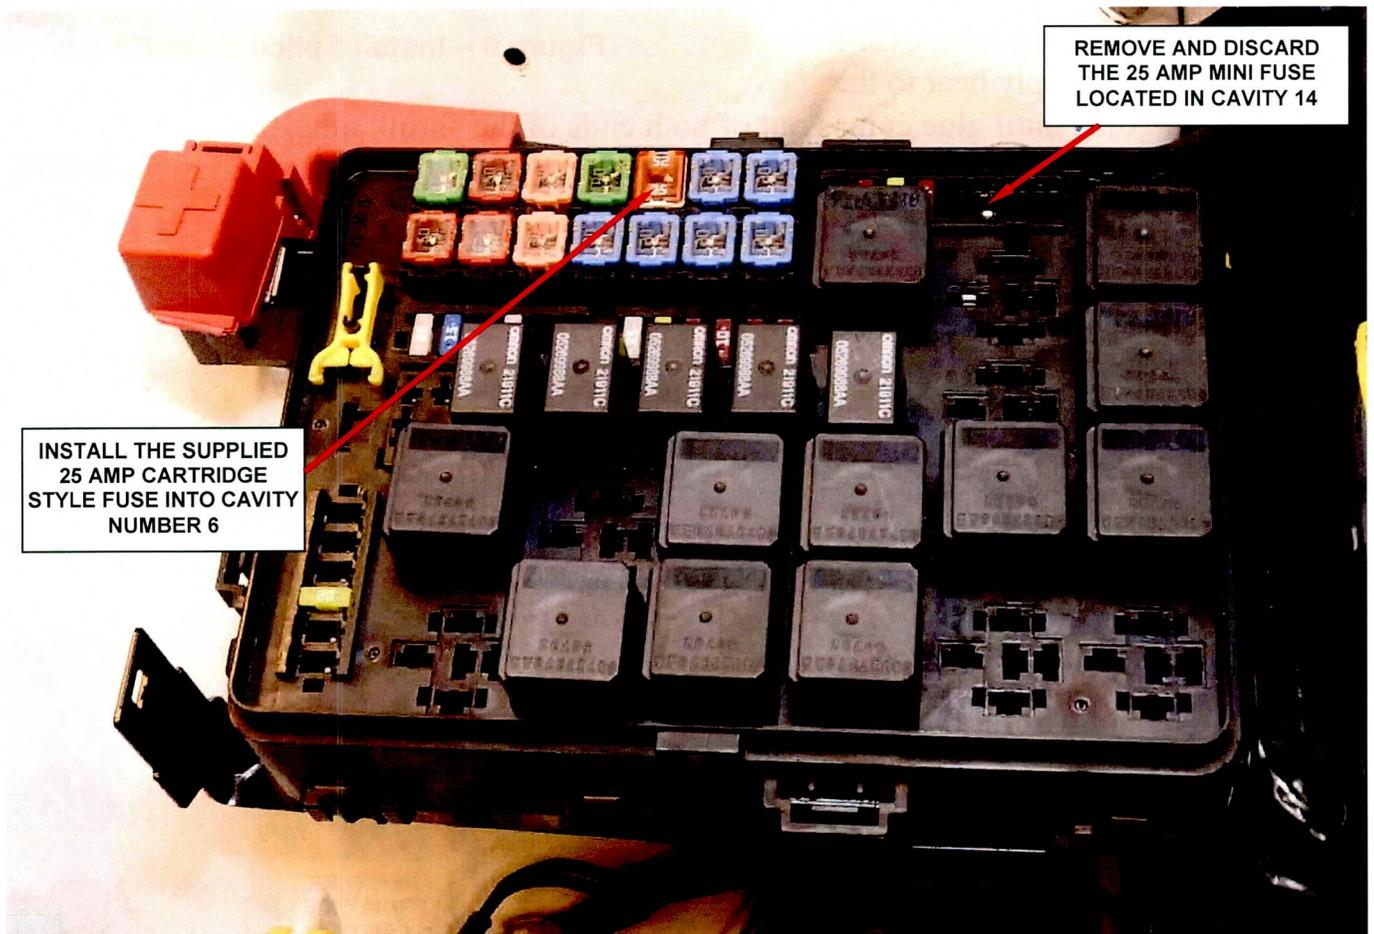
Figure 8 – Fuse Removal and Installation

23. Remove and discard the white 25 amp mini fuse located in cavity number 14 of the PDC (Figure 8).

24. Install the new fuse supplied in the repair kit into cavity number 6 of the PDC (Figure 8).

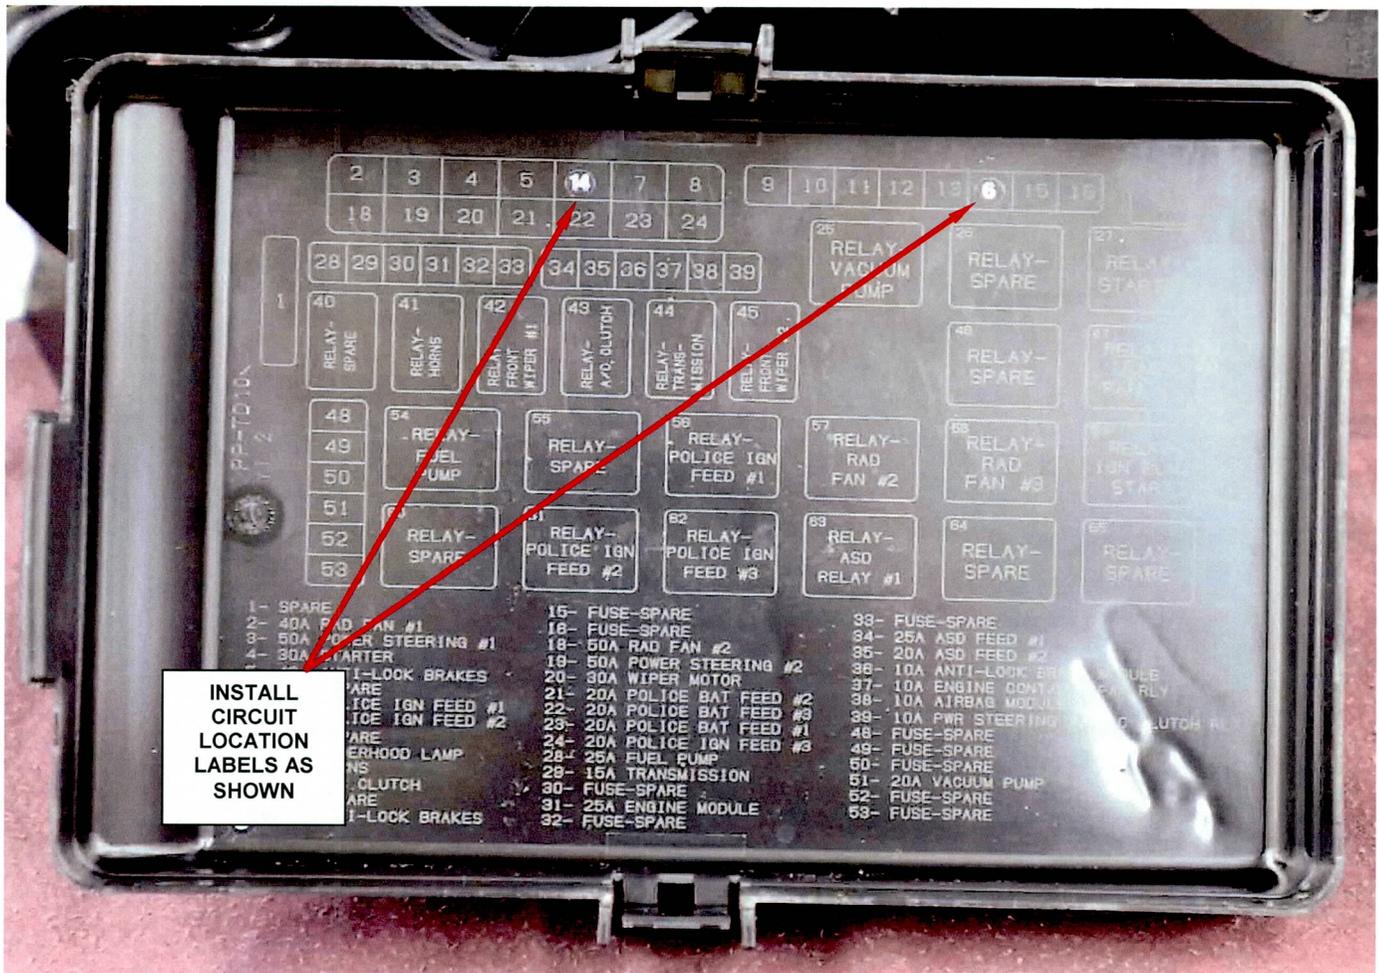
**Figure 9 – Install Circuit Location Labels**

25. Install the new fuse location stickers supplied in the repair kit onto the fuse location diagram on the inside of PDC cover (Figure 9).
26. Install the PDC cover onto the PDC.
27. Connect the negative battery cable to the battery.
28. Connect the wiTECH scan tool and clear all Diagnostic Trouble Codes (DTC's).
29. Start the vehicle and verify that the ABS light, brake light and ESP light in the instrument cluster turn off after the initial "bulb check."
30. Remove the wiTECH VCI pod from the vehicle and return the vehicle to the customer.
