Volvo Trucks North America

SUBJECT: VN Sleeper Window
MODEL(S): VNL, 660/770
ISSUED BY: Ken Moore
APPROVED: Guenter Schlottmann

Big G Express Sleeper Window Failures

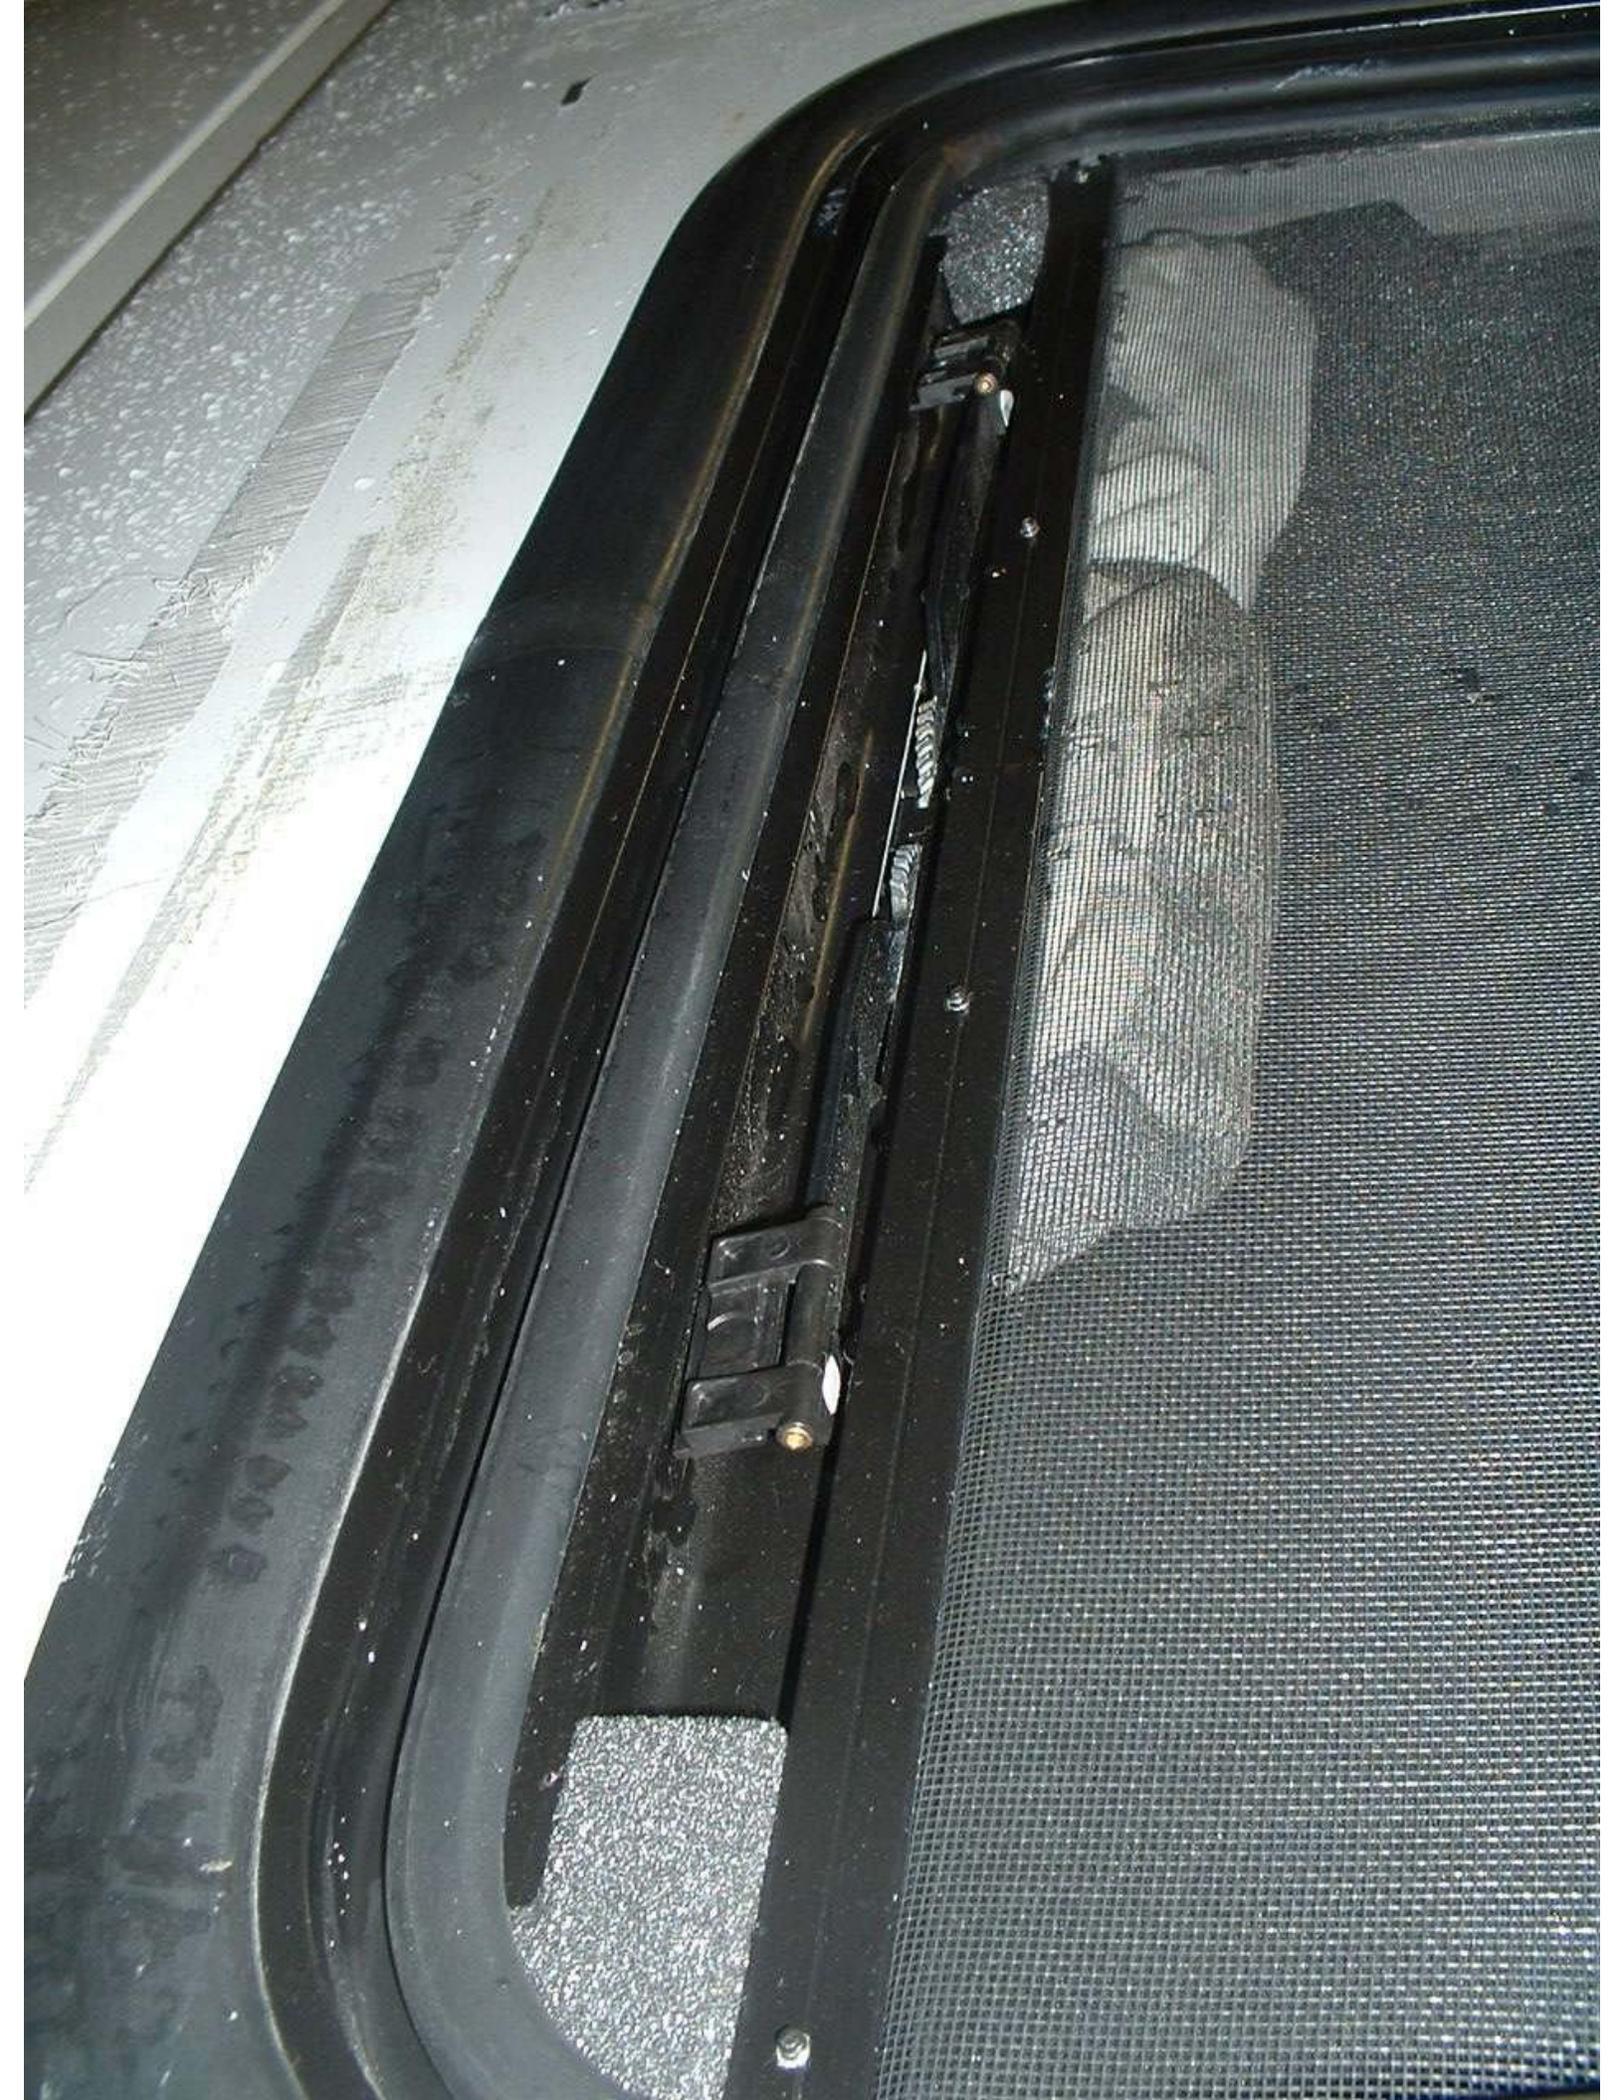
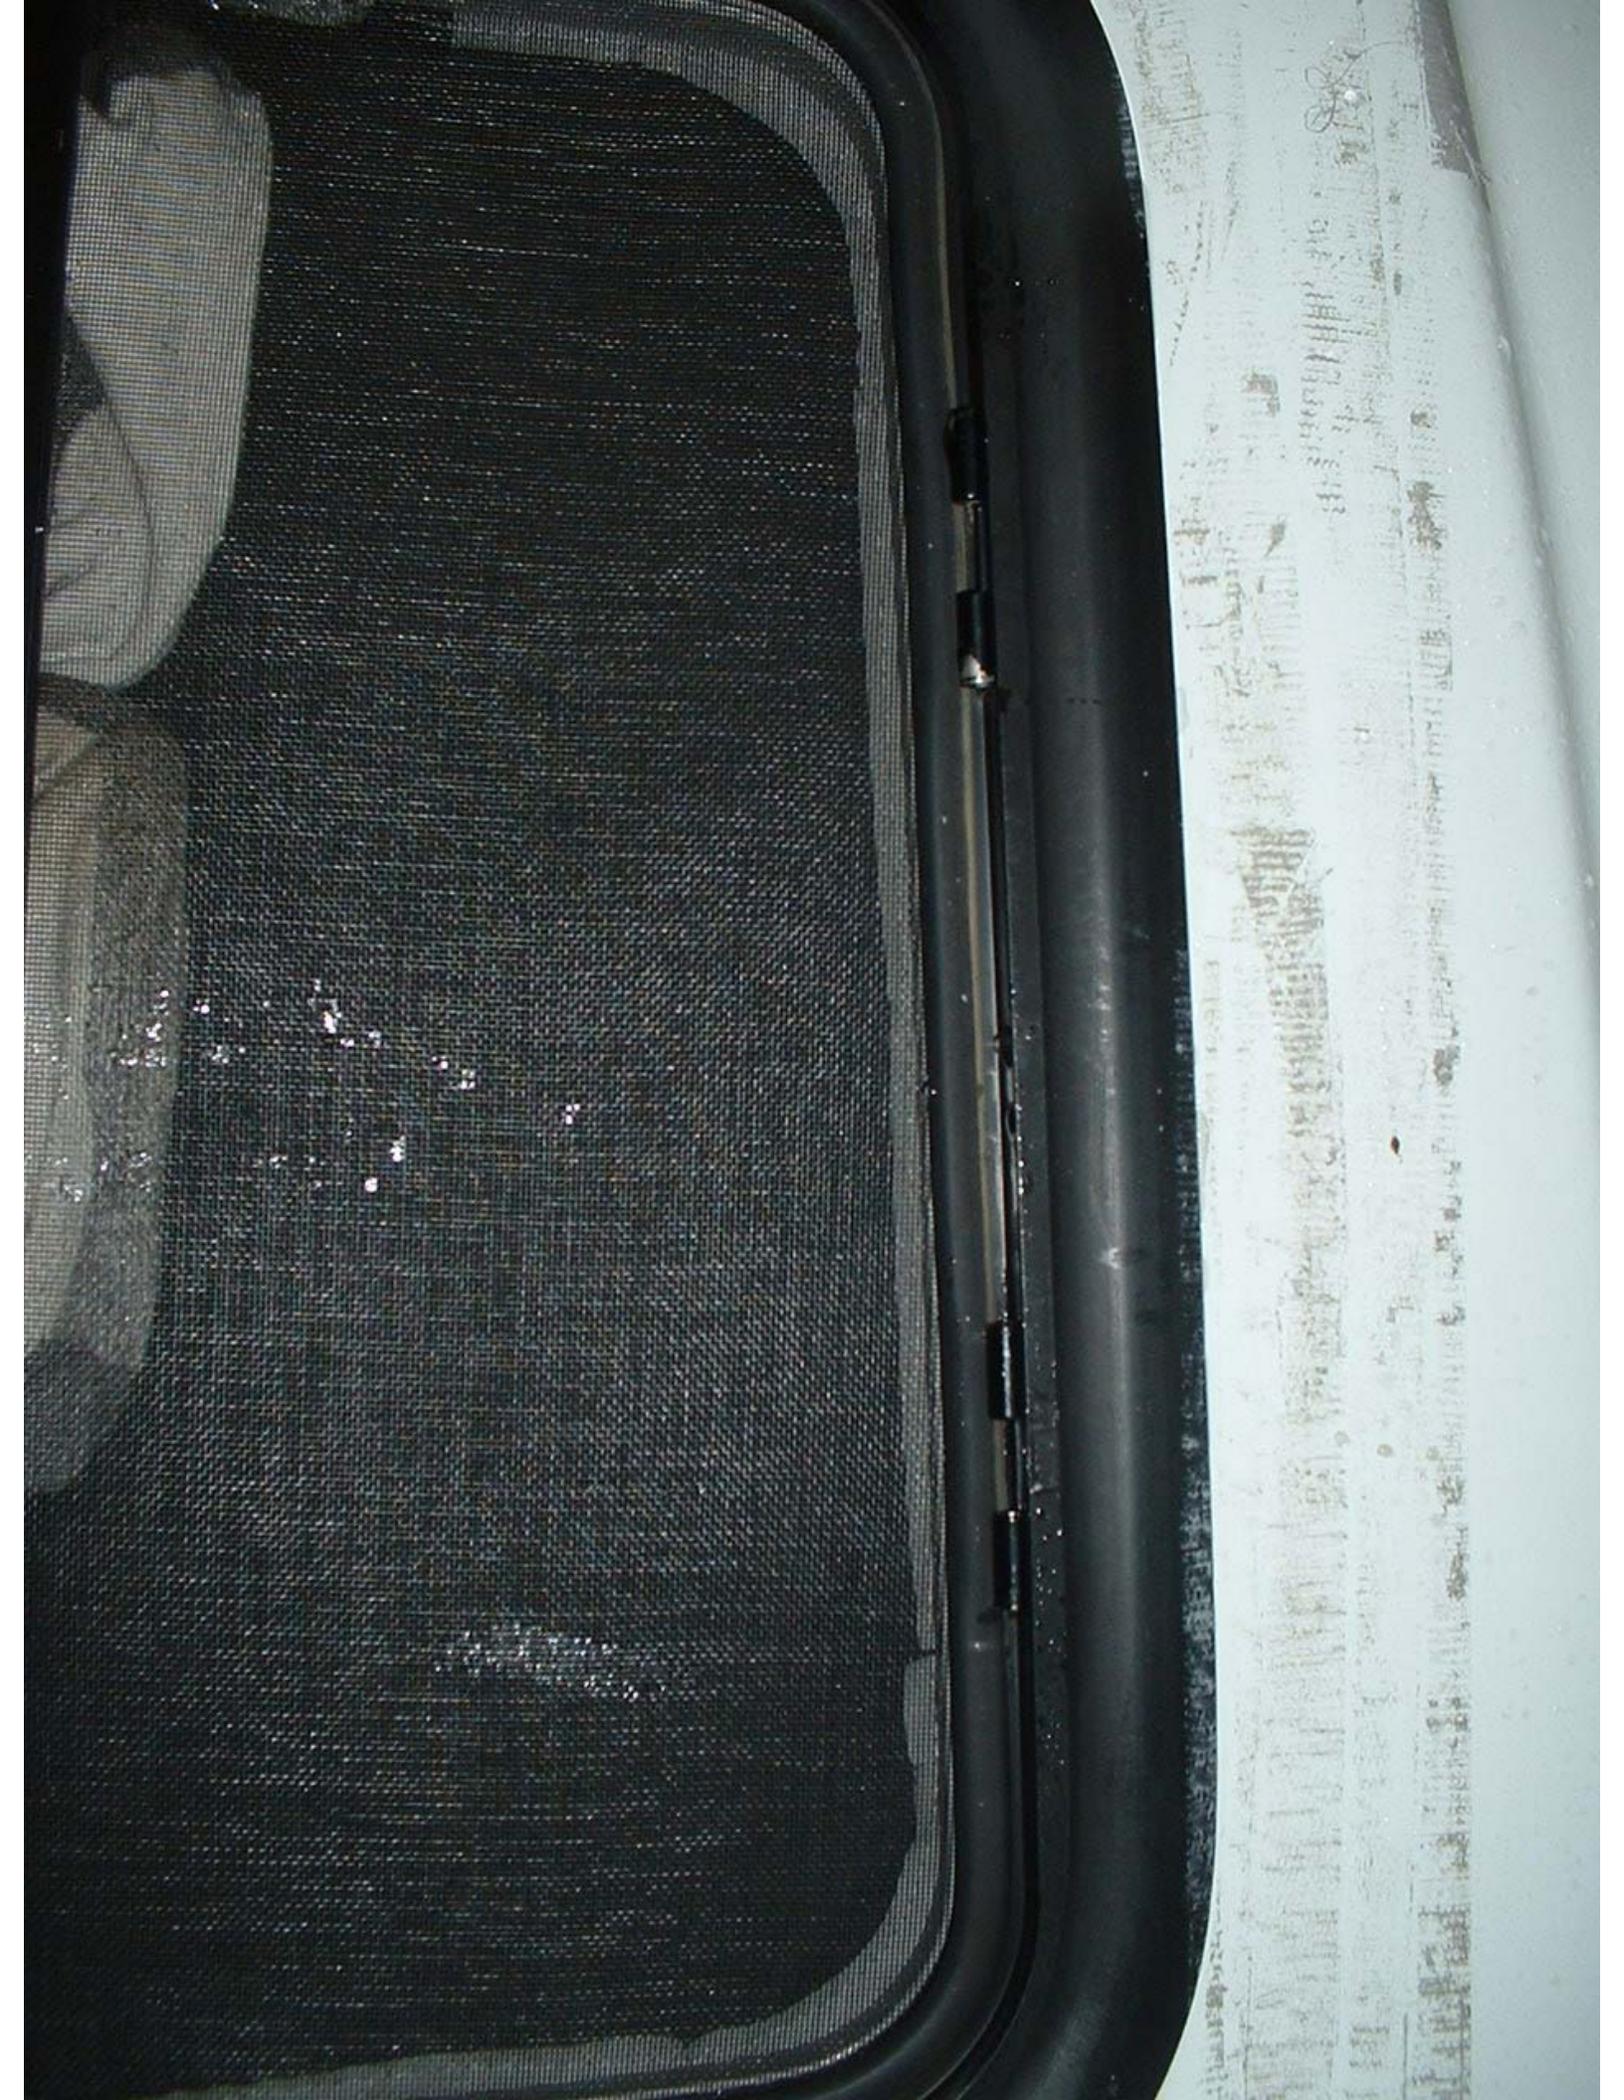
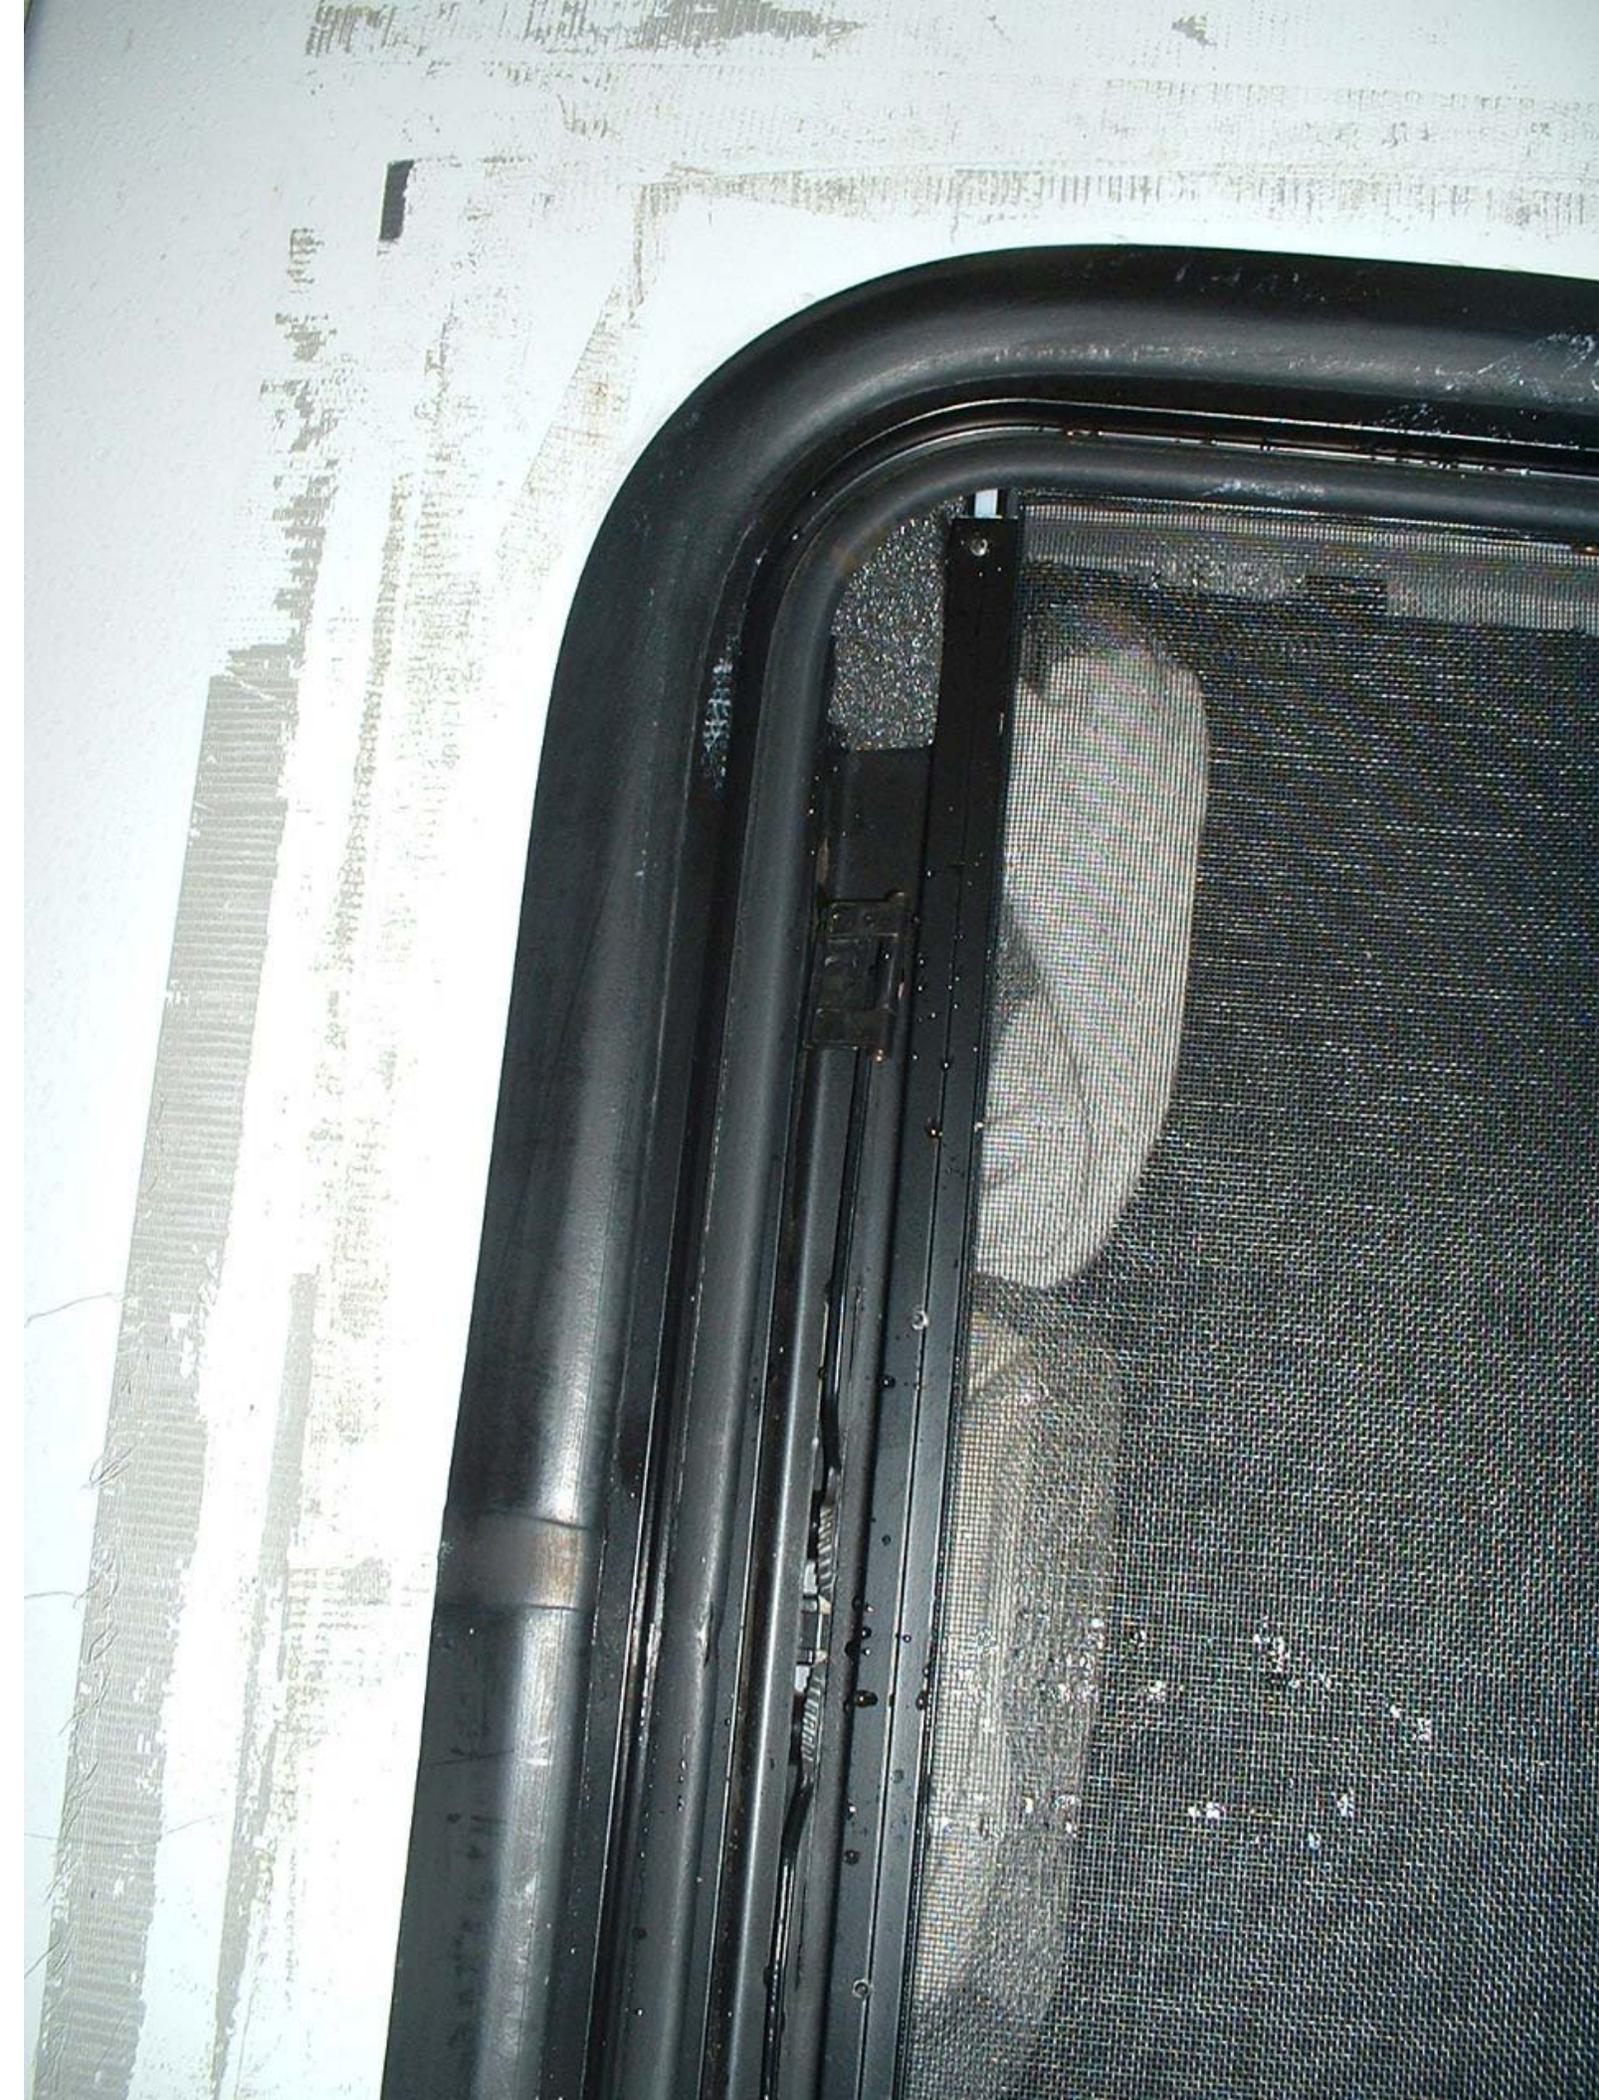
DRIVER STATES THAT BUNK WINDOW JUST FELL OFF GOING DOWN FREE WAY. ATTACHING PICTURES. WILL THIS BE A WARRANTABLE REPAIR?

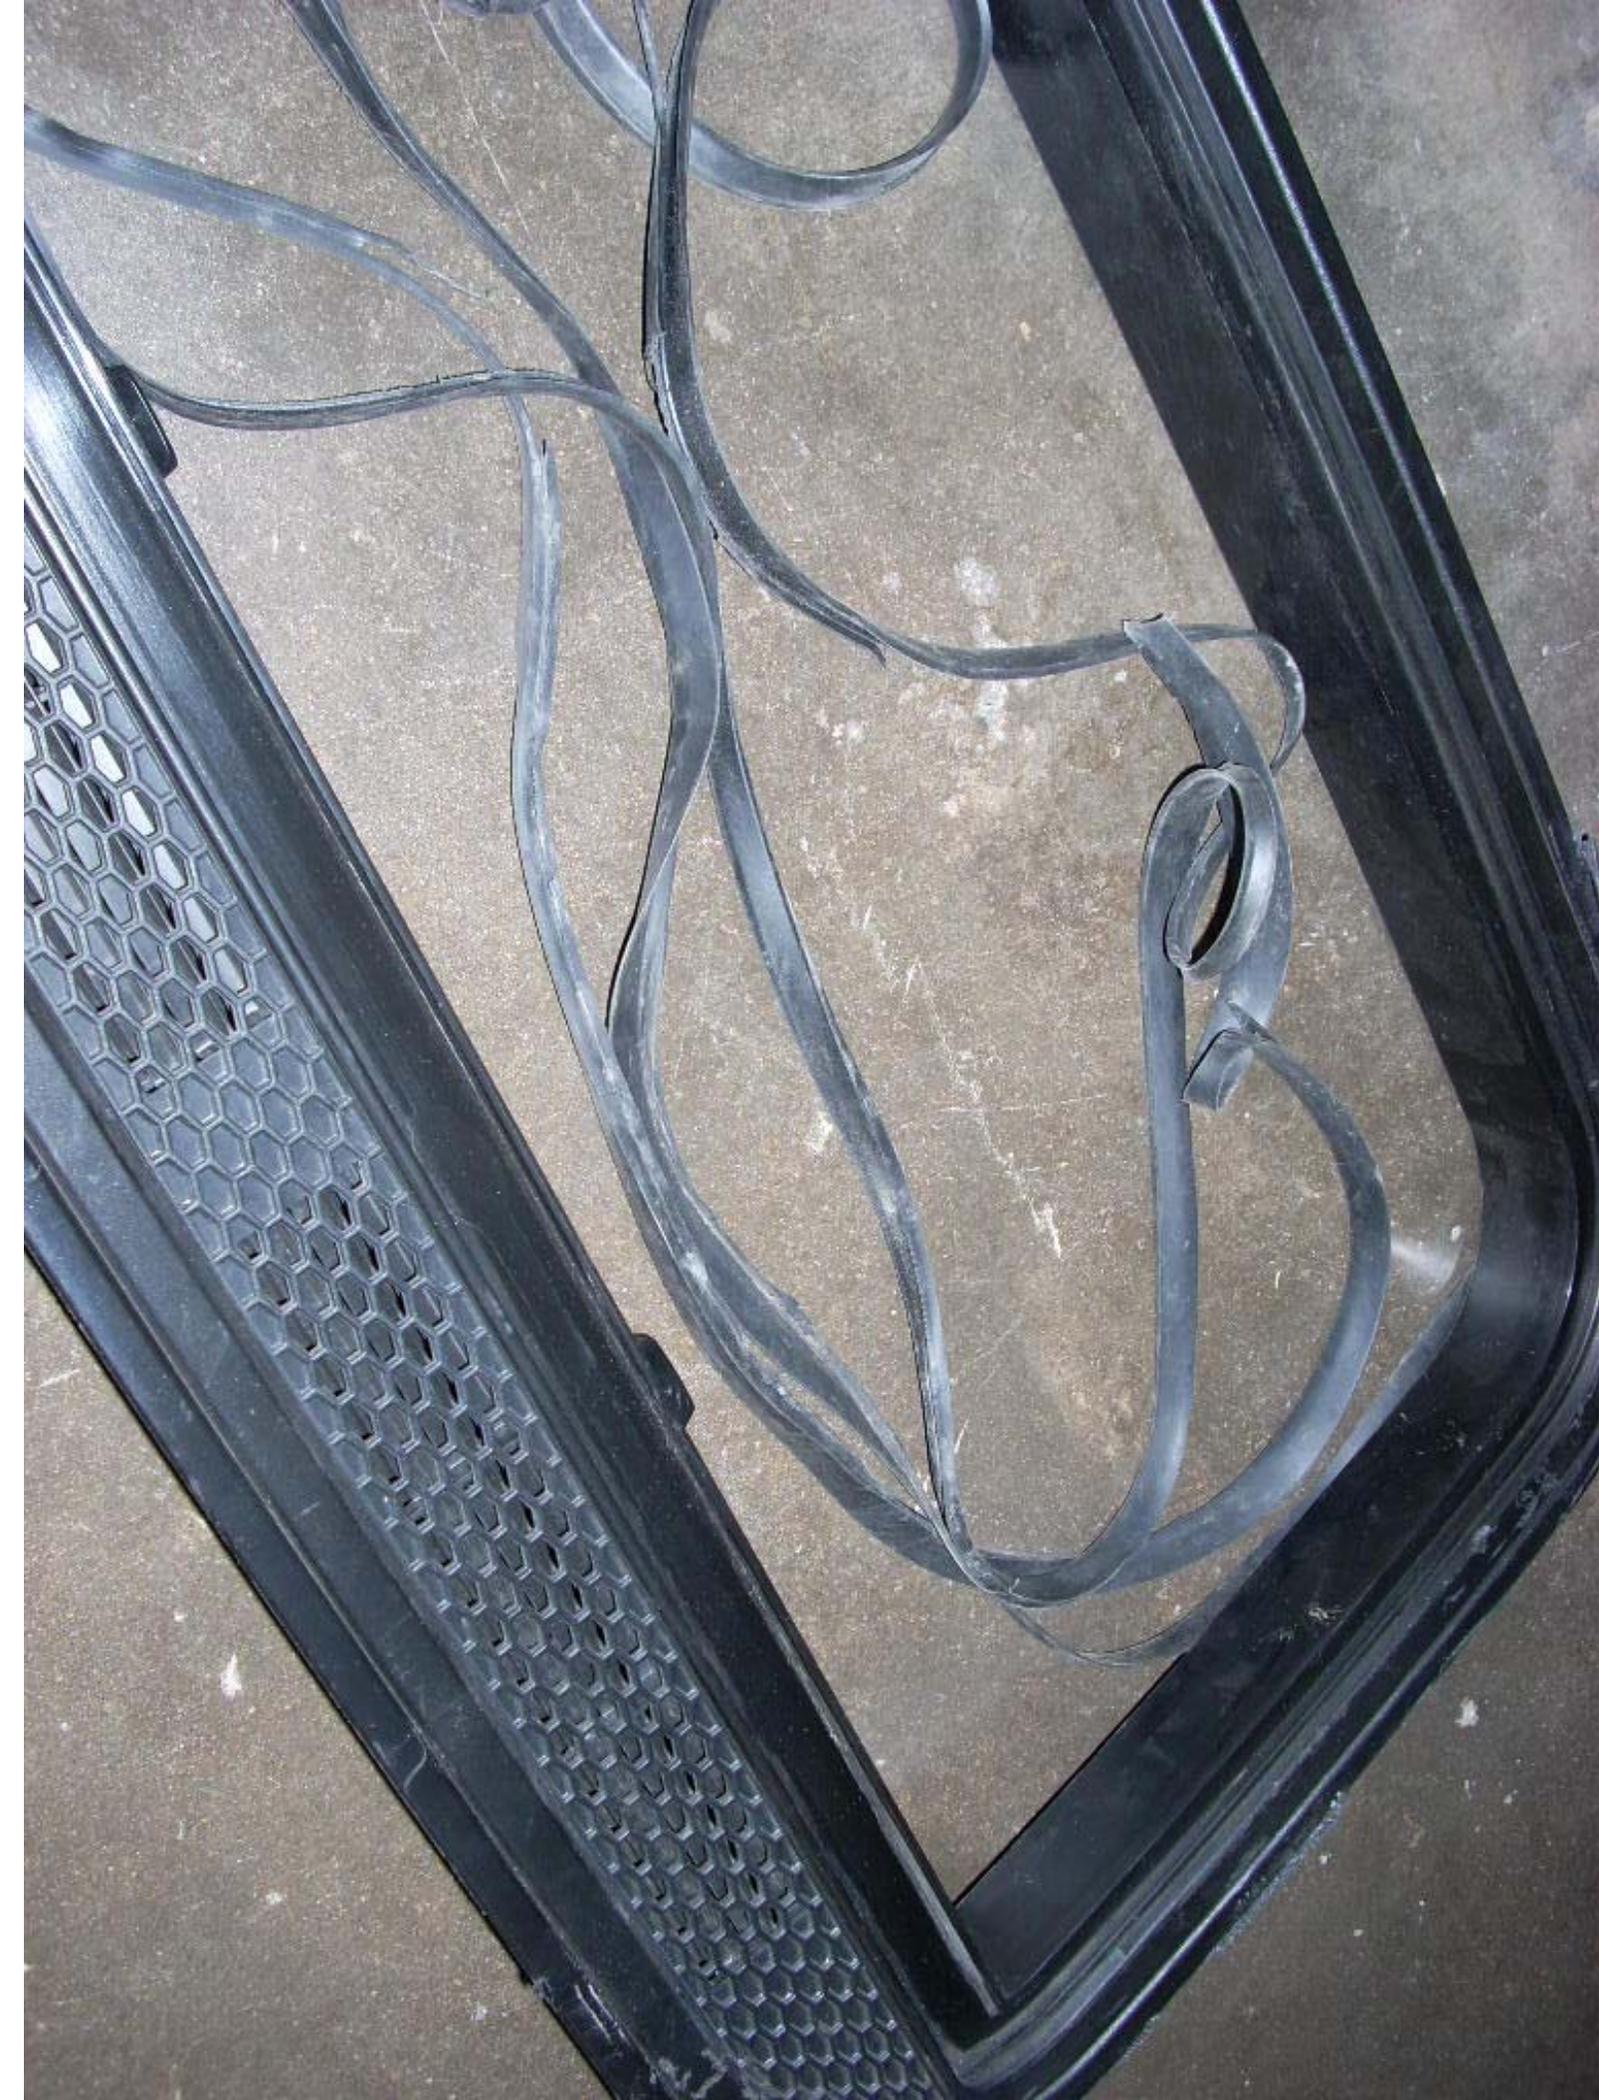
The mileage is from a month ago. The customer is on the road and called in to let us know that the window has fallen out again. We have replaced the left window twice and customer has called to report the left window has fallen out for a third time. We have replaced the right window once. When the left window fell out the third time the customer reports he was in a rain storm and his \$287.65 mattress was ruined. It appears the the glass is not adhered to the frame properly. The picture is from left window after it was replaced the second time. Is it possible that the cab and sleeper are not venting properly when the doors are closed causing too much pressure? The truck will be in our shop the on Oct 28. What should we do differently this time?

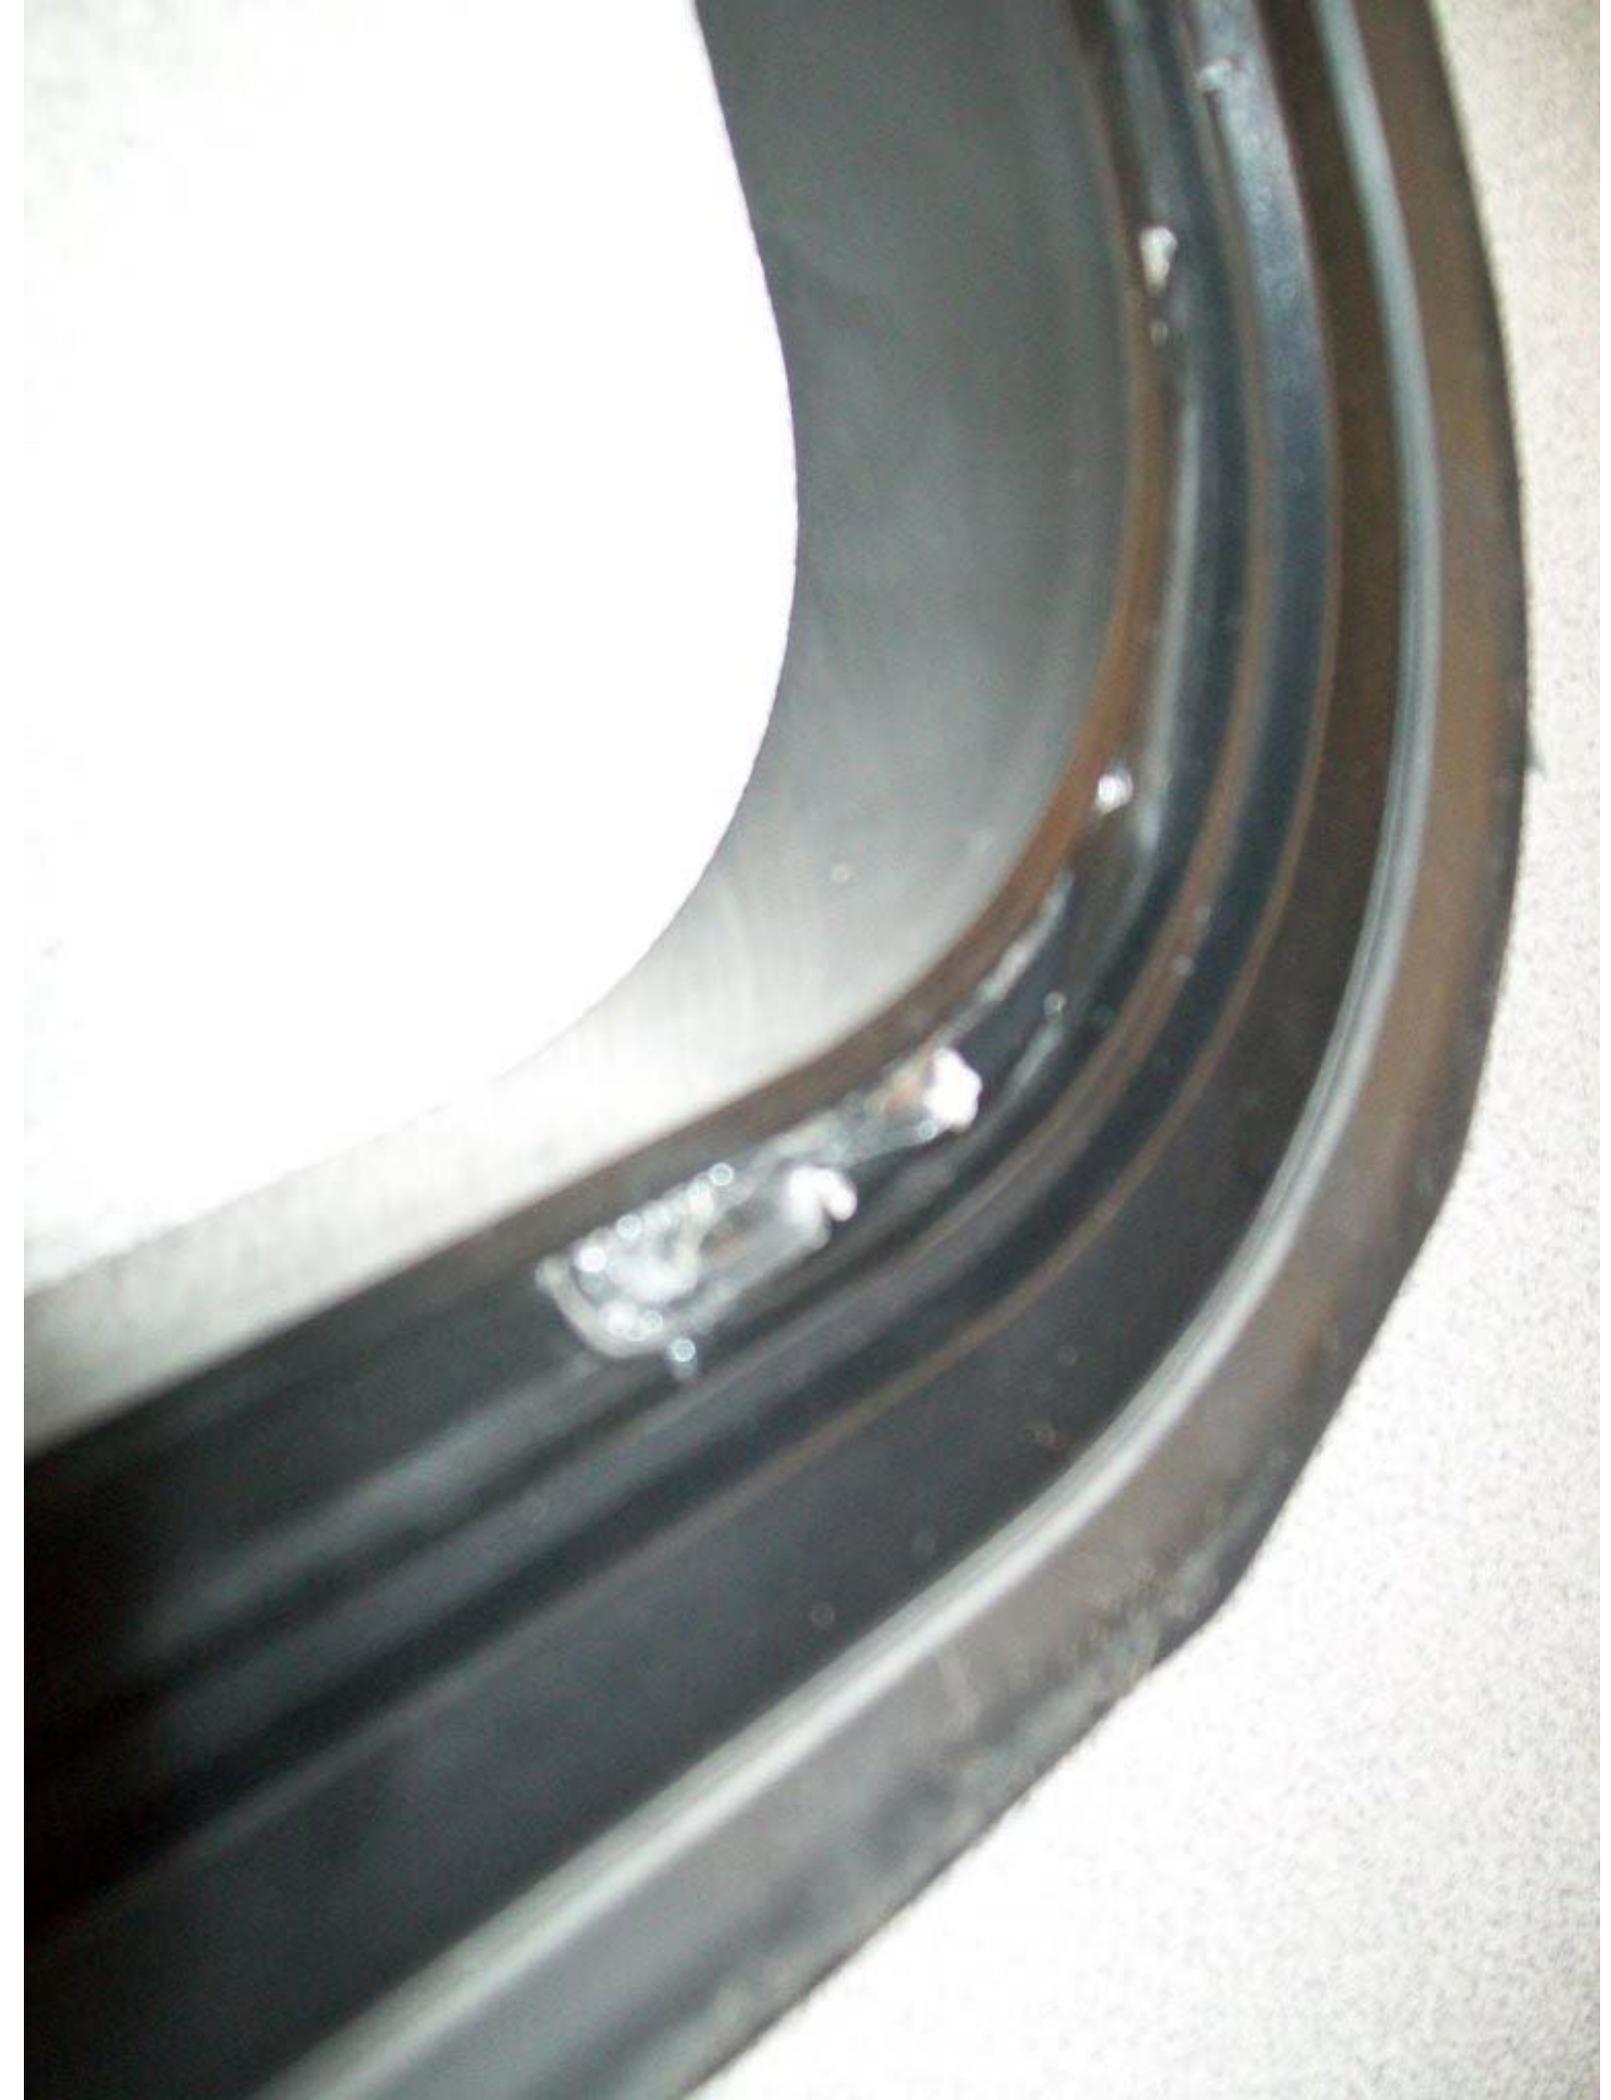
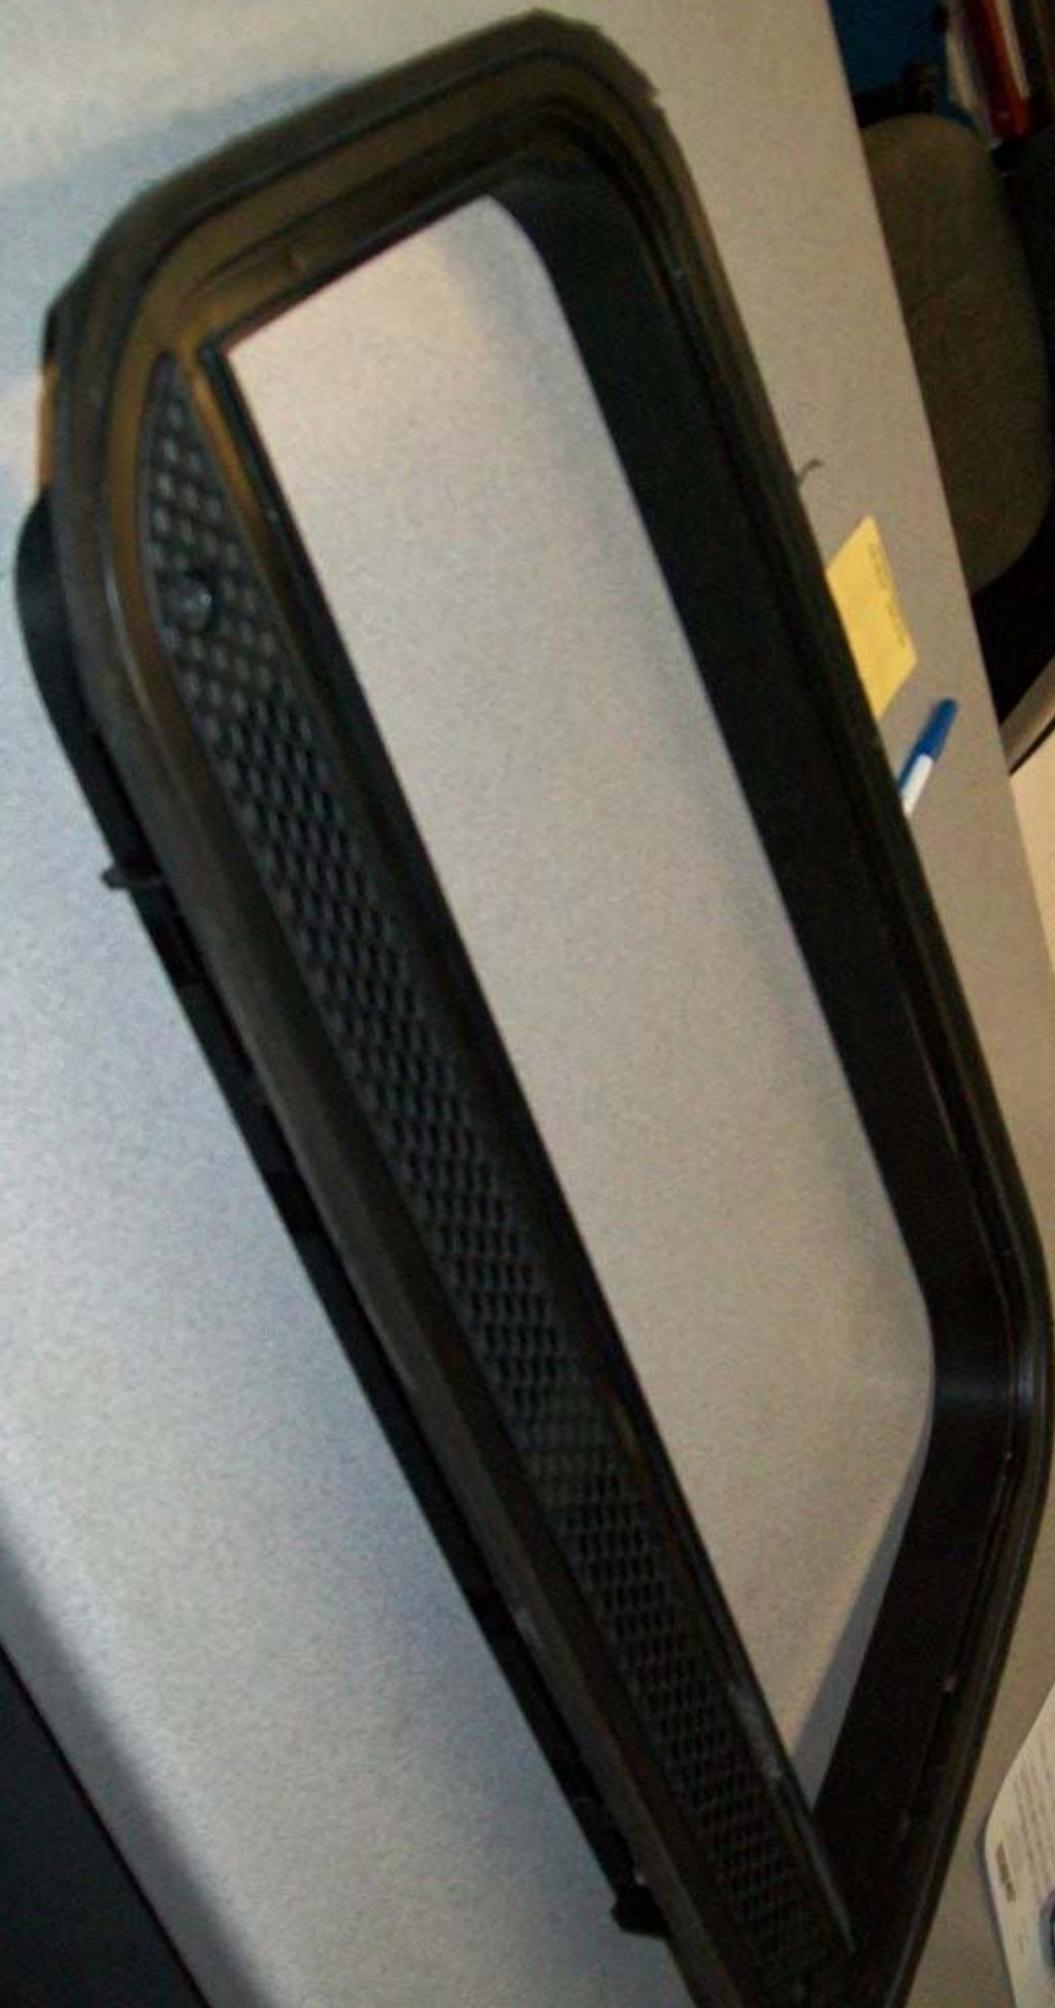
It seems the adhesive is failing again..Can I turn these in for warranty or policy?

Created	Created By	Activity Type	Description
08/25/2009 08:03:02	MICHAEL RANKIN	Response	Please replace windows and send old windows to TMAC in pulaski VA attn. Mike Rankin
08/24/2009 12:18:11	SIEBEL ADMINISTRATOR	Notes	An attachment with filename '100_0118' has been added.
08/24/2009 12:17:10	SIEBEL ADMINISTRATOR	Notes	An attachment with filename '100_0117' has been added.

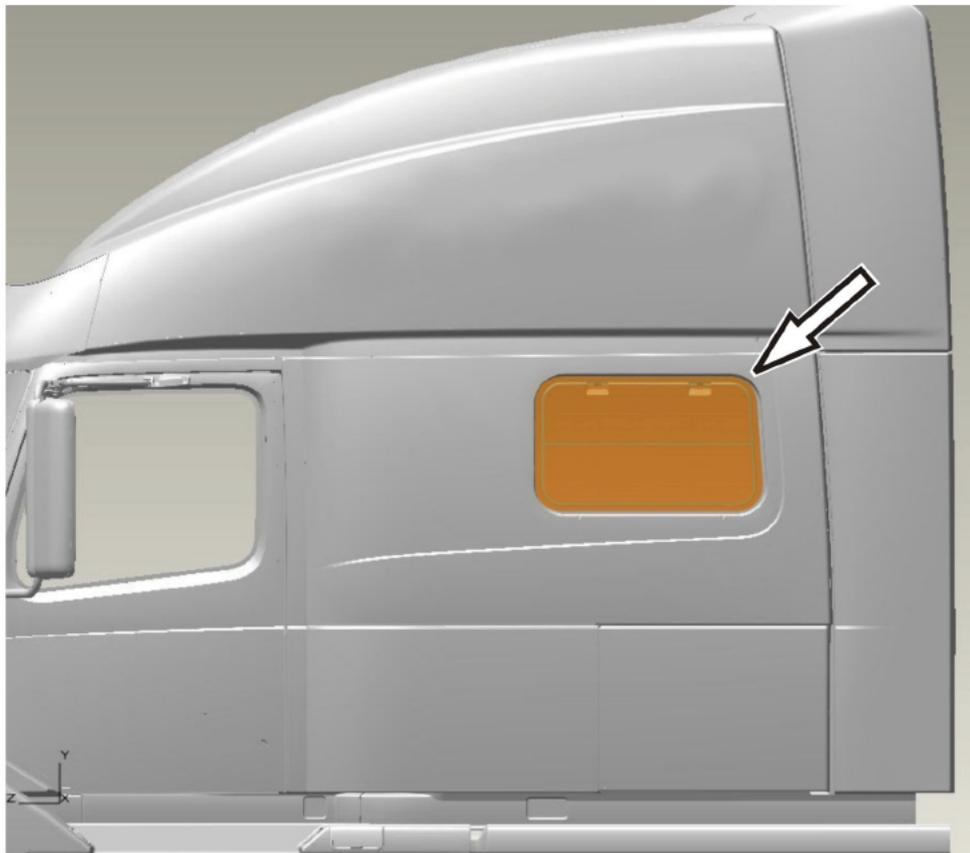
W8063487

Vehicles built prior to May 16th 2011 may experience leaks at the lower sleeper window between the window frame and the seal with the cab body. To resolve this issue, a procedure has been developed to add features which will allow water to drain from the seal. If leaks are identified between the rubber seal and the window frame follow these procedures.
