Program Bulletin

CUSTOMER SATISFACTION PROGRAM

SUBJECT: Low Beam Headlamp Inoperative - Replace Connector

MODELS: 2008-2010 Cadillac CTS
2010 Cadillac SRX
2007-2010 GMC Acadia
2007-2010 Saturn OUTLOOK
Equipped with Halogen Headlamps

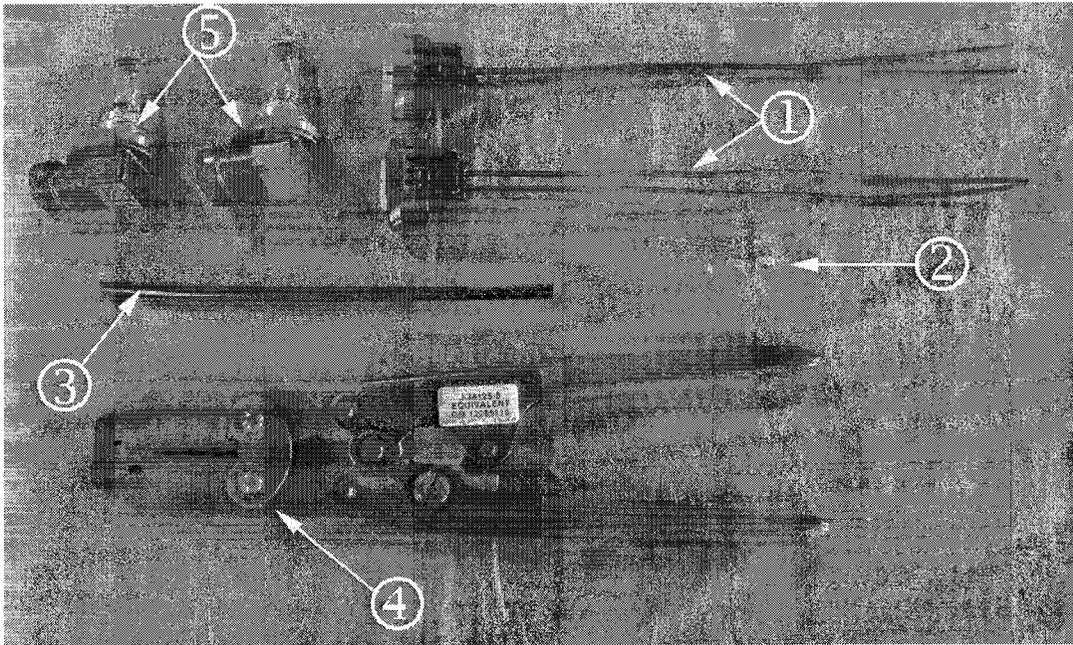
2734347

Note: The service kit, P/N 22848987, includes two service pigtails (1), four splice clips (2), one piece of heat shrinking tube (3) and two bulbs (5). Use Special Tool J-38125-8 (4) to complete the repair.

5. Locate the two service pigtails (1) included in kit P/N 22848987.

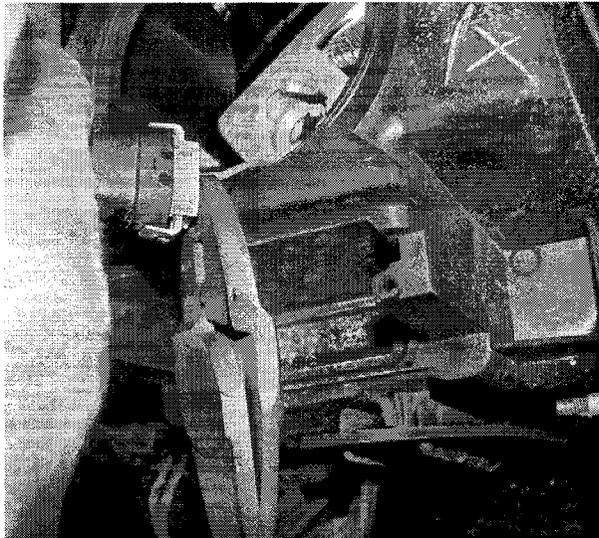
2734376

Note: If the head lamp wiring harness already has a service pigtail and connector attached with a splice, cut the wiring harness beyond the existing splice to ensure the old splice is removed from the head lamp harness.

- 9.1 Cut the wires of the headlamp harness at the base of the connector.

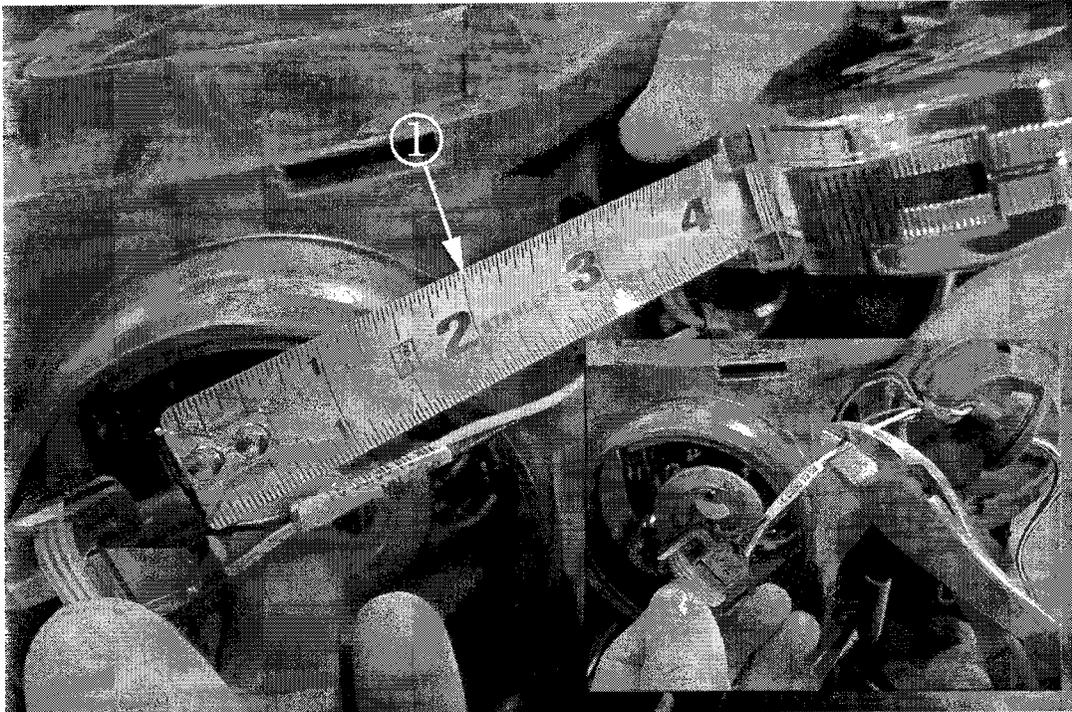
2734406

Note: If the head lamp wiring harness already has a service pigtail and connector attached with a splice, cut the wiring harness beyond the existing splice to ensure the old splice is removed from the head lamp harness.

11. Cut the existing low beam connector and 51 mm (2 in) of wire from the existing low beam wiring harness (1).
12. Fold over the exposed wire on the service pigtail so that there is 13 mm (½ in) of folded wire prepared for the splice crimp. Do not fold over the exposed wire on the existing headlamp wiring harness.

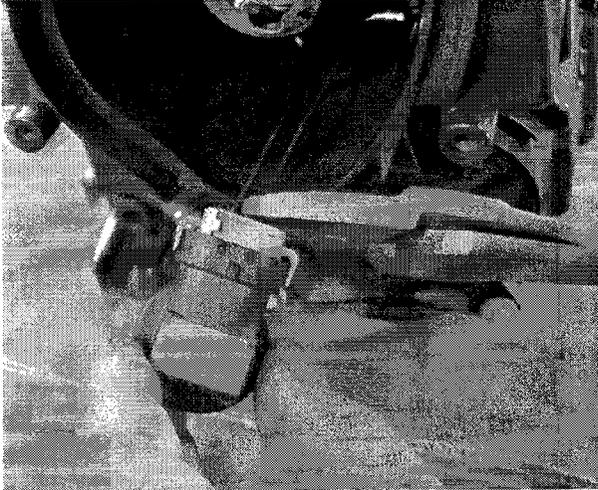
2734414

Note: If the head lamp wiring harness already has a service pigtail and connector attached with a splice, cut the wiring harness beyond the existing splice to ensure the old splice is removed from the head lamp harness.

5. Cut the wires of the headlamp connector at the connector.

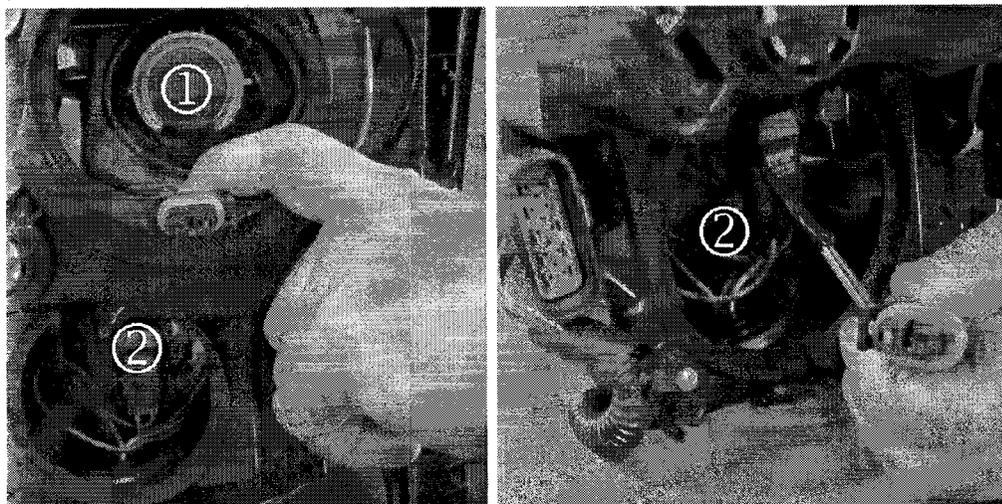
2734426

Note: Access to the low beam connector (1) is accomplished by routing the connector through the high beam access cap opening (located lower on lamp) (2) as shown in illustration.

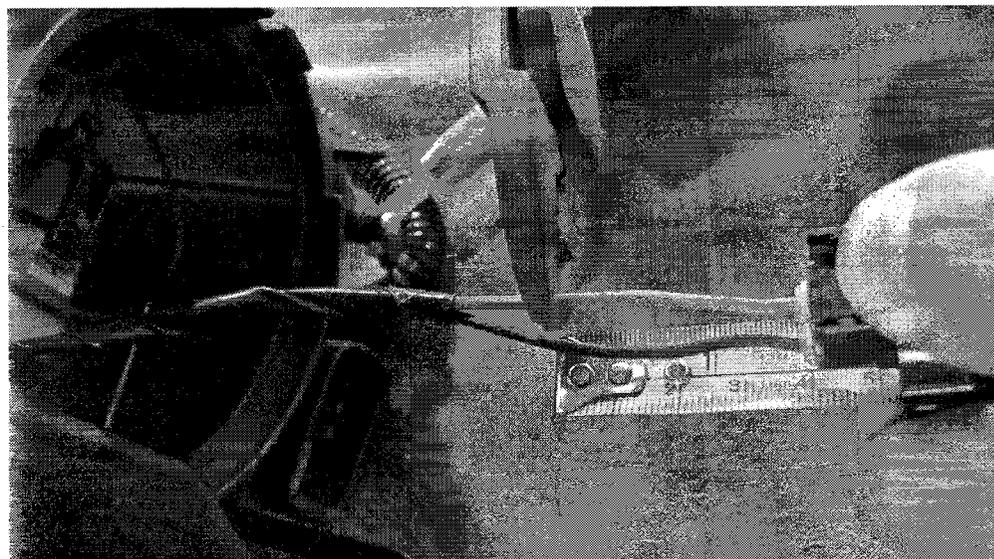
2734427

Note: If the head lamp wiring harness already has a service pigtail and connector attached with a splice, cut the wiring harness beyond the existing splice to ensure the old splice is removed from the head lamp harness.

5. Cut the existing low beam connector and 38 mm (1.5) of wire from the existing wiring harness.
