ITB11-039e

June 8, 2012

VOLUNTARY SAFETY RECALL CAMPAIGN 1997-2003 QX4 IN SALT STATES FRONT STRUT HOUSING CORROSION

CAMPAIGN ID #: R1109
NHTSA #: 11V-244
APPLIED VEHICLES: 1997- 2003 QX4 (JR50)

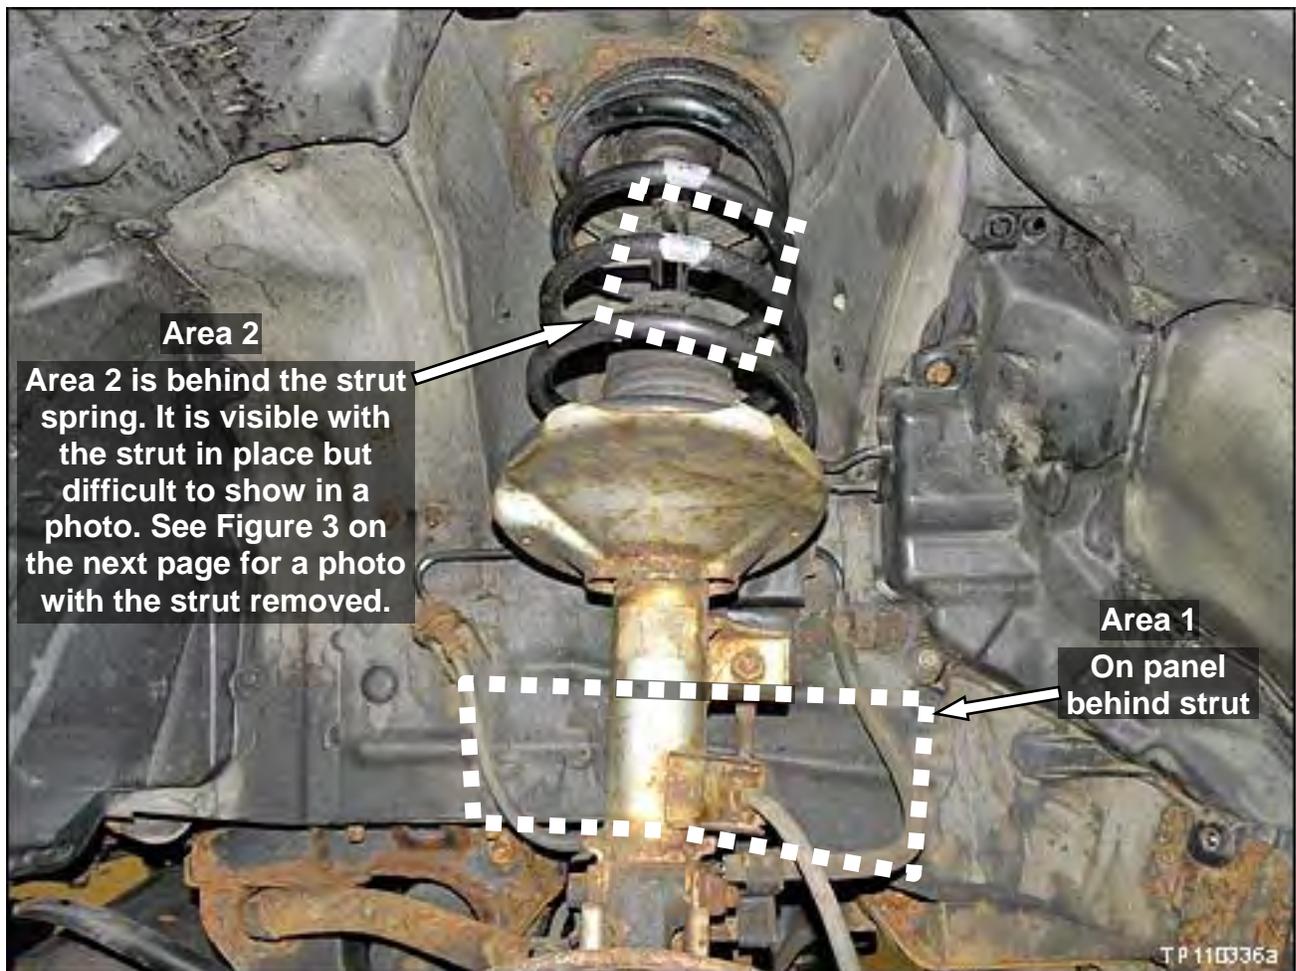
Figure 1

3. Inspect for corrosion on the driver side AND passenger side in the wheel house Area 1 and strut housing Area 2 (see Figures 1, 2, 3, and 4).

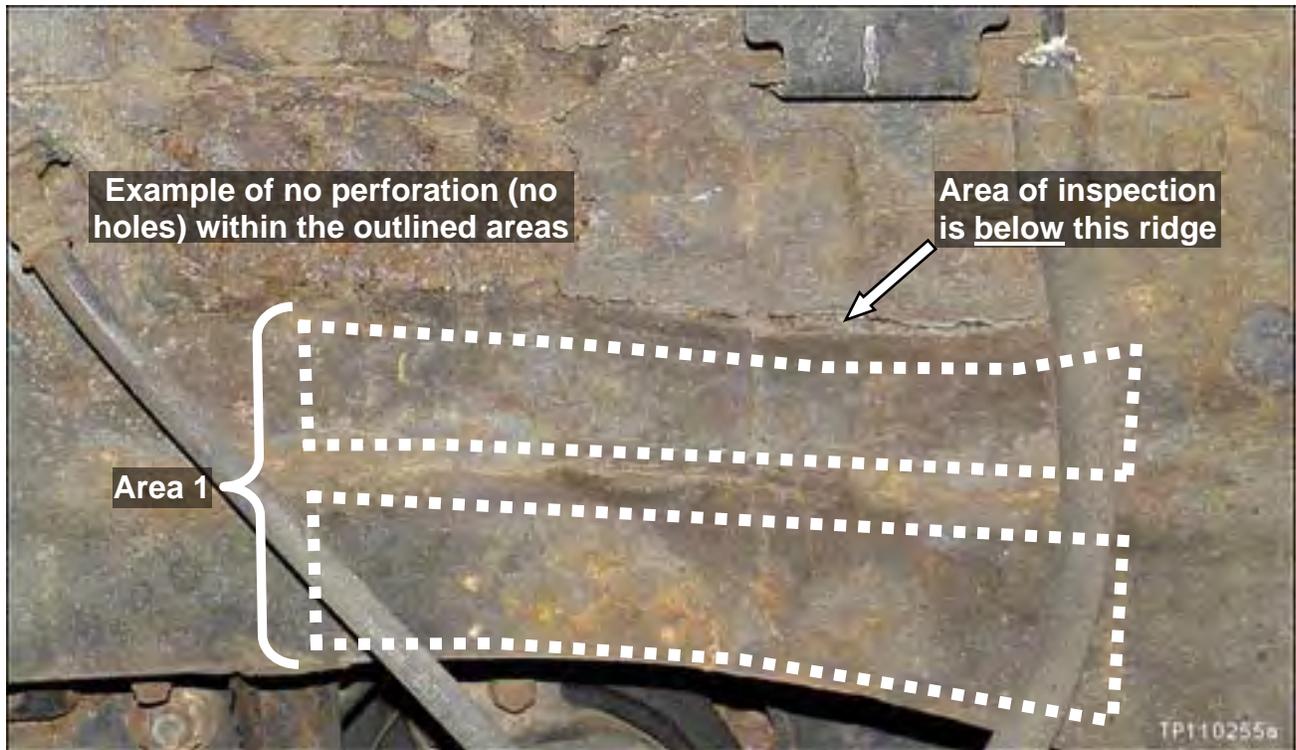
Figure 3

Area 1: Look for perforation (holes) in the metal only in the areas outlined above.

- a. Retain the vehicle at the dealer. (The vehicle is not repairable.)
- b. Supply the customer with a rental car.
- c. Fax a completed Non-Repairable Report to Morley (see page 54).

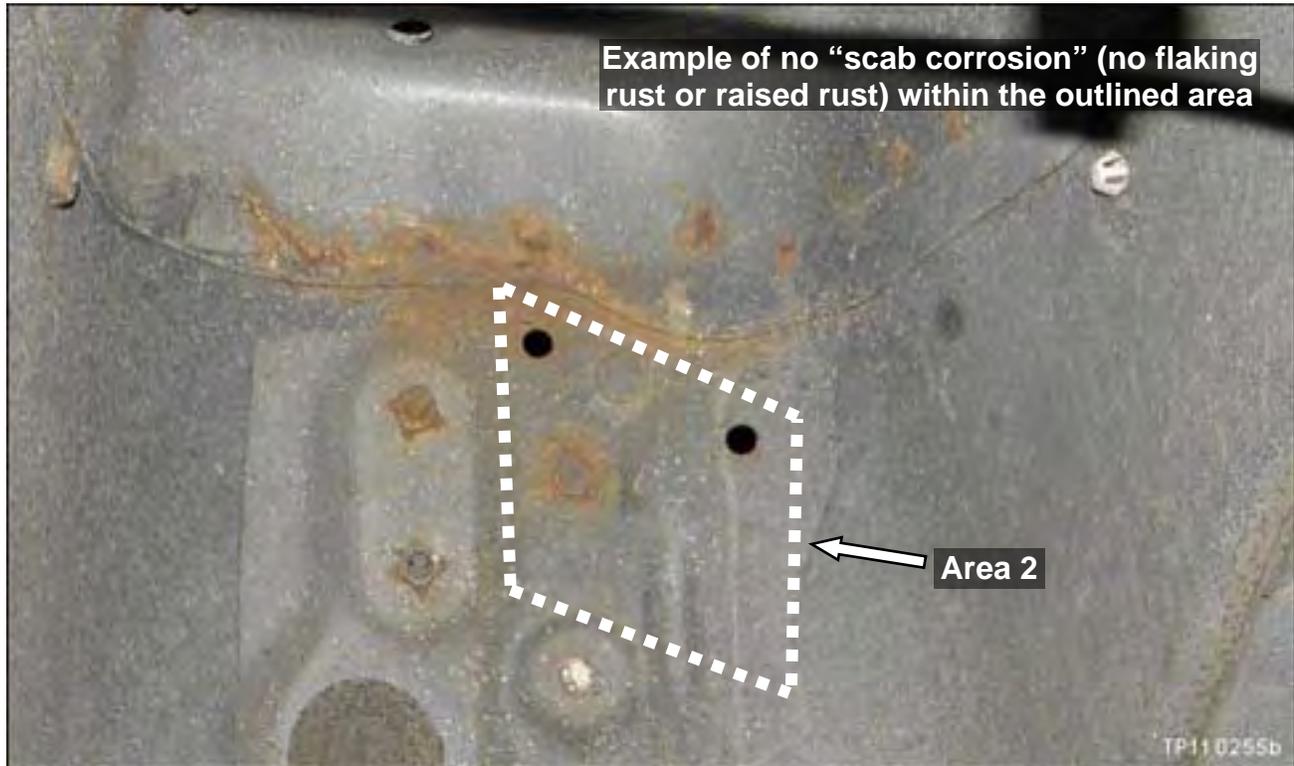
Area 2: Look for “scab corrosion” (flaking rust or raised rust) on driver side **AND** passenger side only in the area outlined above.

- The area shown in Figure 4 applies to driver side **AND** passenger side.
- If needed, refer to examples (additional photos) of Area 2 scab corrosion inspection on page 47.

- a. Retain the vehicle at the dealer. (The vehicle is not repairable.)
- b. Supply the customer with a rental car.
- c. Fax a completed Non-Repairable Report to Morley (see page 54).

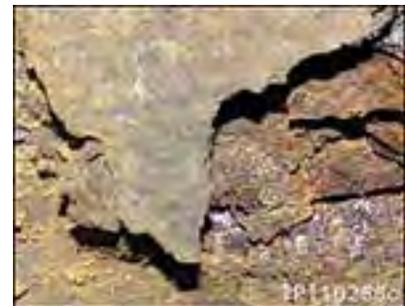
Figure 5 is an example of “scab corrosion” (flaking and raised rust).

If there is **scab corrosion** (flaking or raised rust) in Area 2, driver side **OR** passenger side:

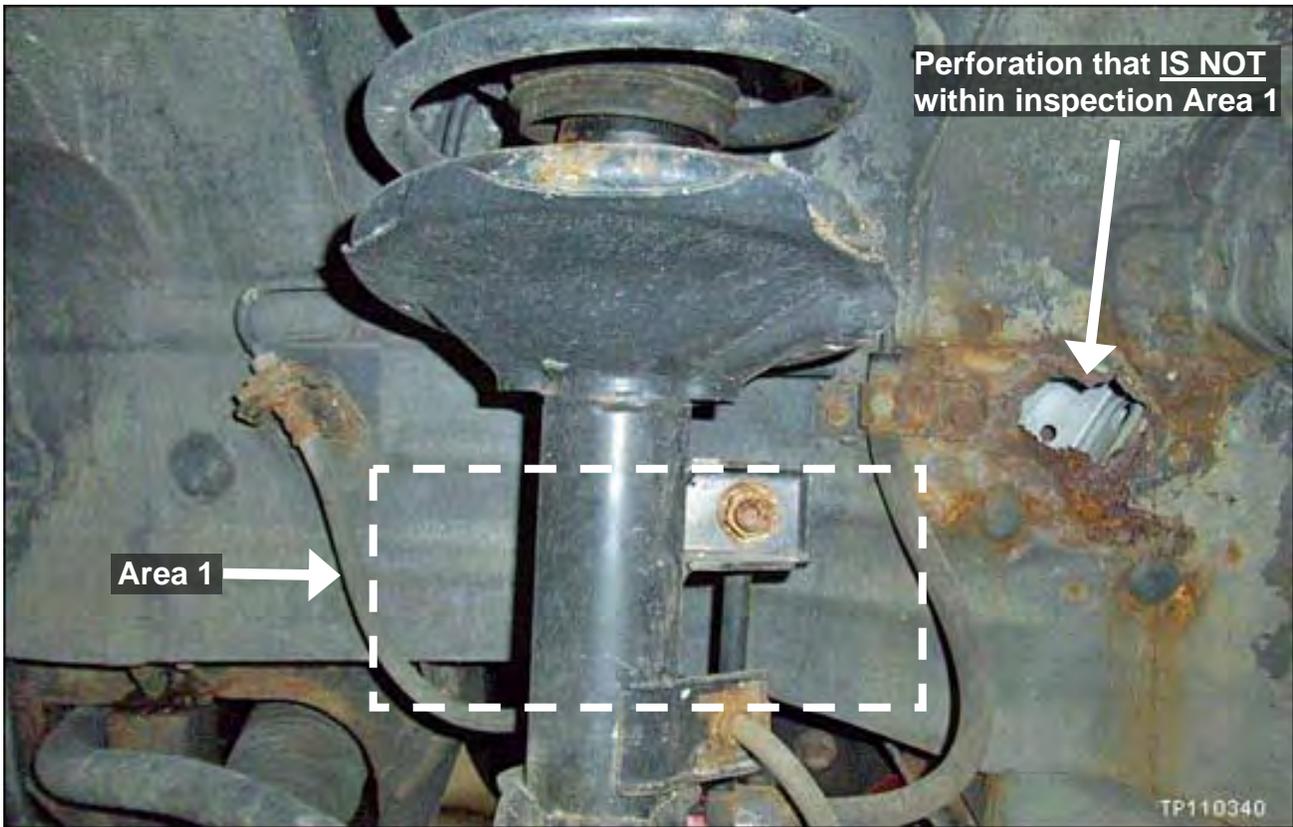
Examples (Additional Photos) of Area 1 Perforation Inspection

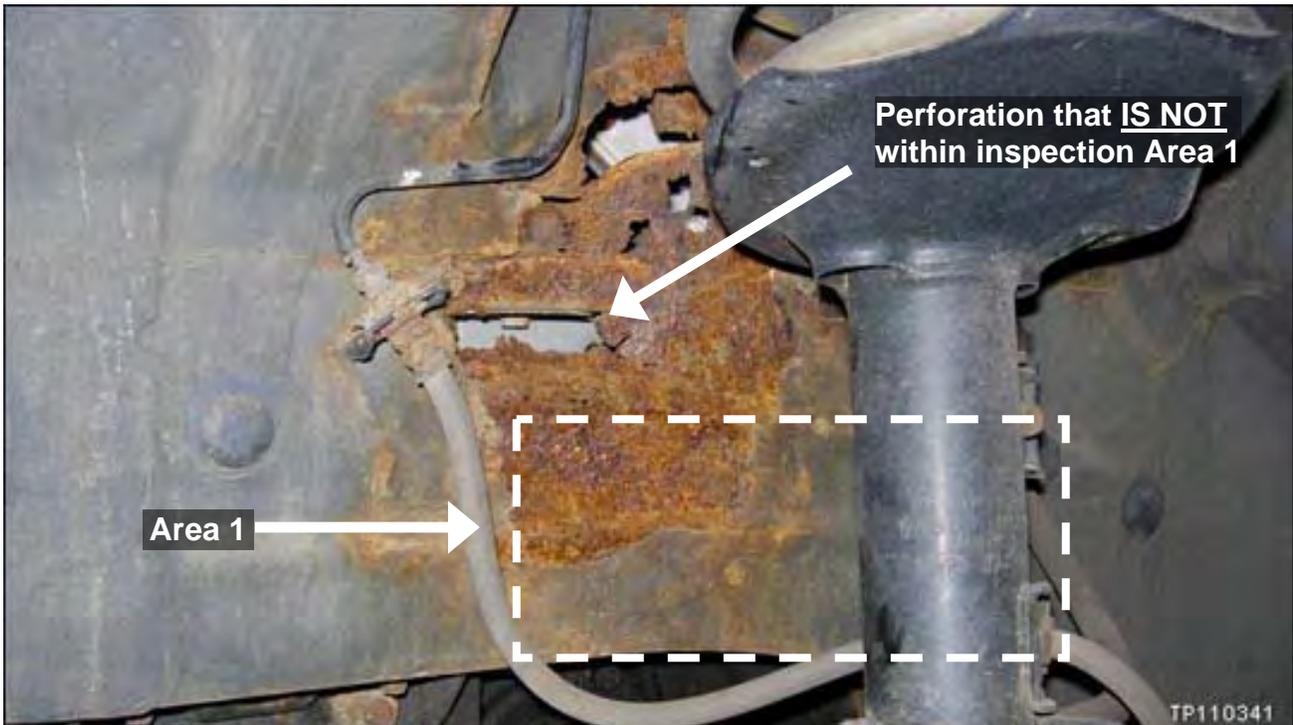
Example (Additional Photo) of Area 1 Perforation Inspection

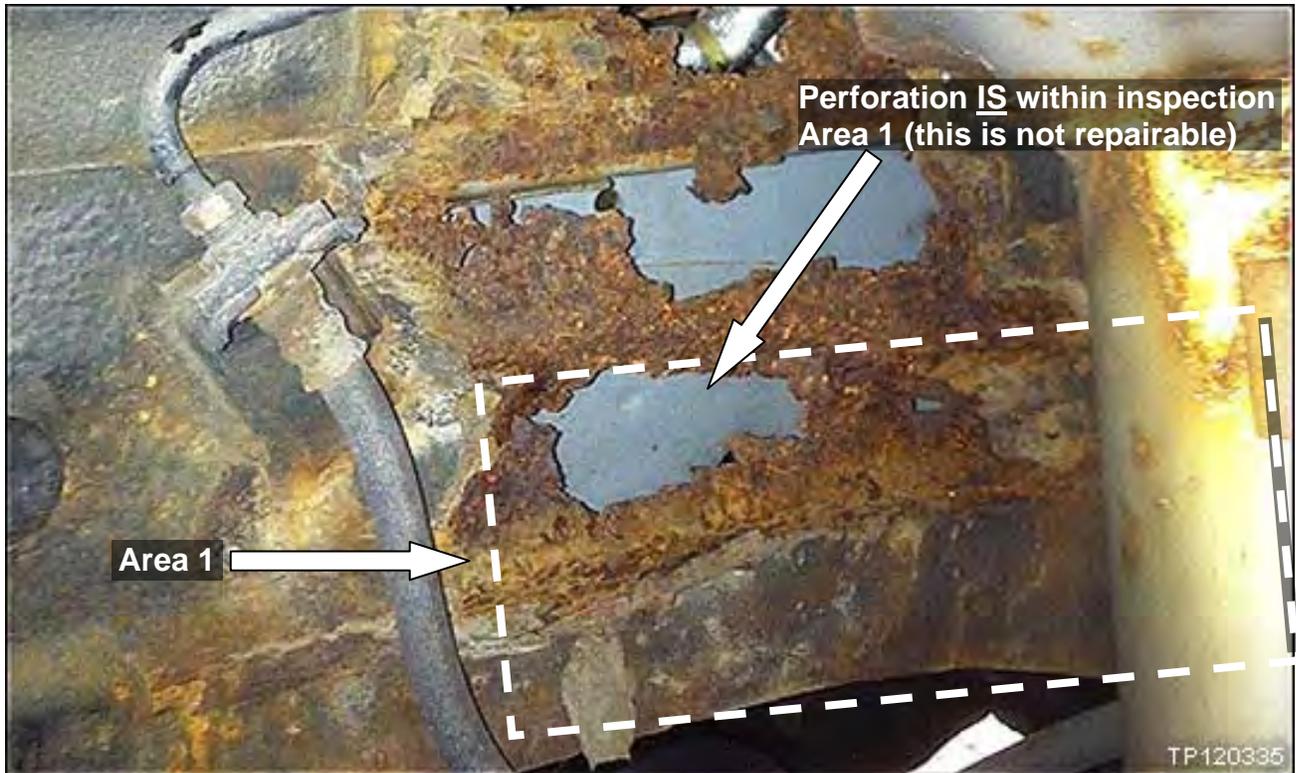
Example (Additional Photo) of Area 1 Perforation Inspection

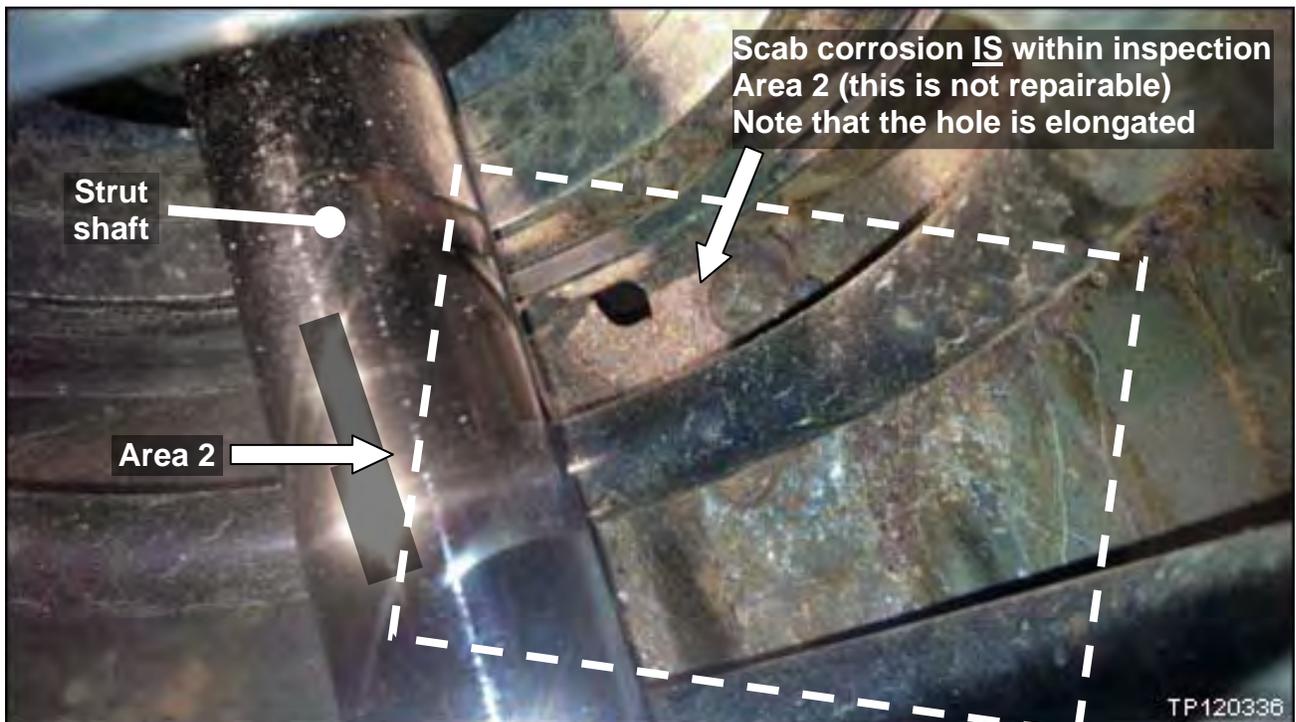
Example (Additional Photo) of Area 2 Scab Corrosion Inspection
