CERTAIN 2001-2004 MODEL YEAR ESCAPE VEHICLES WITH 3.0L ENGINE AND SPEED CONTROL — ENGINE COVER MODIFICATION

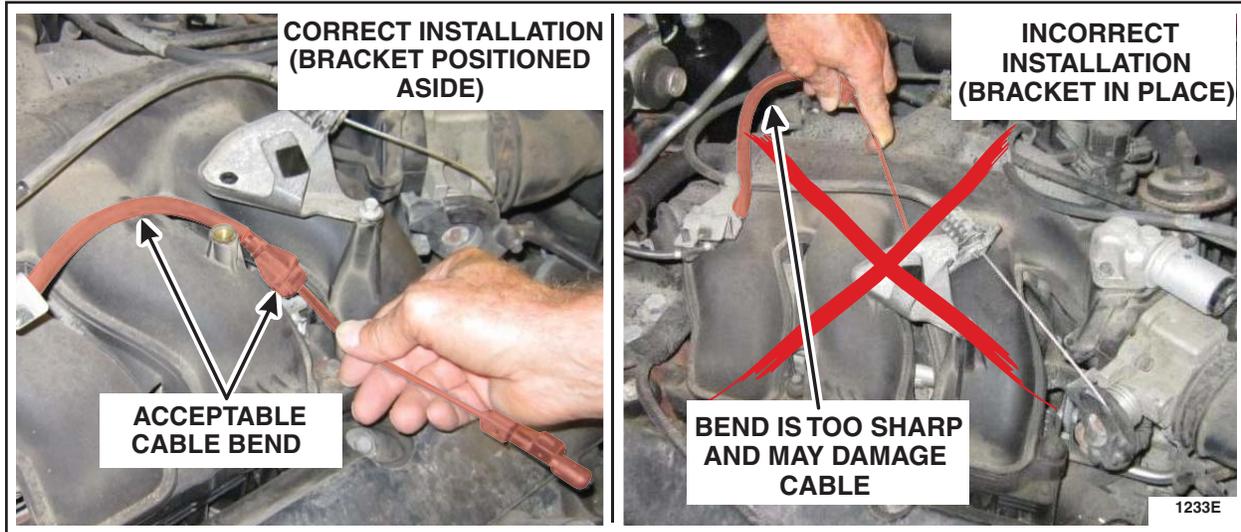
FIGURE 4

NOTICE: Do not bend the speed control cable in order to route it under the throttle cable bracket. The throttle cable bracket must be positioned aside or damage to the speed control cable may occur. See Figure 4.

4. Route the speed control cable under the bracket as shown in "correct installation" below. See Figure 4.
