RECALL DOCUMENT

Mfr Name : GENERAL MOTORS CORP.

Bulletin No.: 05086

SUBJECT: POWER STEERING HOSE FRACTURE

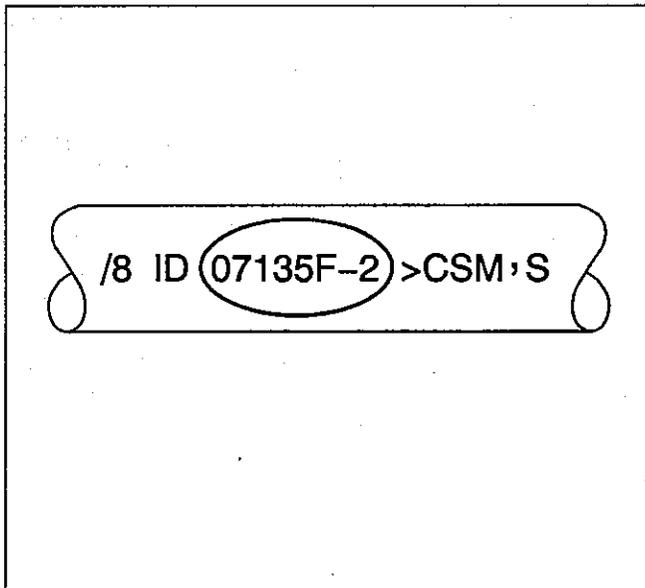
1704027

1. Inspect and record the power steering pressure line for the date code as shown above. The date code is printed on the hose and is repeated approximately every 6 inches (150 mm). Depending on the vehicle configuration, there may be one or two hoses to inspect. Vehicles equipped with the hydro-boost system will have two hoses while others will only have one hose. Removal of conduit may be necessary in order to inspect the date code.

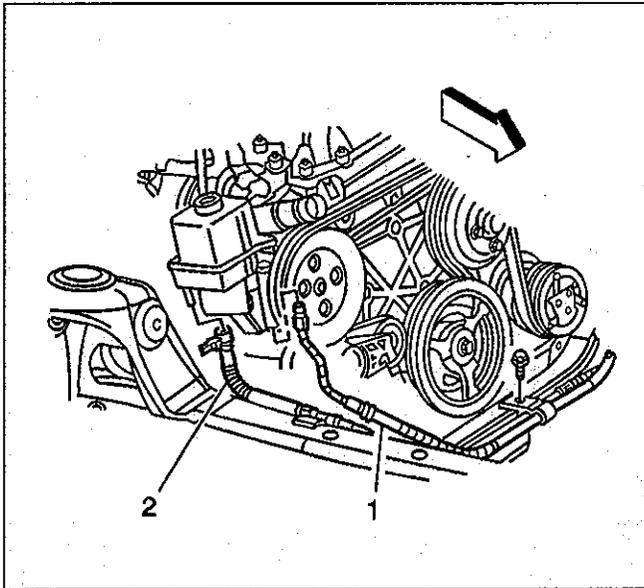
687439

Rainier/TrailBlazer/TrailBlazer EXT/Envoy/Envoy XL with 4.2L Engine Power Steering Pressure Hose (1). This pressure line has two hose sections and both must be inspected. Vehicle may need to be lifted to inspect both.

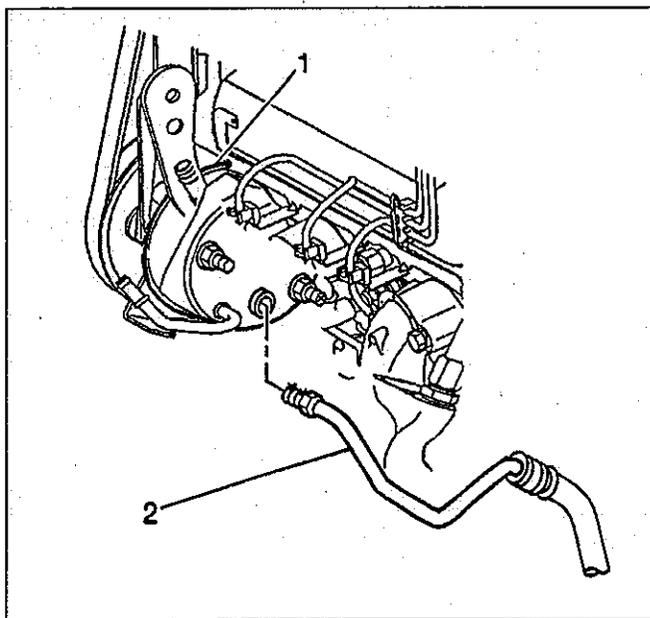
309298

Express/Savana Steering Pump to Hydro-Boost Pressure Line (2)

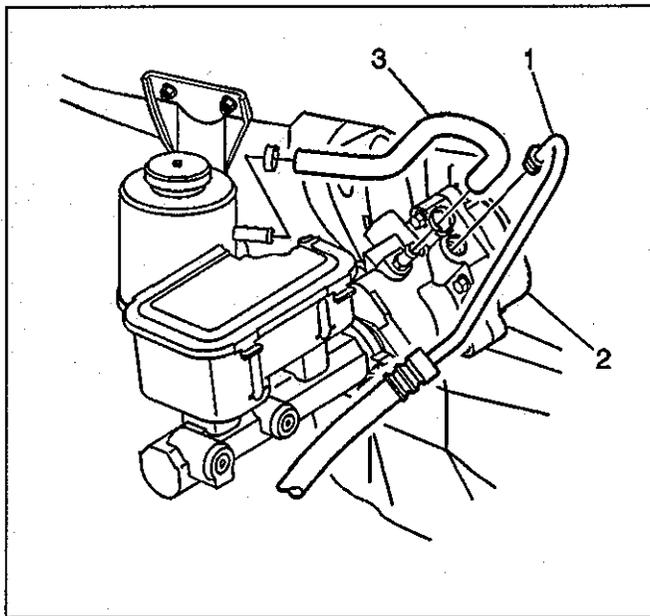
407982

Express/Savana Hydro-Boost to Steering Gear Pressure Line (1).

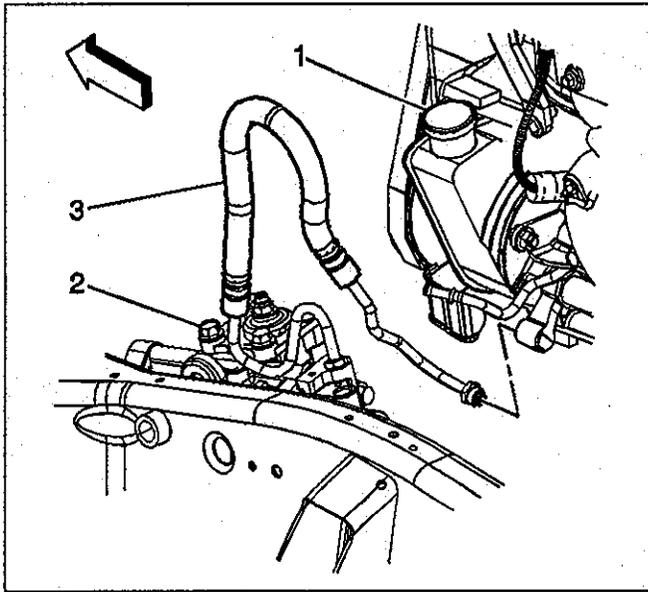
748675

Silverado/Tahoe/Sierra/Yukon/Escalade Non Hydro-Boost Pressure Line (3).

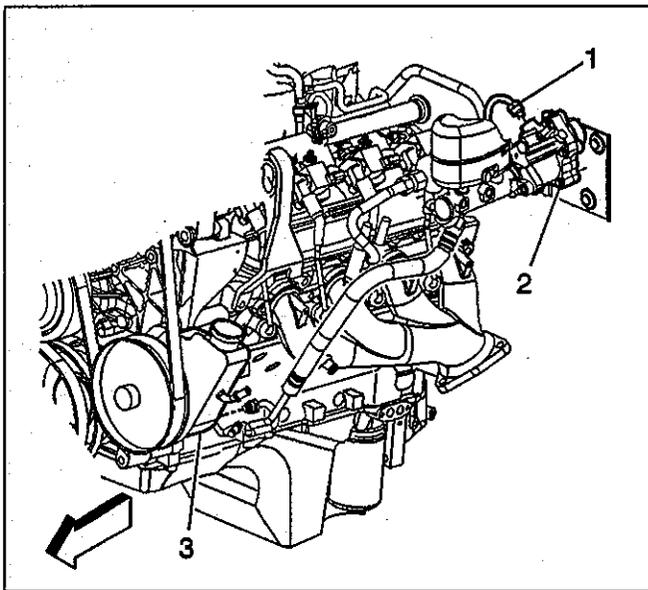
650858

Silverado/Tahoe/Sierra/Yukon/Escalade Power Steering Pump to Hydro-Boost Pressure Line (1).

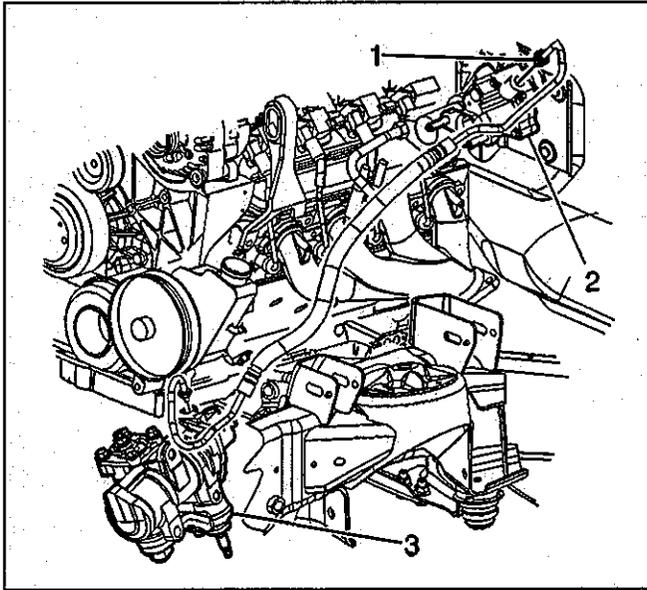
650863

Silverado/Tahoe/Sierra/Yukon/Escalade Hydro-Boost to Steering Gear Pressure Line (1).

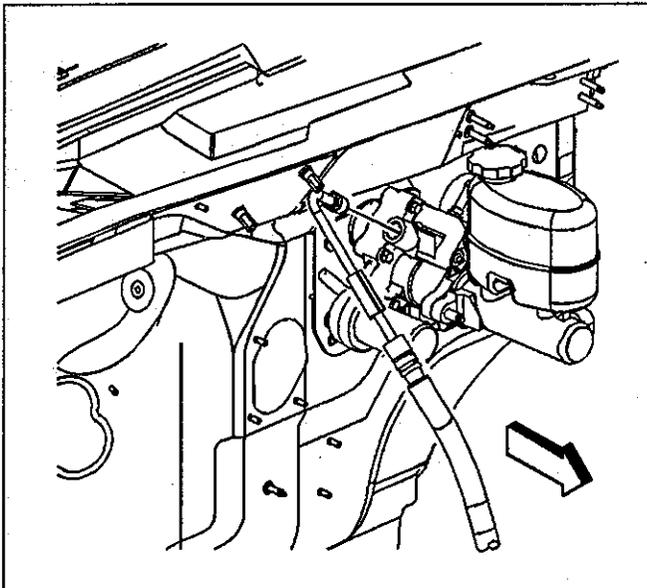
795542

Hummer H2 Power Steering Pump to Hydro-Boost Pressure Line.

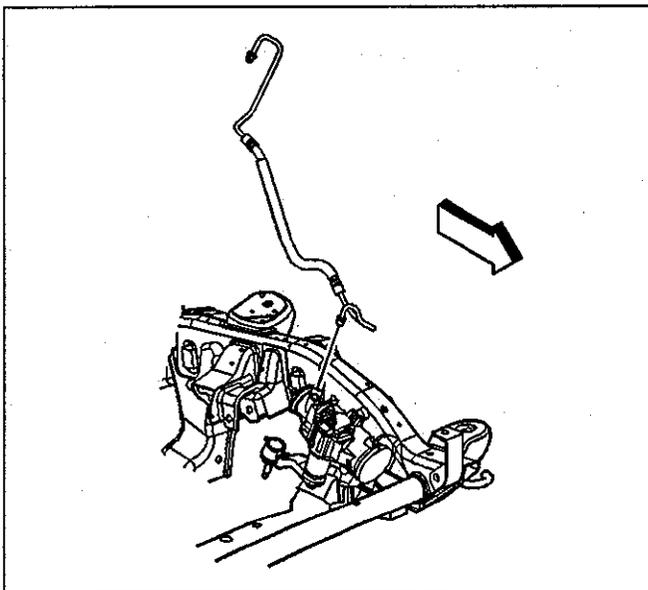
793265

Hummer H2 Hydro-Boost to Steering Gear Pressure Line.

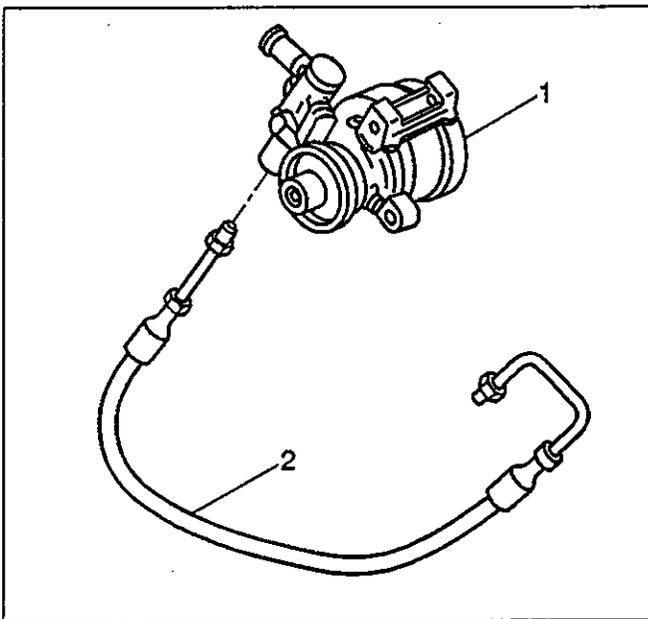
65356

Corvette Power Steering Pressure Hose (2). The vehicle will need to be lifted on a hoist for inspection. Removal of the power steering cooler bolts will give increased access to the pressure hose.
