Subject: Chrysler Group LLC Assertions - Karco ZJ-Body Impact Test of 16 May 2011
Reference: EA12-005 File Update (Chrysler Jeep Fuel Tank System Defect)

Jeep Vehicle Fuel Tank Breach: Source Documents History and Background

In April 2011 my expertise was solicited by Mr. Clarence Ditlow, Director for the Washington D.C. based Center for Auto Safety (CAS), regarding a planned real world crash test of a 1996 ZJ-Body Jeep Grand Cherokee fuel system. My role as representative for CAS also included confirmation of test vehicle (Jeep Grand Cherokee) condition as competent, representative and authentic for the stated test purpose(s).

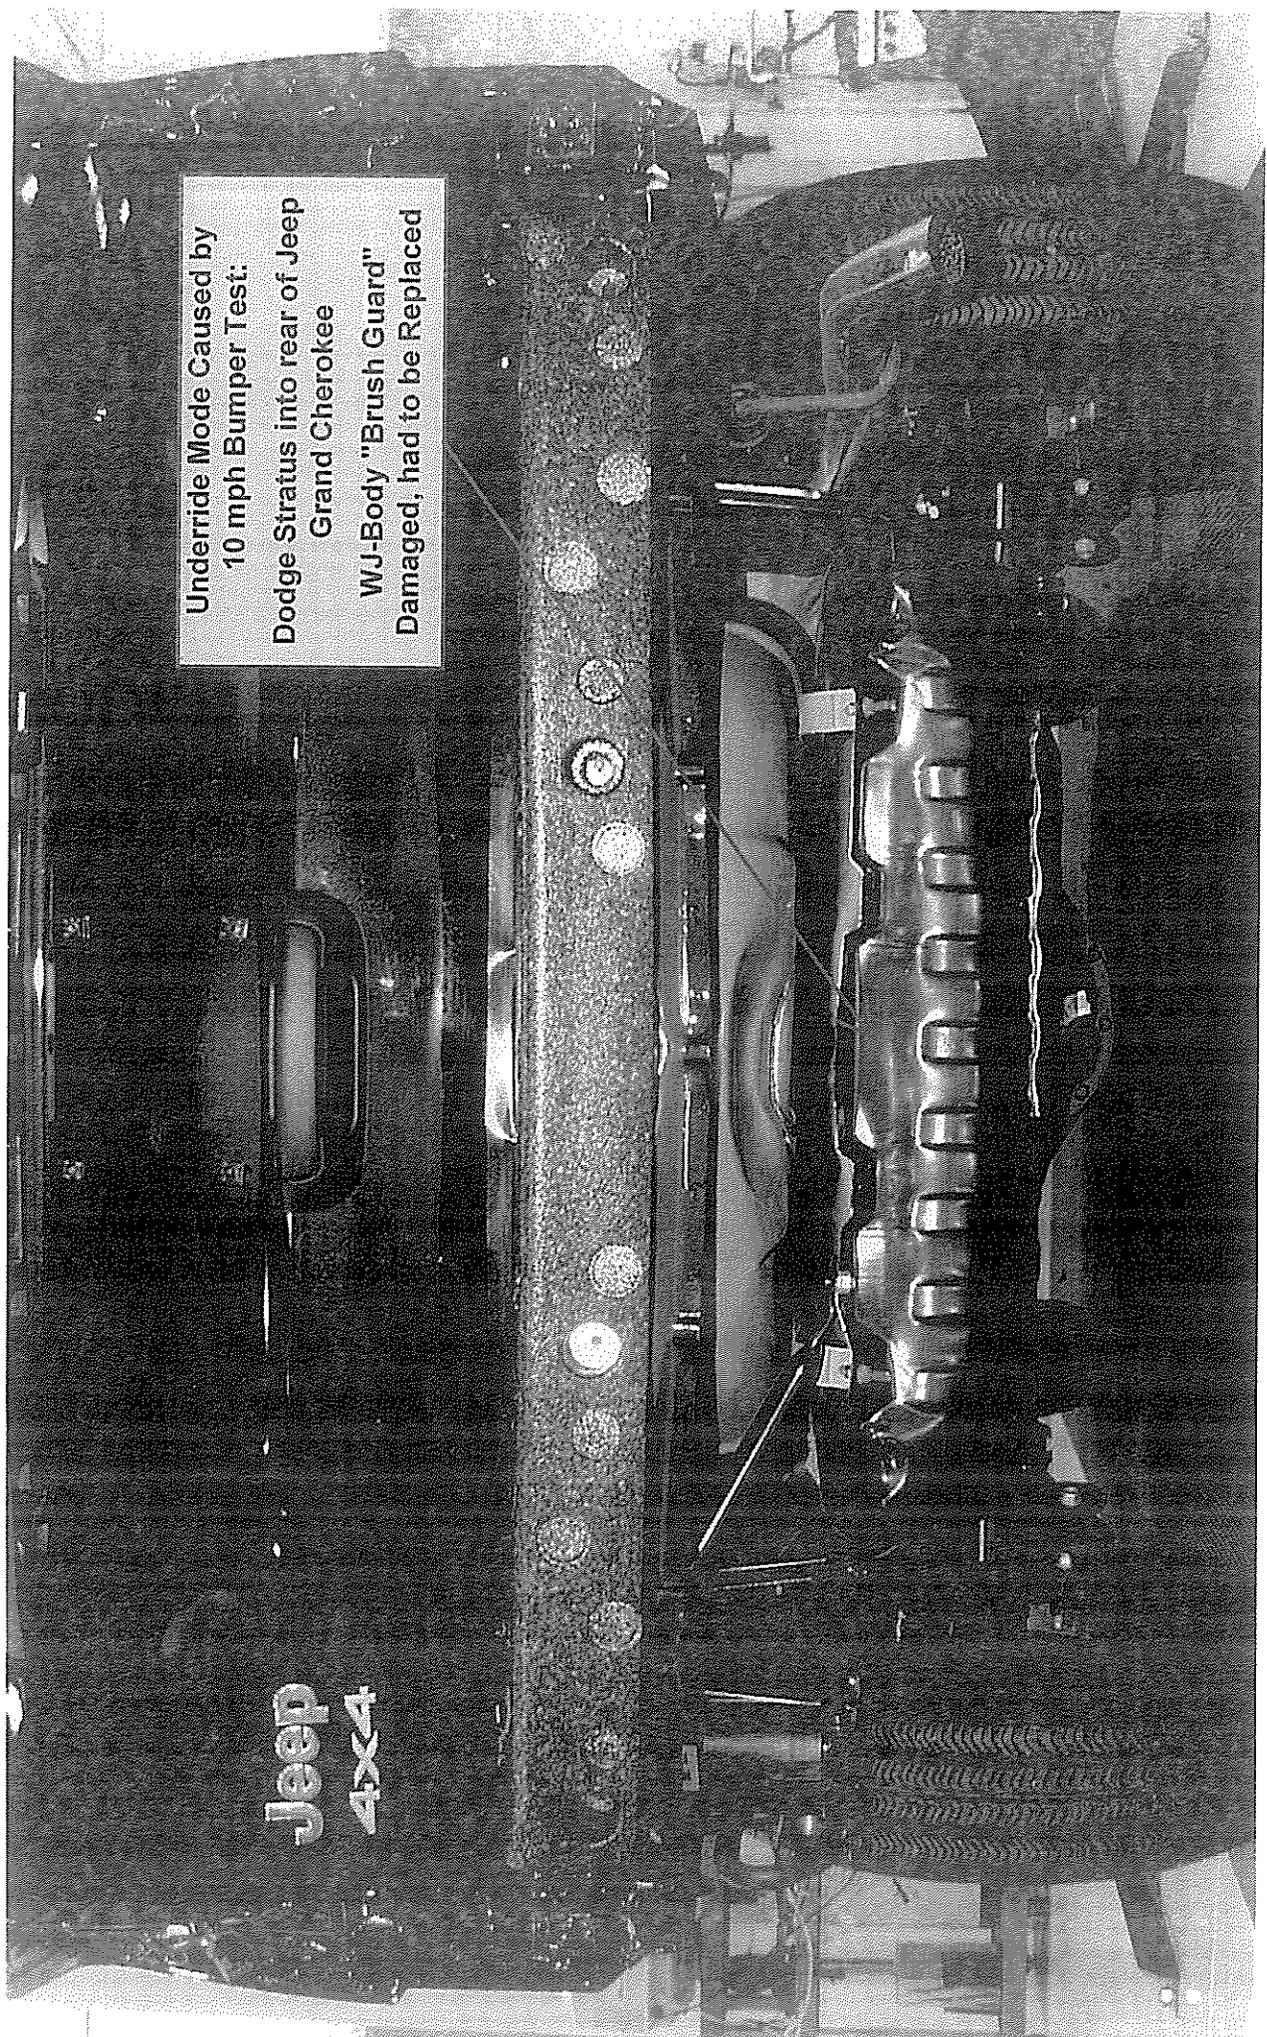
Underride Mode Caused by
10 mph Bumper Test:
Dodge Stratus into rear of Jeep
Grand Cherokee
WJ-Body "Brush Guard"
Damaged, had to be Replaced

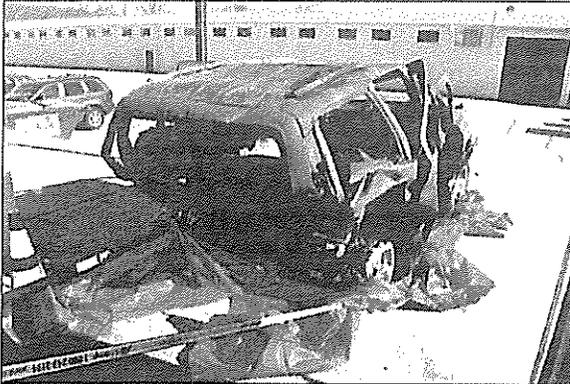
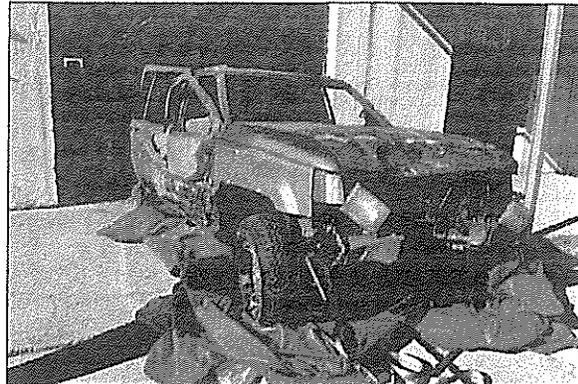
1996 Jeep: The Jeep involved in this crash was a 1996 model year Grand Cherokee Laredo (VIN- 1J4GZ58S9TC ██████████) equipped with a 4.0-liter 6-cylinder gasoline engine and an automatic transmission. Figure 3 shows the Jeep at the time of our inspection. As can be seen in the figure, the Jeep exhibits signs of impact damage to both the front and rear of the vehicle as well as fire damage.

Kineticorp determined that the maximum static crush to the rear of the Jeep was approximately 37 inches. The forces of the collision caused the rear axle of the Jeep to move forward.

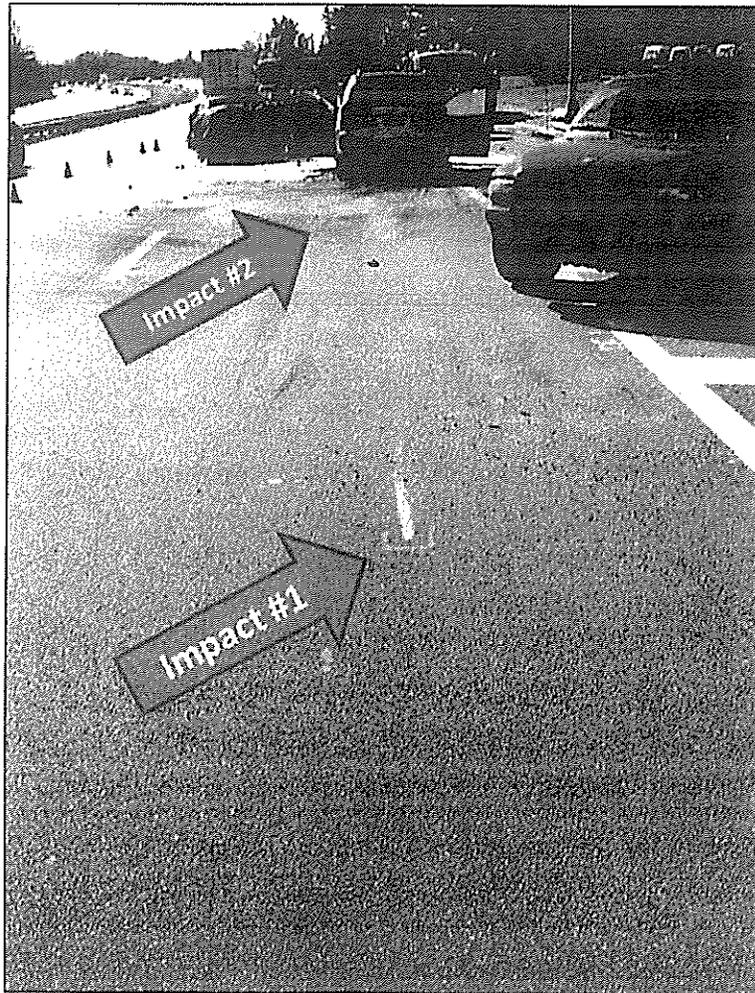
Figure 11 below shows a gouge mark created during impact one when the Toyota first impacted the rear of the Jeep. The gouge mark was likely created when the Jeep's undercarriage made contact with the pavement. Analysis of the vehicle's bumper structures shows that the height of the Toyota's front bumper is in line with the Jeep's rear bumper and that there was good engagement between the bumper structures. As mentioned earlier, the Toyota pushed the Jeep ahead approximately 30 feet into the rear of the Subaru. During this second impact, the Jeep was crushed between the two vehicles and the rear structure of the Jeep, which had already been damaged, was crushed additionally. As seen in Figure 11, the fire pattern on the ground is located in the area of impact two. As depicted in Figure 9, the Toyota penetrated underneath the left side of the Jeep causing it to roll towards its right side. It is during this second impact where there is evidence of a fire pattern on the ground due to the Jeep's fuel system being breached.

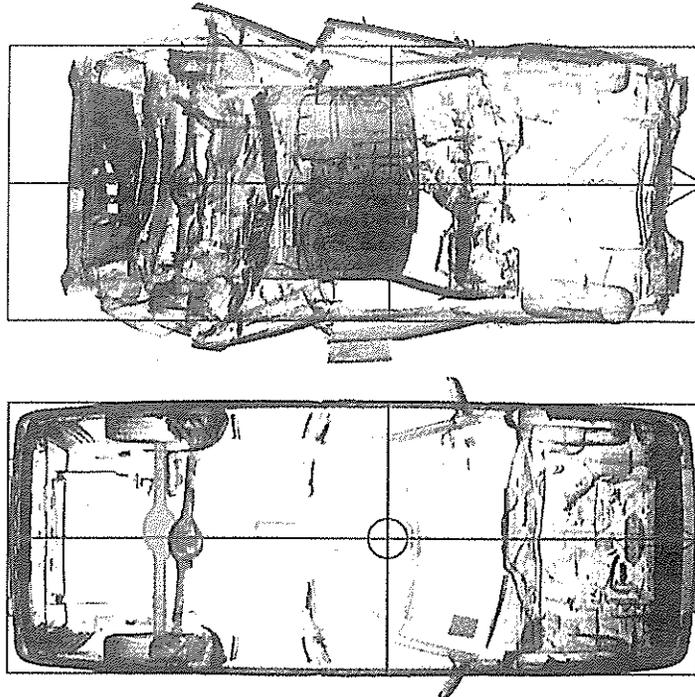
The top image in Figure 12 depicts the damage to the Jeep, as documented with our three-dimensional scan. The rear axle is highlighted in blue in Figure 12. The bottom image of Figure 12 depicts the relative movement of the rear axle compared to its original undamaged position. The axle would have moved further forward dynamically during the crash.

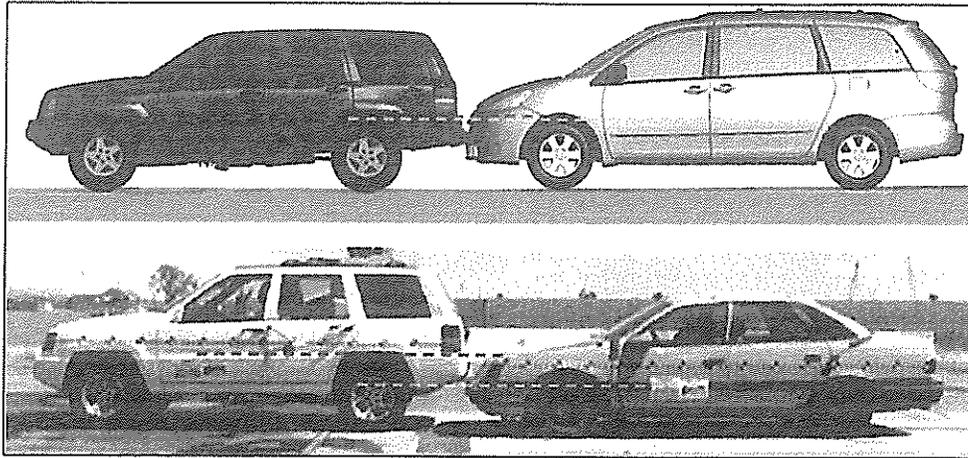
The subject accident was significantly different than the KARCO tests in terms of the lateral and vertical alignment of the vehicles. The top image in Figure 13 depicts the initial impact alignment between the Toyota and the Jeep. The image below shows the alignment between the Taurus and Jeep from test TR-P31070-01-NC. The top of the bumper of each vehicle has been indicated, the Jeep in red and the impacting vehicle in yellow. As depicted, there was good bumper alignment in the subject accident. However, in the KARCO test, the entire bumper of the Taurus was beneath the bumper of the Jeep. The test setup is conducive to vehicle under-ride, the subject accident was not. In both KARCO tests, the tires on the Jeep were significantly larger than the tires on the subject Jeep at the time of the accident. Also, the tires on the test Taurus were significantly smaller than the recommended tire size for that vehicle in test TR-P31070-01-NC. These tire differences make it easier for the Taurus to under-ride the rear of the Jeep in the tests. Further, the test tire pressures were not listed in the test reports and it appears that the tires of the Taurus were underinflated for the test. This would lower front of the Taurus and make it easier for the tires of the Taurus to compress during the impact. Low tire pressure would also make it easier for the Taurus to under-ride the Jeep. The alignment between the test vehicles was drastically different than the alignment during the accident. In terms of under-ride propensity, the vehicle and tire selections in the test are skewed towards a worst case scenario for the Jeep's structural ability to absorb the crash energy. These conditions did not exist in the subject accident.

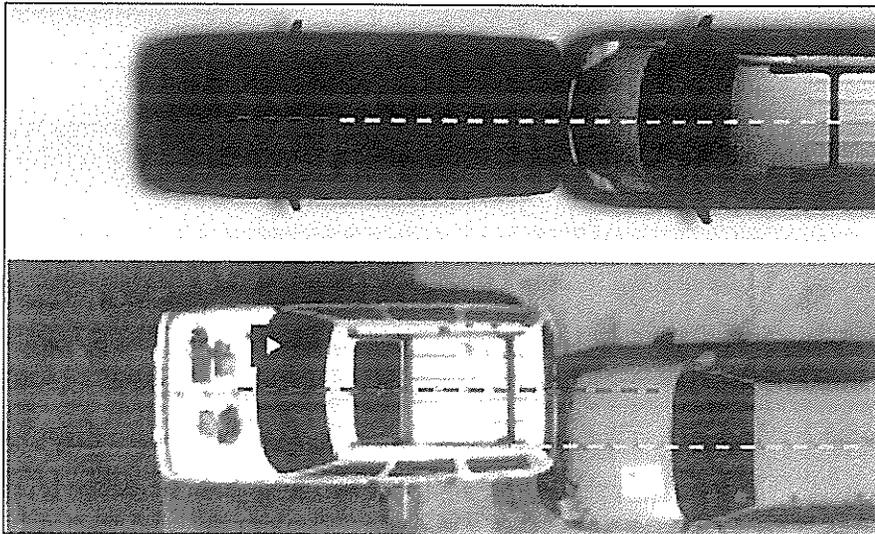
In the subject accident, the Toyota impacted squarely into the entire rear of the Jeep. In the KARCO tests, the collision was offset, such that the entire rear of the Jeep was not directly involved in the collision. This offset in the test is significant because less of the vehicle's width is available to absorb the impact energy. In other words, offset collisions are more severe in terms of energy absorption demands placed on the impacted vehicle. Since the subject accident was a full overlap collision, the offset tests are misrepresentative of the subject accident. The top image in Figure 14 depicts the lateral alignment of the vehicles in the subject accident. The red line indicates the center of the Jeep, the yellow line indicates the center of the Toyota. The KARCO test is depicted below.² In the KARCO test, the Taurus is offset significantly to the left at impact. Due to the lateral and vertical alignment differences, no meaningful comparisons can be made between the subject accident and the KARCO test results. It should also be noted that components in the test Jeeps were removed, such as the spare tire, door panels and the rear side windows. At this time Kineticorp has not made a determination as to the effect of removing these items in the tests.

² Note the distortion from the KARCO video makes the Jeep appear wider than it is.

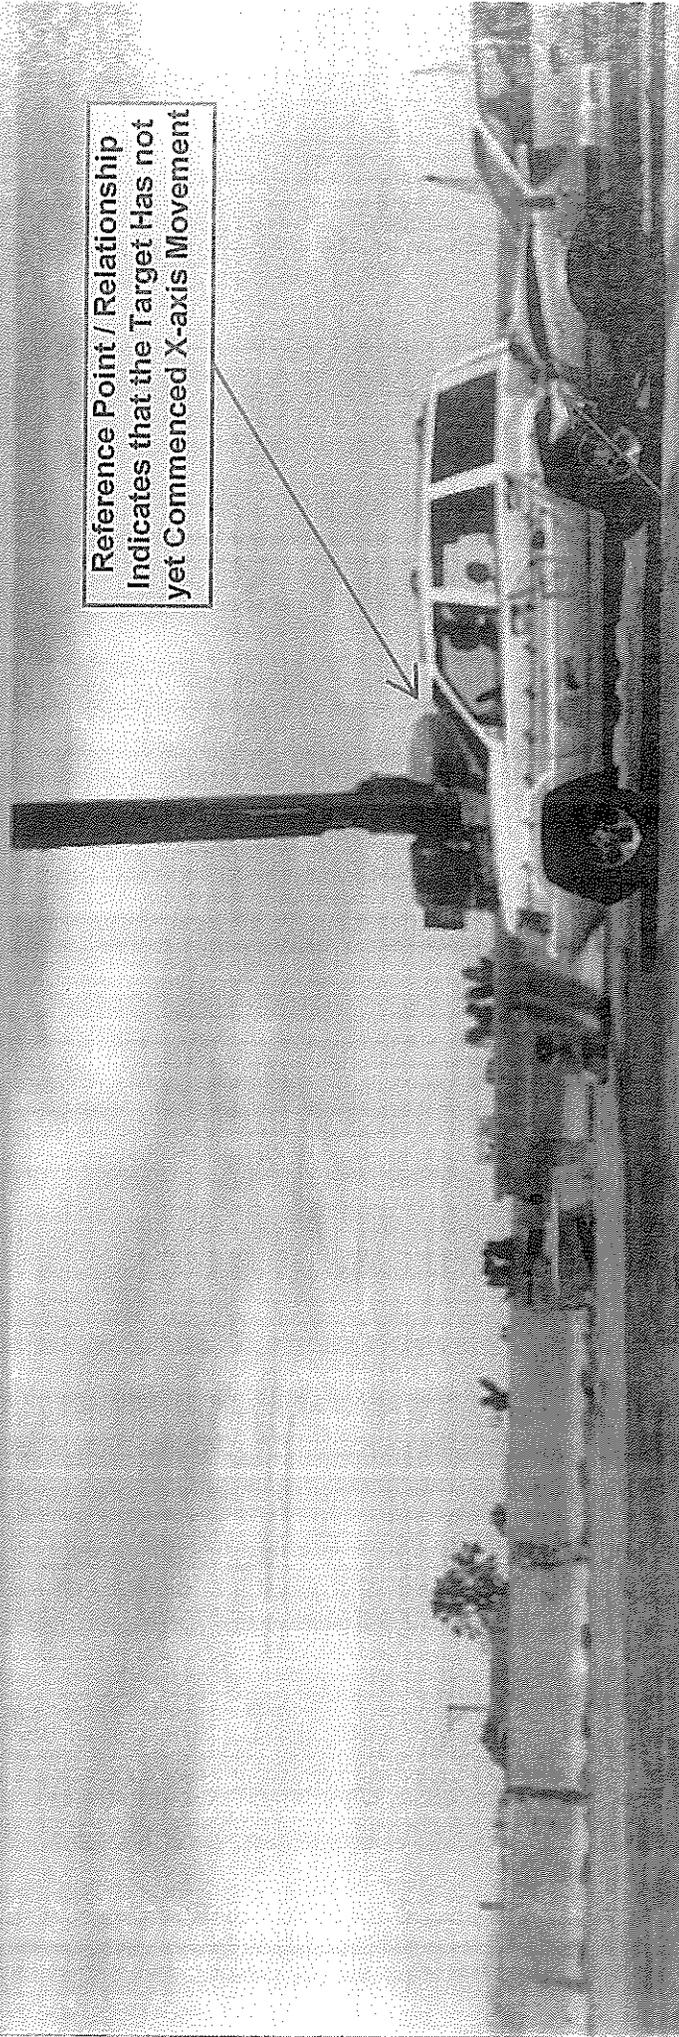
Camera View-01

Bullet in underride mode has completely encroached into the position occupied
by the unprotected, rear-mounted fuel tank of the Jeep Grand Cherokee.
At this time (T = 0.052) leakage of stoddard has commenced.

Stoddard Leakage Due to Fuel
Tank Breach Not Yet Visible

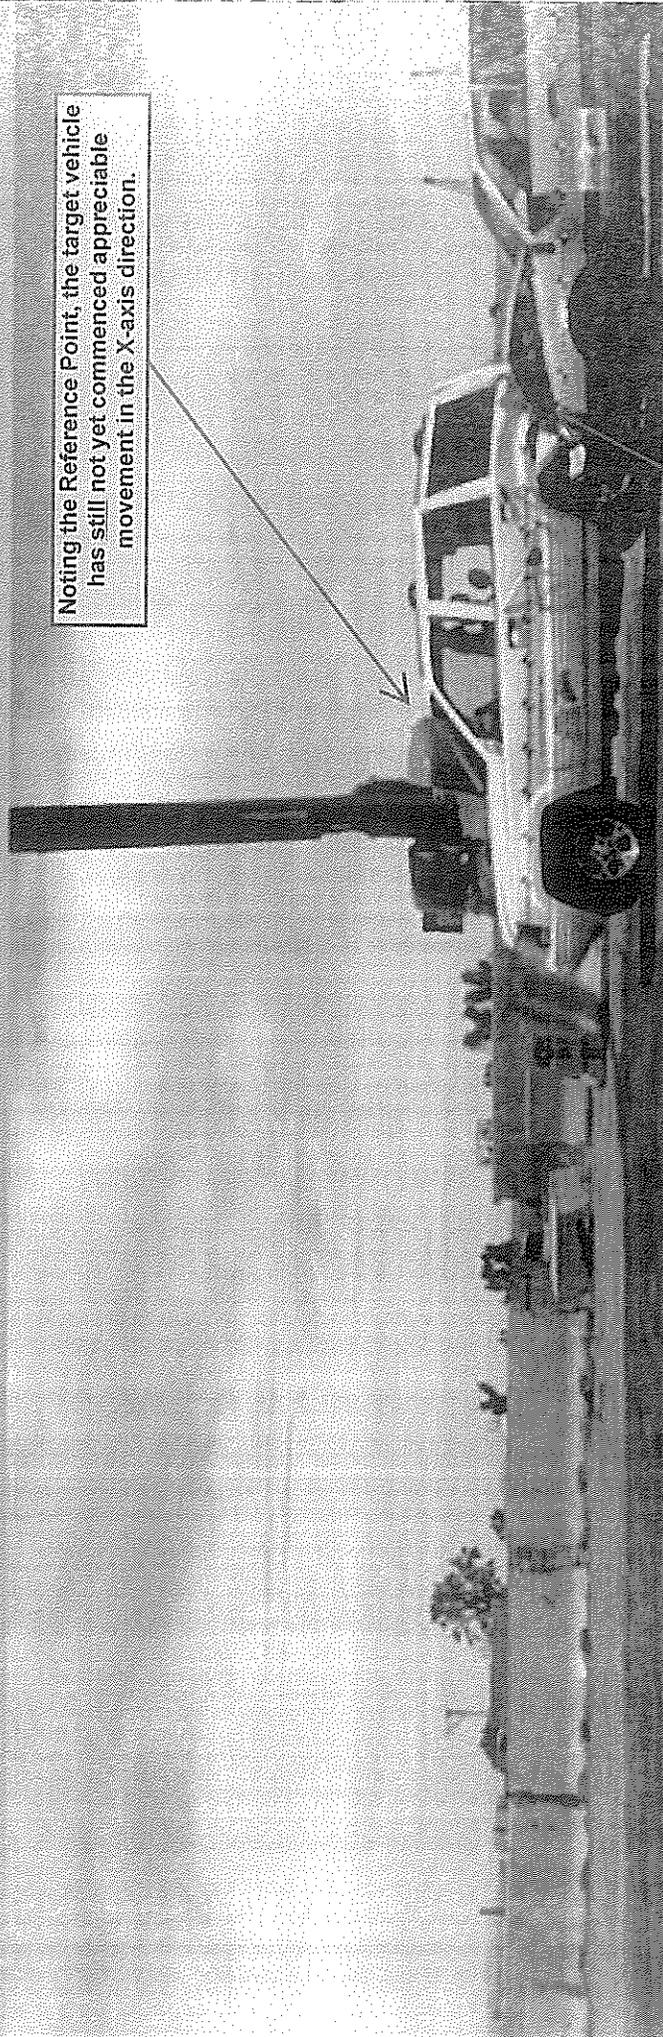
Camera View-01

At T = +0.073 the breaching of the fuel tank by the "underriding" bullet vehicle is ongoing.

At T = +0.073 Bodyside and Door Frame
Deformation has Occurred.
All four ZJ-Body Doors are Jammed,
Occupant Egress is Near Impossible.

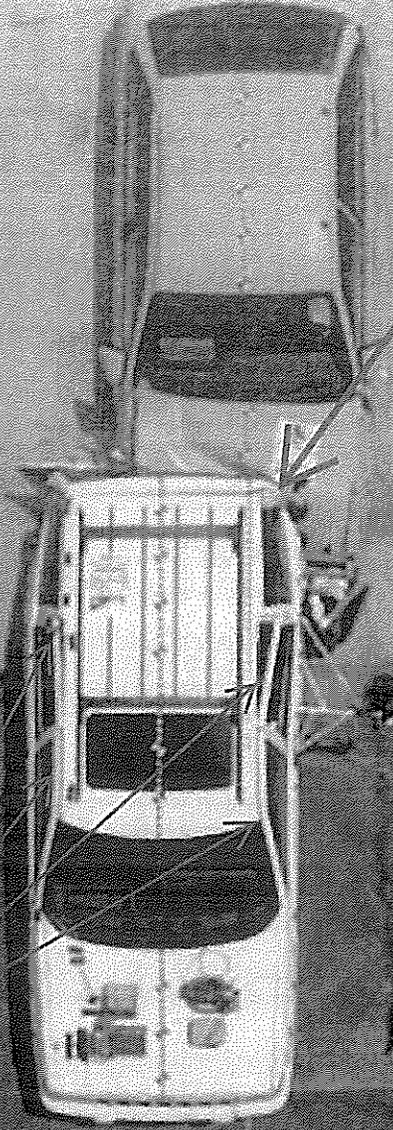
Frame # 73

Ongoing Underride of Bullet Vehicle into Jeep
Grand Cherokee has produced catastrophic
Breaching of the Unprotected Fuel Tank

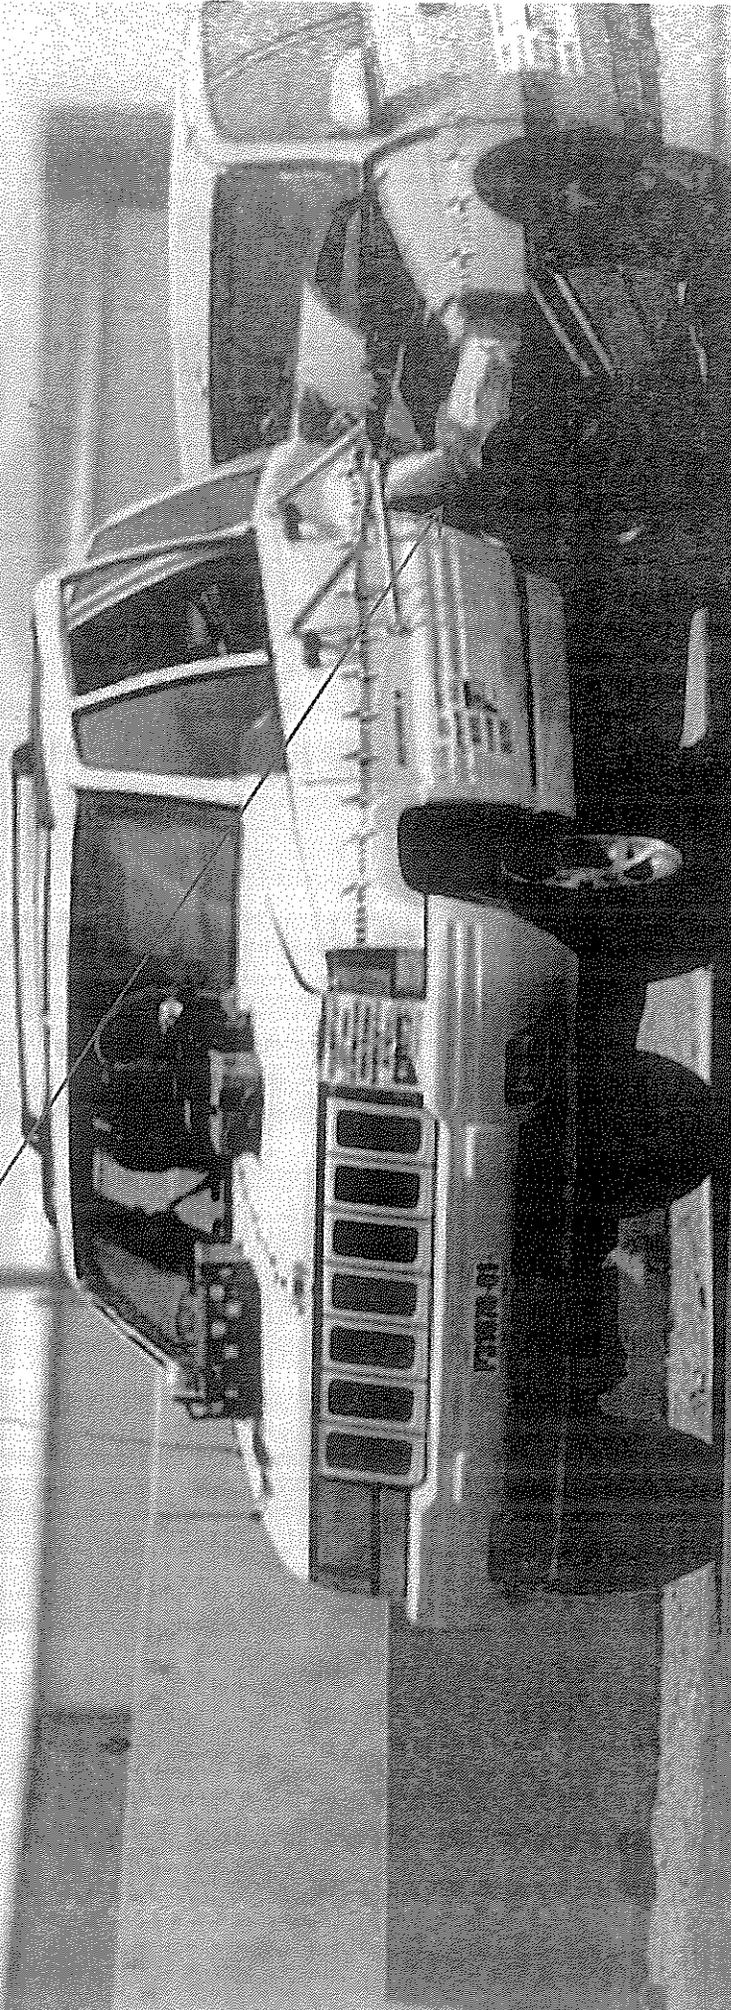
Even in this Low Speed Impact Test, Underride of Bullet Vehicle has produced catastrophic Breaching of the Unprotected Fuel Tank

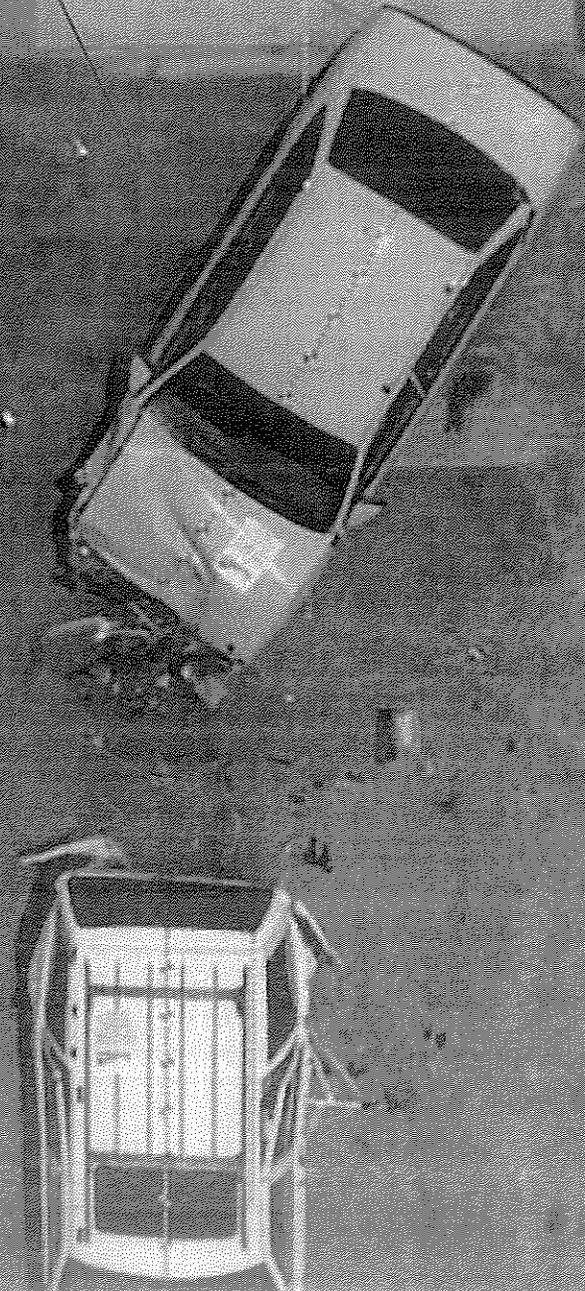
Purple-Dyed Stoddard from TWO Fuel Tank Breaches Now Visible. Wiping in two separate streams from Target Jeep Grand Cherokee.

With Bullet Vehicle Skewed, First Indications of Fuel Tank Breach and Purple-Dyed Stoddard Stain Evidence Appears/Visible on Impact Pad

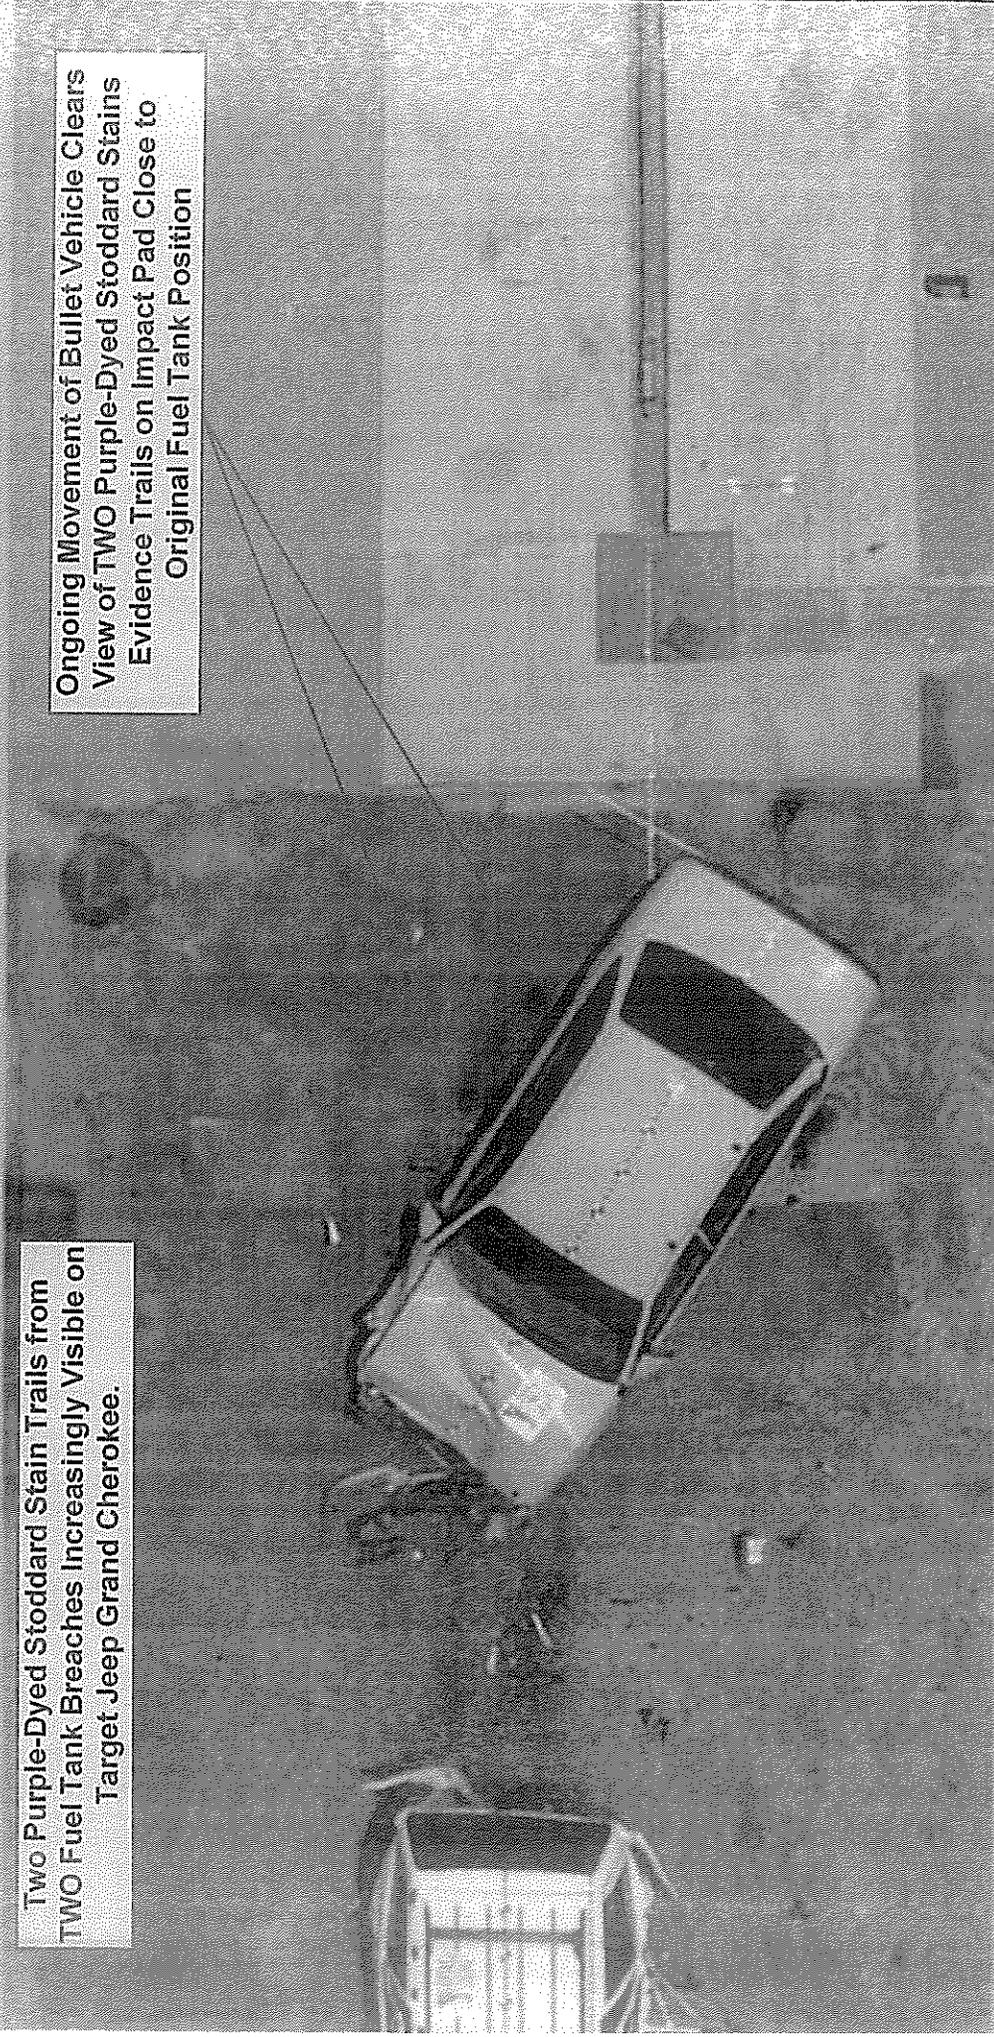
- At T = +1.000 (one second after impact) not one, but TWO fuel tank breaches are evidenced by the purple-dye staining of the impact pad and asphalt run-off areas.

Ongoing Movement of Bullet Vehicle Clears
View of TWO Purple-Dyed Stoddard Stains
Evidence Trails on Impact Pad Close to
Original Fuel Tank Position

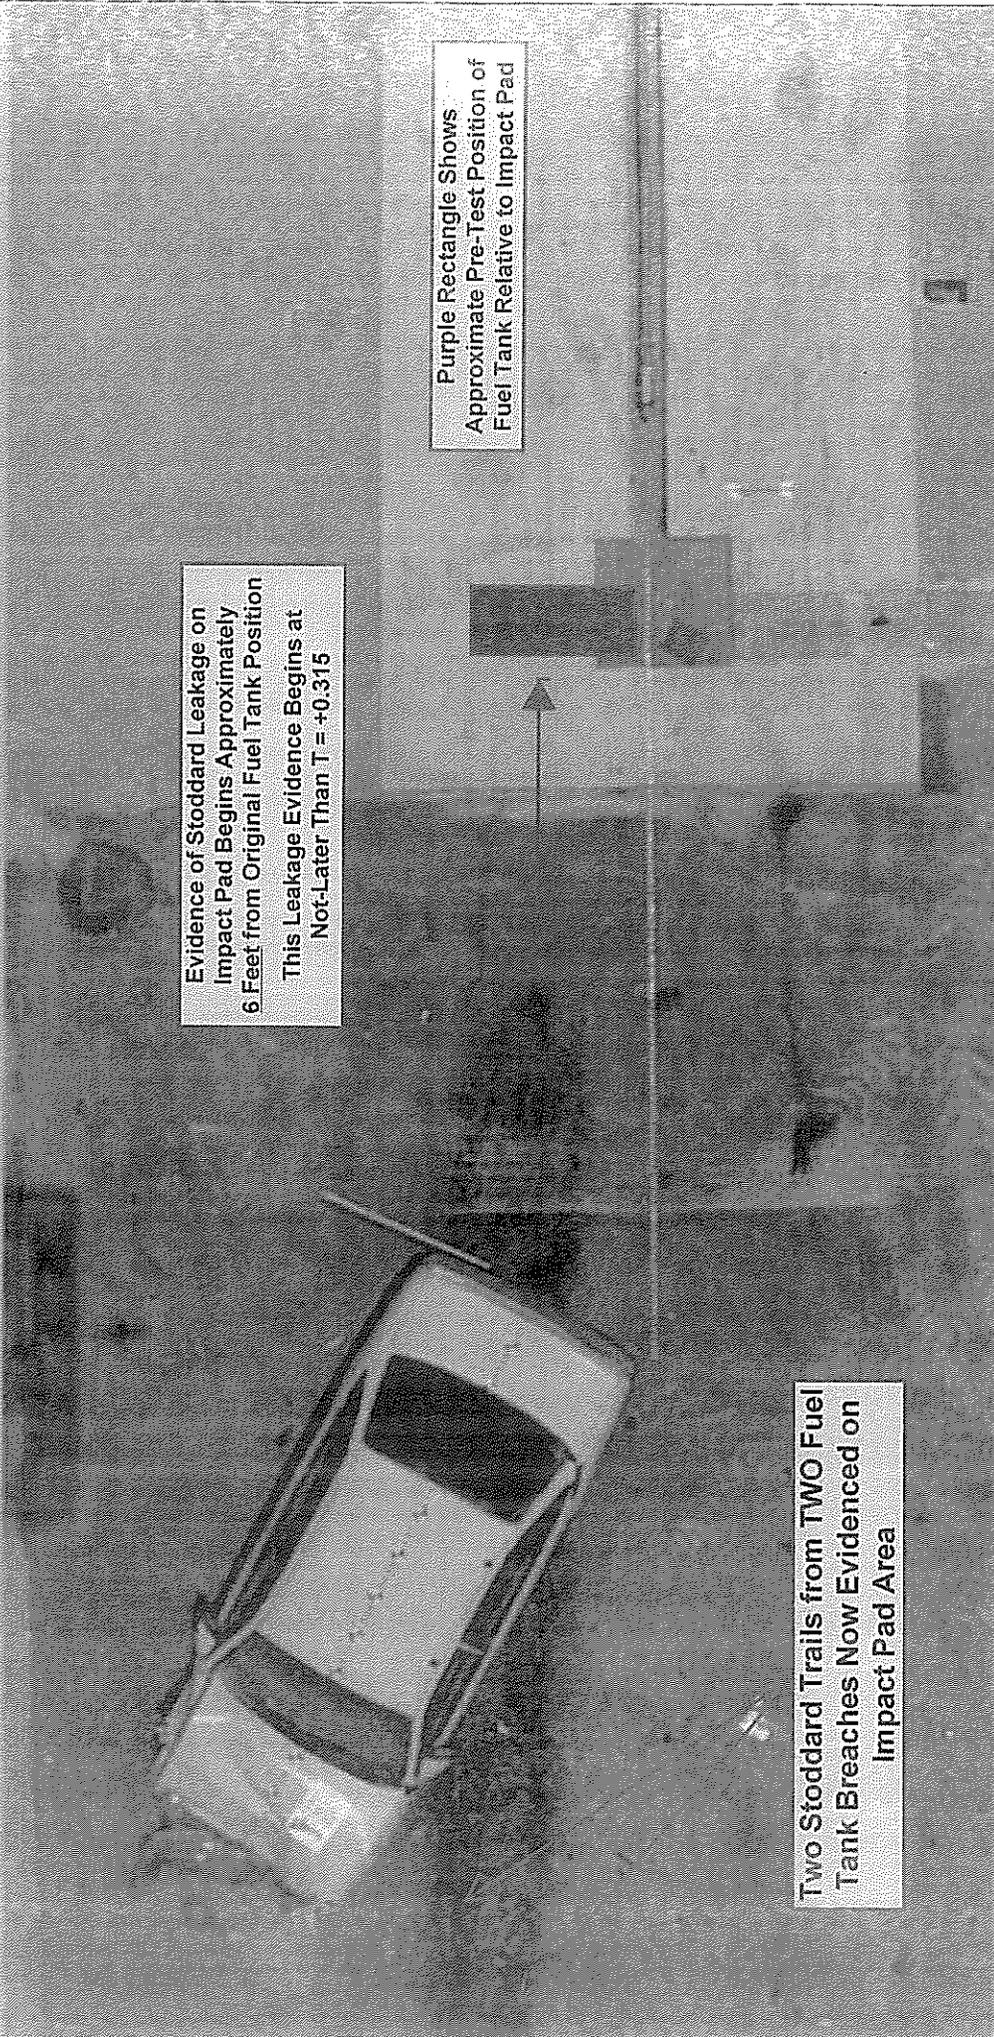
T = +1.598 represents the end of Camera 2 video recorded data. Note that the stoddard staining of the impact pad is near-instantaneous, occurring at a mere 6 feet from the pre-impact location of target vehicle fuel tank.

Evidence of Stoddard Leakage on Impact Pad Begins Approximately 6 Feet from Original Fuel Tank Position
This Leakage Evidence Begins at Not-Later Than T = +0.315

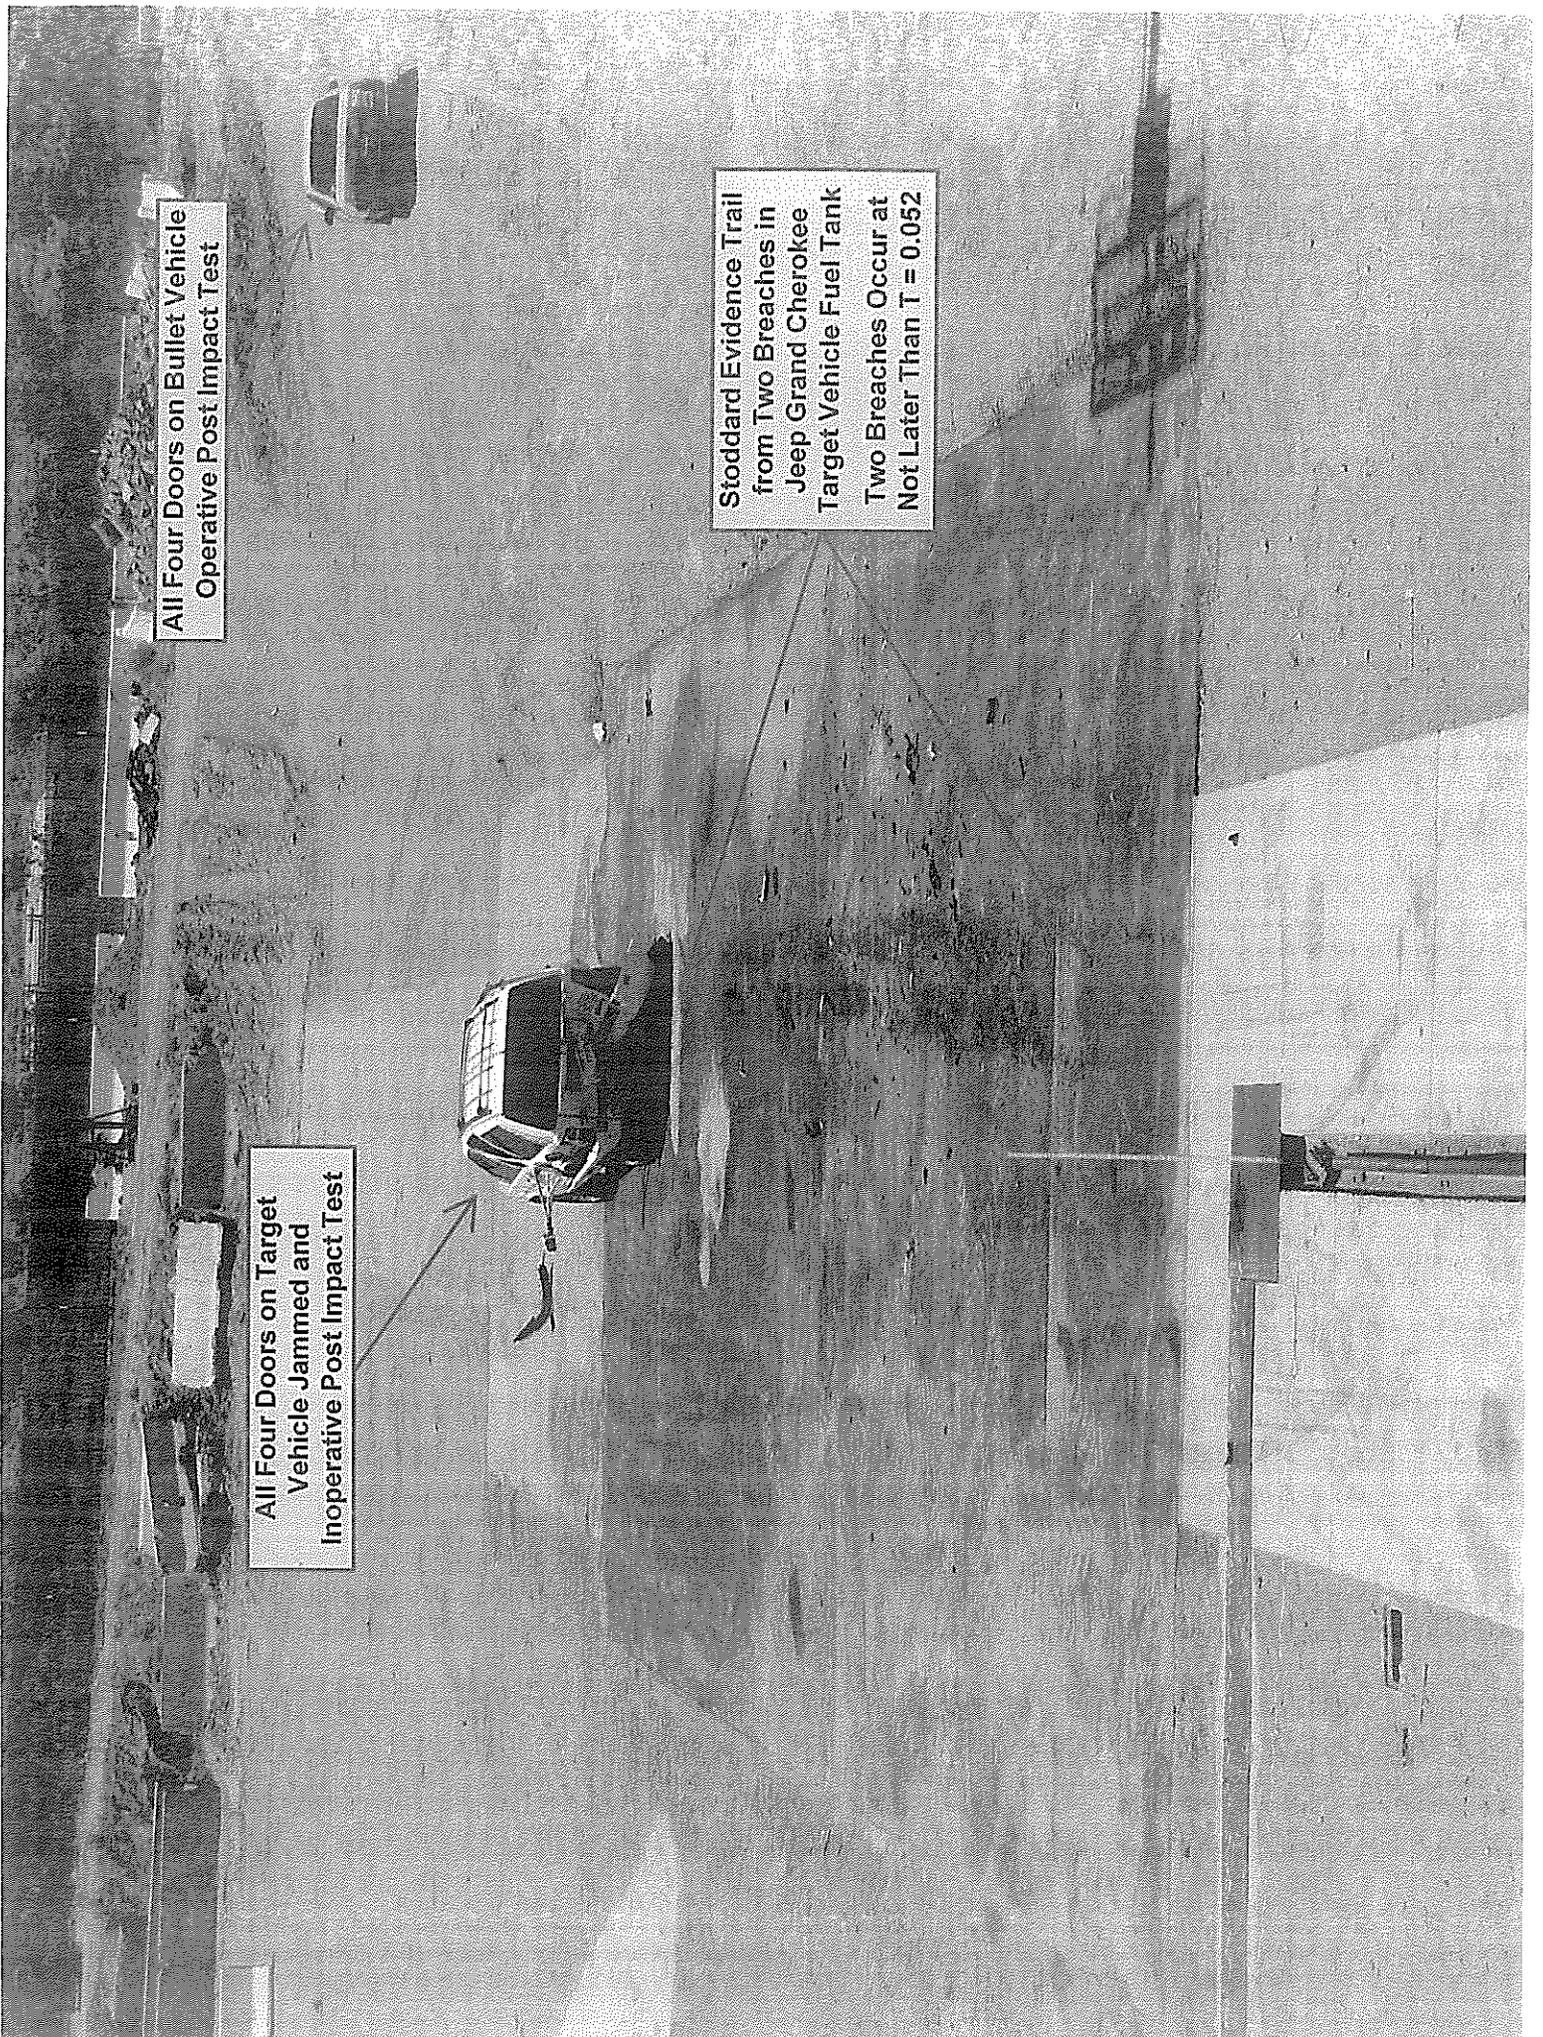
Stoddard Evidence Trail
from Two Breaches in
Jeep Grand Cherokee
Target Vehicle Fuel Tank
Two Breaches Occur at
Not Later Than $T = 0.052$
