Our Ref: TA/USREP/573

Date: 28 September 2012

Subject: Part 573 Recall Notice – Lotus Cars Limited

VVT OIL PIPE ASSEMBLY

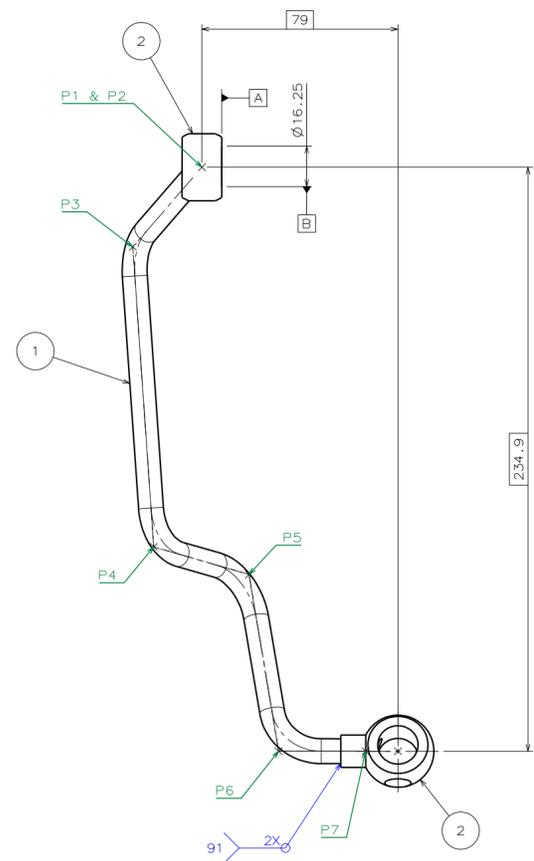
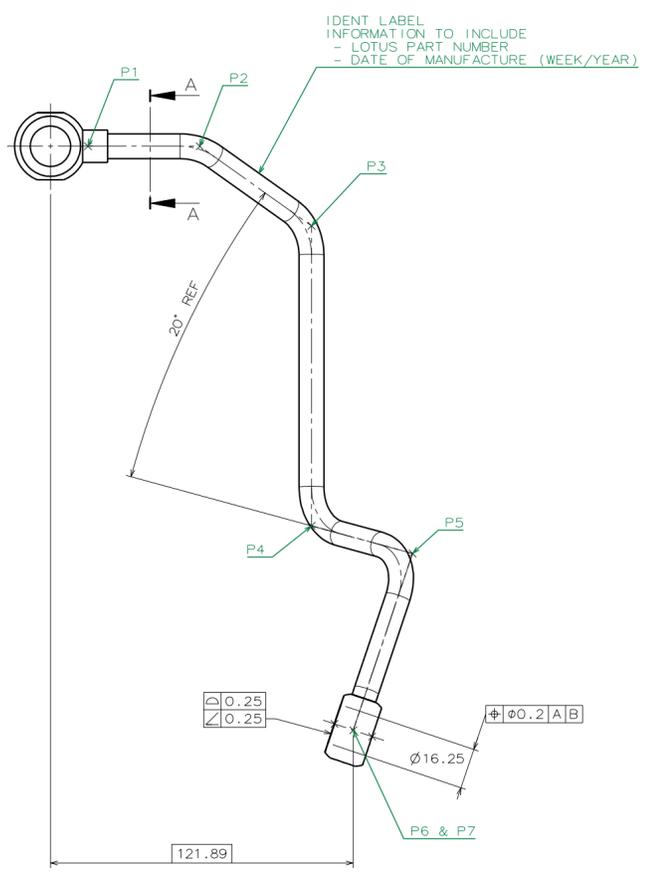
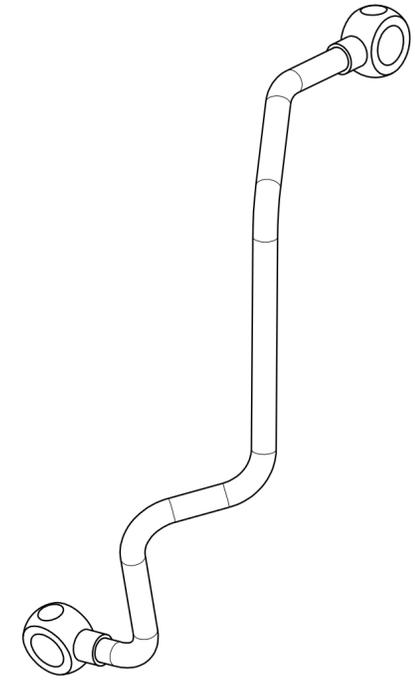
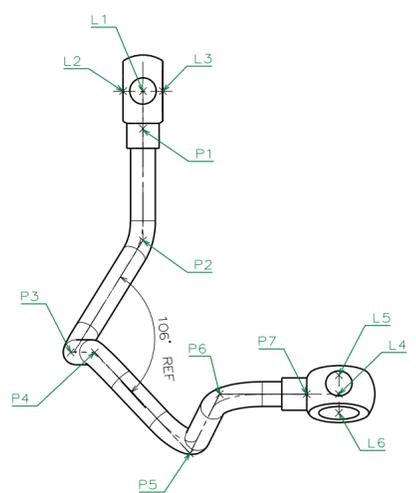
There have been a number of incidents where an engine mounted oil feed pipe has ruptured resulting in oil loss. The pipe is used to supply oil to the variable valve mechanism located in the engine cylinder head. In some cases this has caused engine damage and there have also been two reported cases of fire which may be related to this issue. Initial investigation has indicated that a flexible section of hose that forms part of the oil pipe assembly may be defective.

It is proposed that the variable valve timing oil feed pipe installed on affected vehicles is replaced with the latest level of part, which utilises a rigid pipe in place of the 3-piece assembly (see Annex C).
