Model: Evora S & S-IPS
Prior to '12MY VIN CH_10156

Number: 2012/03R
USA

Retrofitment of revised RH cylinder bank Variable Valve Timing (VVT) pipe.

Lotus Recall 2012/03R (NHTSA recall # 12V-477)

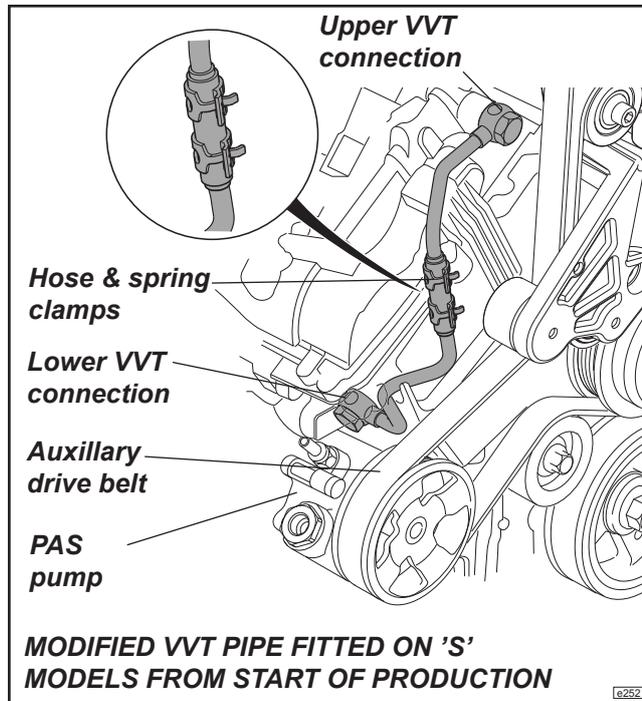
The pipe modification consisted of a small section of rubber hose joining the modified VVT upper and lower pipe union connections together using two 16mm hose or spring clamps.

Originally positioned forward of the cylinder head, the modified 3 piece pipe for the supercharged engine is now routed over the top of the RH camshaft cover, travelling downwards in front of the timing chain cover before terminating at its cylinder head connection located behind the Power Assisted Steering (PAS) pump.

It has been determined that under extreme circumstances the rubber hose section of the VVT pipe can leak.

The 3 piece VVT pipe fitted to vehicles prior to '12MY VIN BH_10156 should be replaced with the current production single piece metal VVT pipe and retaining clip.
