13E-005  
(16 pages)

Re: Notification of Defect Affecting Motor Vehicle Safety

FRAM Group Operations, LLC ("FRAM") has determined that a limited number of replacement oil filters it manufactured and sold to Subaru of Indiana Automotive, Inc. ("SIA") for distribution to the Subaru of America ("SOA") dealer network have a manufacturing defect related to motor vehicle safety. SOA and SIA may be referred to collectively and generally as "Subaru". No motor vehicle accidents or personal injuries have been reported. The following information is submitted pursuant to the motor vehicle equipment defect and non-compliance reporting regulations of the National Highway Traffic Safety Act (49 CFR Part 573). Based upon reported data from the field, the defect resulted in a leaking filter that, shortly after installation, could have resulted in a loss of motor oil. That loss of motor oil could, in certain circumstances, result in a fire and engine shut down. As further set forth below, five incidents impacting motor vehicle safety have been reported to FRAM.

This notice relates to FRAM's model 15208AA12A filter (the "filter") which is sold exclusively to SIA for OES applications. The filters s

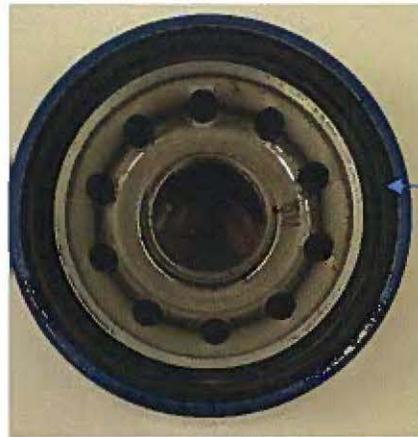
P-Ring Gasket

The tap plate has a female threaded portion that is concentric to the outer diameter of and perpendicular to the plate. The tap plate also has a channel that holds a "P" ring gasket that is inserted during manufacture.

FRAM's investigation of field incidents and returns shows that non-conforming filters have failed because engine oil pressure extrudes the gasket out of the channel,<sup>1</sup> ultimately breaching the seal and causing a rapid loss of nearly all engine oil.<sup>2</sup>

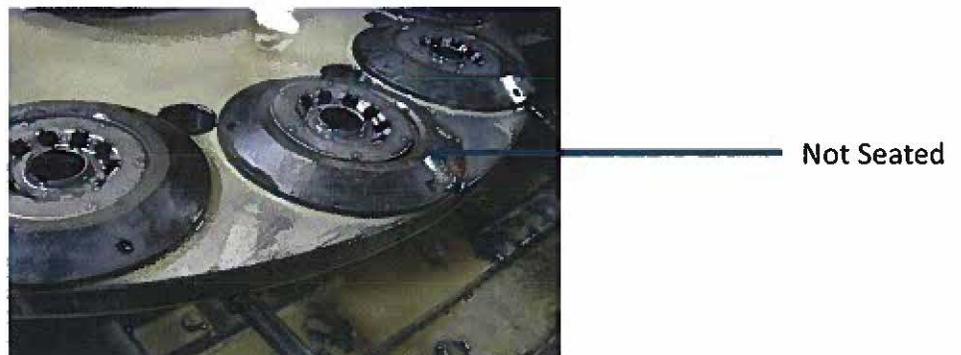
2012. Between July 5 and October 12, 2012, the threads on a limited number of tap plates were not properly threaded and the assembled filter did not meet the related perpendicularity specification. During this time frame, there were twenty-three multi-shift production runs of this filter, and FRAM's investigation shows that the non-conformity in the tap plates primarily occurred on three multi-shift production runs beginning on July 30, 2012, September 18, 2012 and September 27, 2012. The tap plates are threaded with a high speed, automated tapping machine that makes approximately 3,000 tap plates per hour. The metal blanks that form the tap plates were on a few occasions not aligning properly in the tooling seat that holds the blank in place during the tapping operation (see photograph below):

As of October 25, 2012, FRAM implemented corrective measures to its tapping equipment, which included making changes in the manufacturing process, as well as installing additional sensors on the tapping equipment that now ensure that each blank is properly seated before it is tapped.

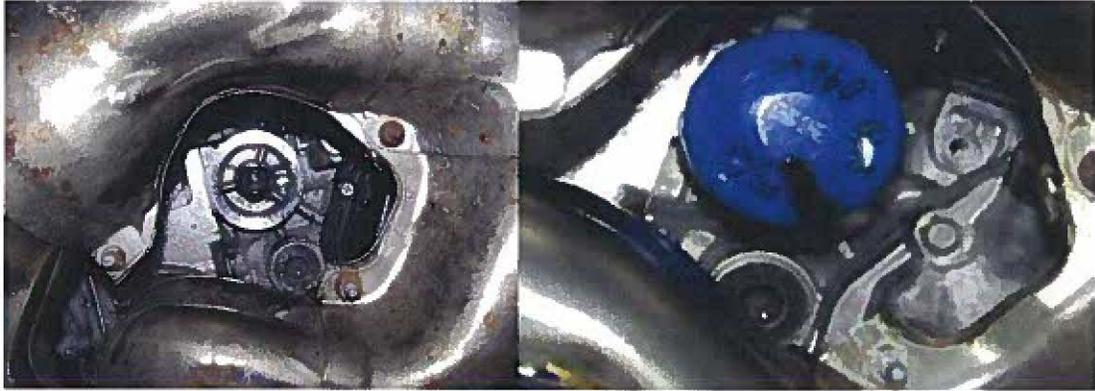
FRAM believes that the reported observations of smoke or flame occurred because, as shown below, the exhaust and catalytic converters of the Subaru engine are located in close proximity to the oil filter.

Oil likely came in contact with the exhaust or catalytic converter and caused smoke or flames. In the event of a failure, the oil will rapidly be depleted and may drip onto exhaust components. When the oil fouls those components, smoke and potential flames may occur. FRAM does not believe that there is sufficient oil available to support a thermal event that could endanger vehicle occupants or surrounding structures. The five incidents are more fully described below:
