Safety Defect and Noncompliance Report Guide for Vehicles
PART 573 Defect and Noncompliance Report³

On , January 31st , 2013 Fontaine Modification determined that a defect which relates to motor vehicle safety exists in the motor vehicles listed below, and is furnishing notification to the National Highway Traffic Safety Administration in accordance with 49 CFR Part 573 Defect and Noncompliance Reports.

International Cross Shaft C-clip Replacement Process

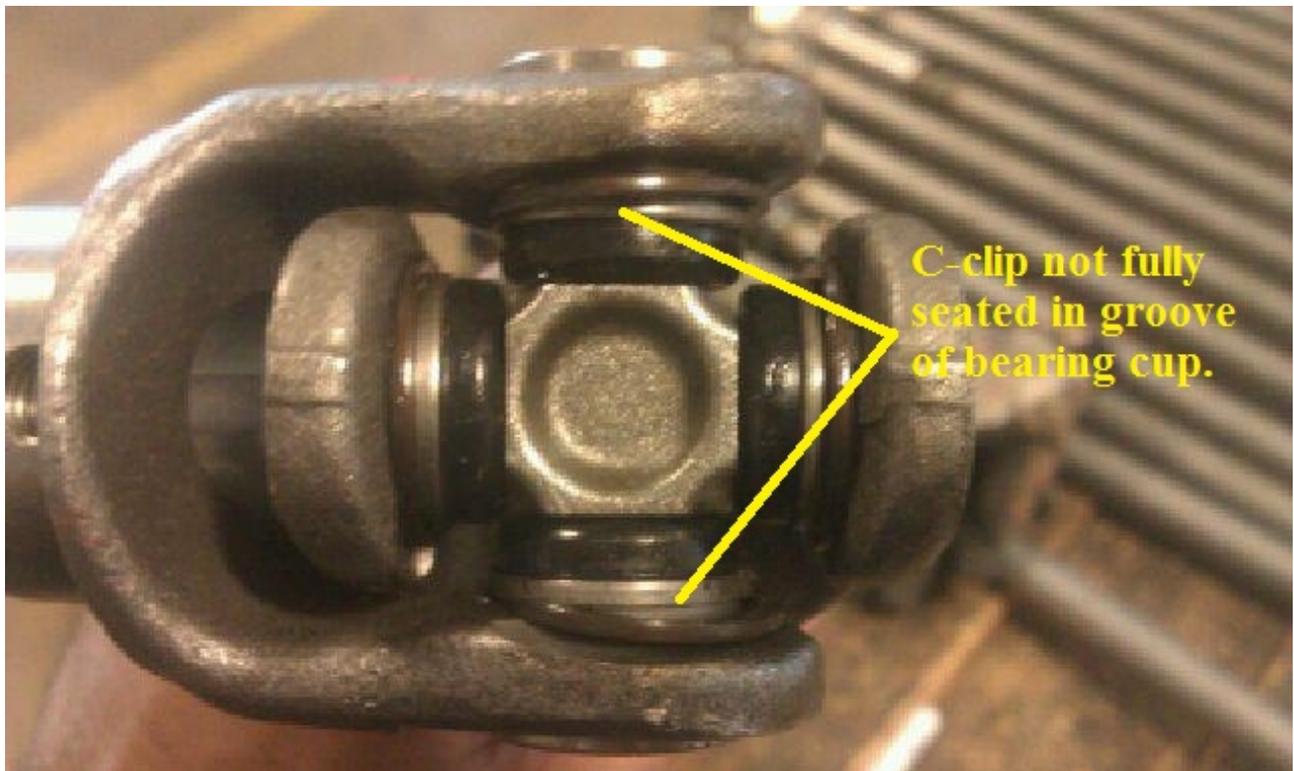
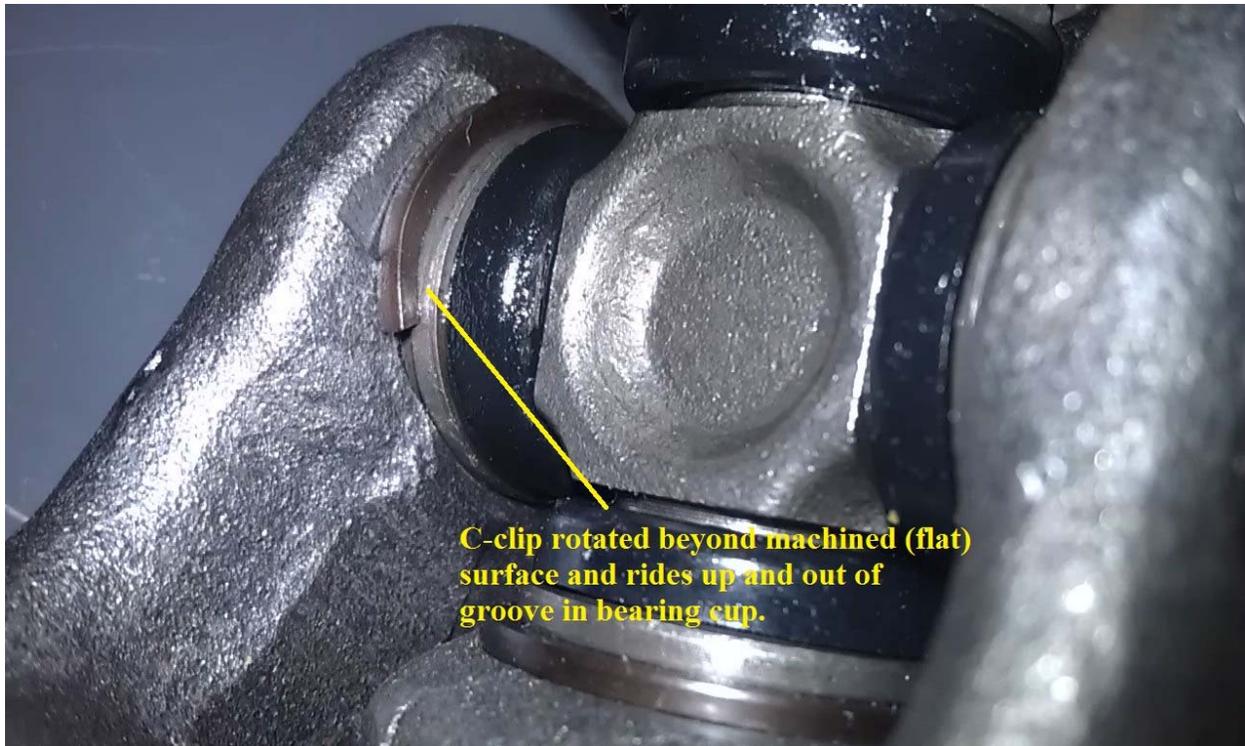
The steering cross shaft assembly installed by Fontaine Modification is the part in question. Fontaine installs 1 cross shaft assembly per truck. It is connected from the Fontaine installed 3-way steering box that is part of the LH steering column over to the Fontaine installed 2-way steering box that is part of the RH steering column. C-clips that retain the bearing cups for the u-joint assemblies that are part of the steering cross shaft assembly were found to not be completely engaged in the groove of the bearing cup(s) which could result in the c-clips coming loose allowing an unsafe condition with the steering cross shaft assembly.

The primary root cause was determined to be improper installation of the c-clips that retain the bearing cups in the cross shaft assembly by Fontaine's supplier, Valco Industries Inc. A secondary root cause appears to be poor machining practices by Valco's casting supplier.

Describe the consequence(s) of the defect or noncompliance condition. *When the c-clip(s) disengage from the bearing cup of the u-joint, the bearing cup can work it's way out of the yoke causing excessively lost motion in the steering cross shaft. The steering from either side may feel un-responsive, or feel "loose" as excess movement occurs in the cross shaft assembly.*

Possible warning signs that a c-clip or c-clips have disengaged and a bearing cup or cups is loosening up in the yoke of the steering cross shaft is excess play in the steering system when the truck is driven from either side.

V. Identify the Remedy: *The remedy for any non-compliant steering cross shaft assemblies found during inspection of trucks in the field is to change out the complete assembly with a known compliant assembly supplied by Valco Industries Inc. per enclosed work instructions.*
