13E-011  
(5 pages)

Re: Defect Information Report  
Pursuant to 49 CFR 573.6(c)  
Dear Associate Administrator:

1. *Manufacturer's name (573.6 (c)(1)):*  
Robert Bosch LLC
2. *Identification of motor vehicle equipment (573.6 (c)(2)):*  
Hydro-Max® master cylinders with 2.0 inch bore and 84 cubic inch reservoir containing fluid level indicator switch and without differential pressure switch manufactured between July 1, 2011 and April 12, 2012 sold to one vehicle manufacturer and also supplied as service parts ( hereinafter referred to as "subject Hydro-Max® master cylinders"). The list of customers and number of the subject Hydro-Max® master cylinders purchased by each customer is listed below in section 3.

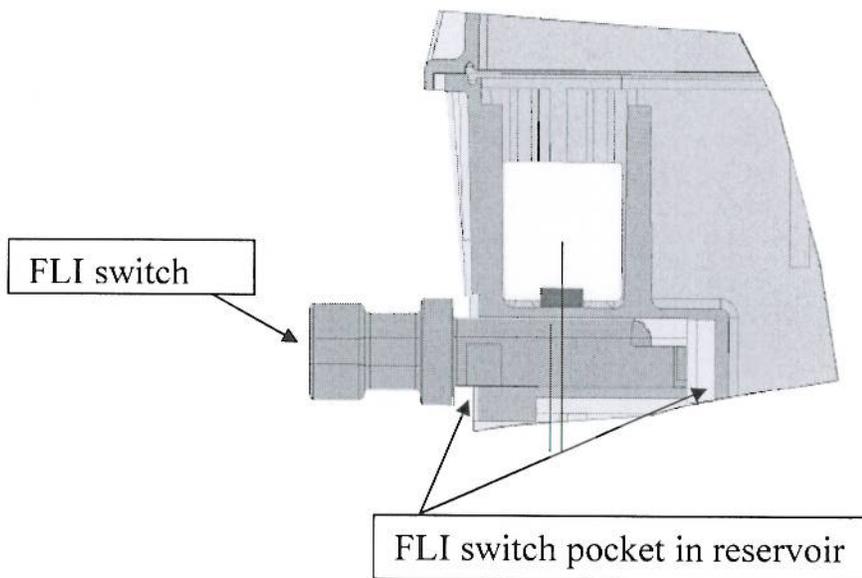
Parts manufactured by Bosch since July 1, 2011 incorporate a reservoir switch pocket with additional clearance to more efficiently install and latch the FLI switch. The added clearance created a condition in which the FLI switch has the potential to move outward, but remain within the reservoir switch pocket. If the FLI switch were to move outward on parts manufactured between July 1, 2011 to April 12, 2012 and the float magnet is on the lower allowed level, the FLI may not be close enough to the float magnet to activate in the event of low brake fluid. If the low brake fluid level is caused by an external leak resulting in the escape of fluid from the brake system, it can result in increased pedal travel. If this condition goes unheeded it can result in a reduction of hydraulic pressure to the disk brake calipers or wheel cylinders and lessen the braking force available. A reduction in braking

force can cause an increase in stopping distance and a vehicle crash may occur. An illustration of the subject Hydro-Max® master cylinder is below:

Cutaway view of reservoir with switch pulled outward

As a remedy in the field, Bosch is working with its customers to develop a notification process for their customers. An inspection procedure for the subject master cylinders will be provided. If no certification mark is present and the reservoir date code is equal to 1151 or later (higher) the gray colored FLI switch (Bosch P/N 0 204 232 939) would be removed and replaced without charge with a redesigned brown colored FLI switch, (Bosch P/N 0 204 232 107). At this time, the redesigned switch is not available for distribution. Bosch is not aware of any customer complaints or warranty related to the subject issue. However, if a customer has replaced a master cylinder with one involving the subject issue, Bosch will reimburse the customer for the new switch and cost of repair.
