March 5, 2013

Re: **Kenworth T270, T370 Seat Belt Anchor Reinforcement**
Kenworth Recall Campaign No. 13KWE

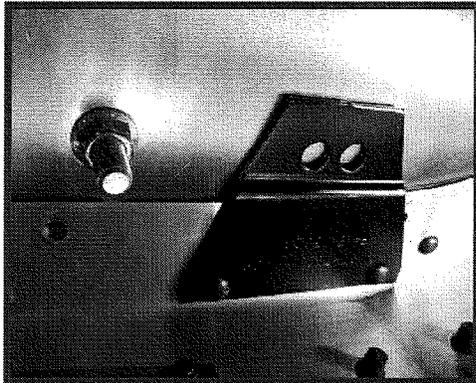
The left hand seat belt floor pan reinforcement bracket was not positioned correctly during the assembly of some T270 and/or T370 vehicles. This reinforcement is

employed to secure the seat belt anchor to the floor of the cab. In the affected vehicles, the reinforcement was riveted to the underside of the cab structure at a location that did not align with the seat belt anchor mounting hole. When the seat belt anchor bolt was installed later in the assembly process, the bolt was installed through the floor pan but did not pass through the reinforcement due to the misalignment. Incorrect placement of the reinforcement bracket may contribute to a failure of the seat belt anchor mounting, which could result in personal injury or death in the event of a crash.

Defective Position of Bracket

A subsequent investigation revealed that this error occurred in connection with a staffing change during which a right hand operator was reassigned to perform left hand tasks for one day. The operator was accustomed to positioning the bracket on the left hand end of a 3-hole sequence, and he continued to install the bracket in the same position while working on the opposite side. The population of potentially affected vehicles includes vehicles from that day as well as vehicles from half a day prior and after to ensure all potential vehicles were captured.

The proposed remedy involves removing, repositioning, and reinstalling the reinforcement bracket in the proper location.

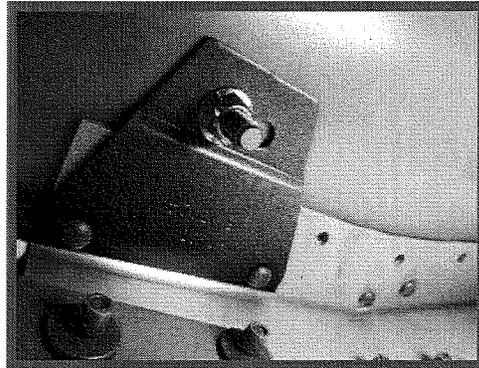
Correct Position of Bracket
