May 13, 2013
Ref. No.: GR13-032

RE: Part 573 Defect Information Report – Steering Column Disengagement on 2013MY Subaru Legacy and Outback Vehicles

Defect Information Report (49 CFR Part 573.6)

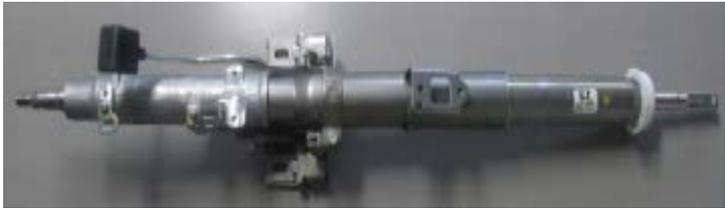
Steering Column Assembly

The steering column assembly contains a splined inner and outer shaft. The splined shafts are intended to be a tight press fit. Subaru found that the press fit was insufficient to maintain contact between the inner and outer shafts. This insufficient contact could allow the shafts to become disengaged from one another. In this case, the driver would lose the ability to steer the vehicle and a crash could occur.

- (i) The remedy plan calls for dealers to replace the steering column assembly with a new one.
- (ii) Subaru of America, Inc. expects to notify U.S. dealers on or around May 13, 2013. It is expected that owner notification will begin within 30 days. Subaru will update NHTSA if the situation changes significantly.
