IMPORTANT SAFETY RECALL

**RE: Safety Recall 2013-E01
KME Fire Apparatus Vehicles having a Grease Fitting in the Steering
Column Shaft that may get caught in the Rubber Steering Column
Cover Manufactured between September 2008 and April 2013**

PRODUCT/SERVICE INSPECTION BULLETIN

STEERING COLUMN COVER – STEERING SHAFT GREASE FITTING INTERFERENCE

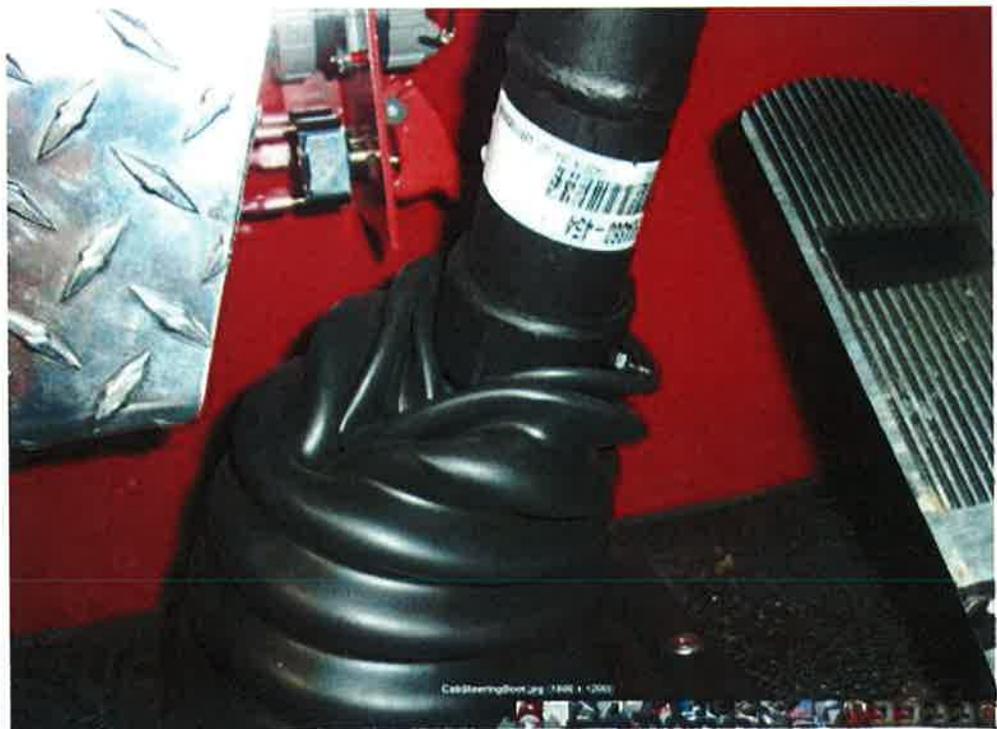
PROBLEM: KME has been notified of isolated instances in which the grease fitting in the steering column shaft gets caught in the rubber steering column cover. We believe that the problem starts when the steering column shaft boot is stepped on over time, and then is compressed below the grease fitting (picture attached for reference). If this occurs the grease fitting can catch and tear the cover or result in a change in handling characteristics of the vehicle which may result in an accident.

CORRECTIVE ACTION: SEE WORK INSTRUCTIONS BELOW.
