IMPORTANT – VEHICLE SAFETY RECALL NOTICE: NHTSA Recall 13V-245

Vehicle Safety Recall - Technical Service Bulletin

Attention: McNeilus Product Owner
Subject: Bridgemaster® V Fender Mount Assembly Replacement
Models Affected: Bridgemaster® V
Date: June 2013

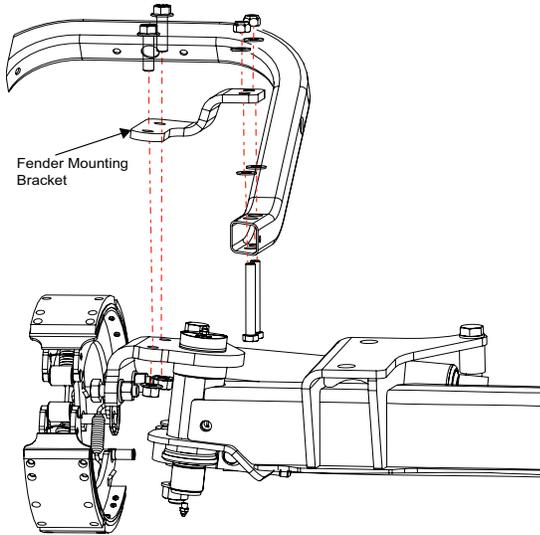
Existing Fender Mount Bracket

The existing Fender Mount Bracket is "Z" shaped.

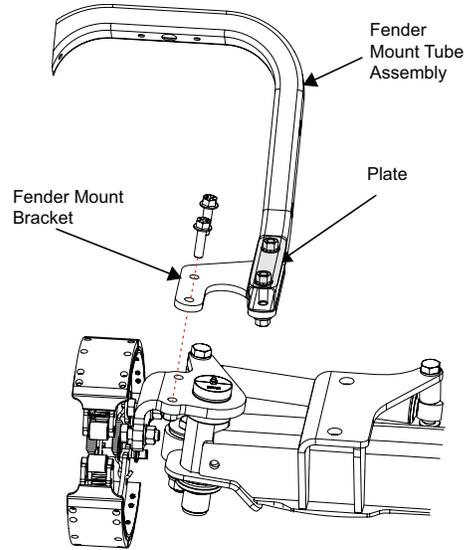
New Fender Mount Bracket

The new Fender Mount Bracket is flat, "L" shaped. The new assembly includes a plate topping the fender mount tube.

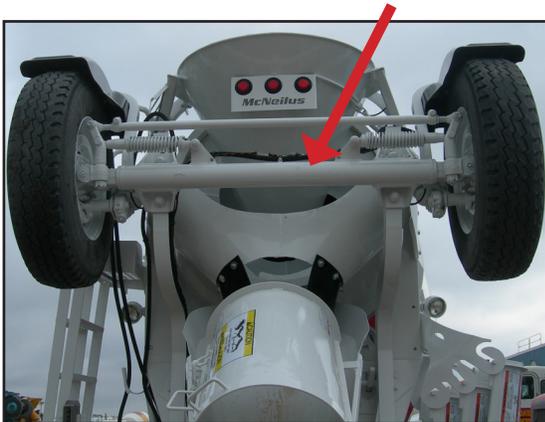
Figure 2: If the axle is a Round Cross Tube, the inspection is completed and the truck can be put back into service.

3. Inspect the axle cross tube. If the axle cross tube is a round cross tube, the inspection is completed and no further action is required (see Figure 2).
4. If the axle cross tube is a square cross tube, follow the remaining instructions in this bulletin (see Figure 3).

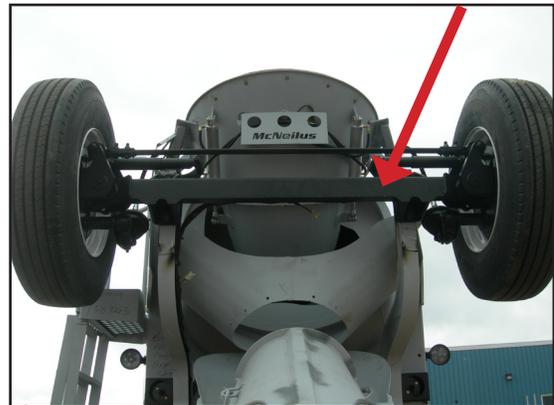
Figure 3: If the axle is a Square Cross Tube, follow the remaining instructions.

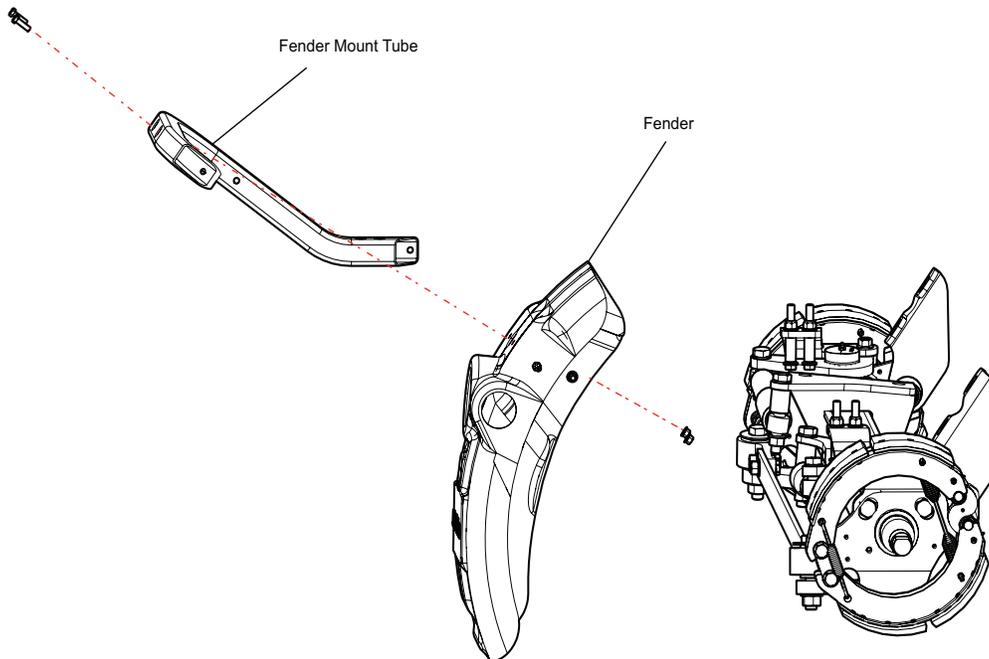
Figure 4: Remove existing fender mount tube and fender.

3. Remove the fender, fender mount tube and its bolts, nuts, and washers, and the light (if necessary). Retain the light and fender for reinstallation (see Figure 4). Discard the fender mount tube and hardware.

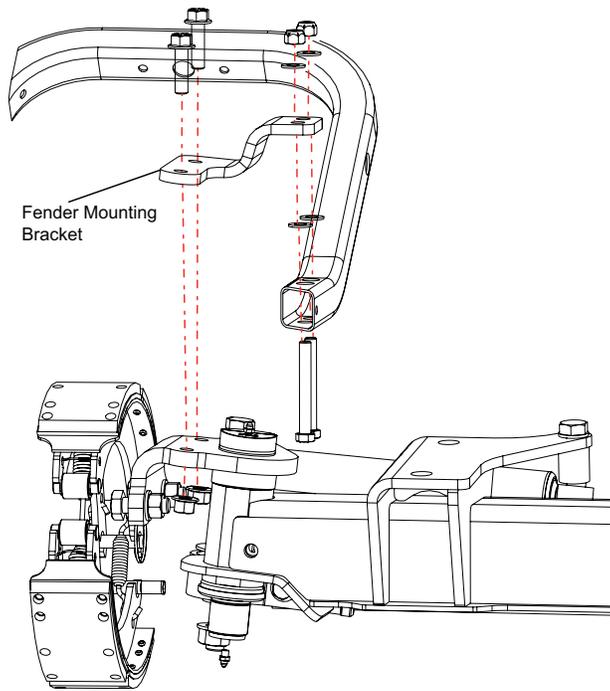
Figure 5: Remove existing mounting bracket.

4. Remove the fender mounting bracket and discard (see Figure 5).
5. Repeat steps 1-4 on the other side of the axle.

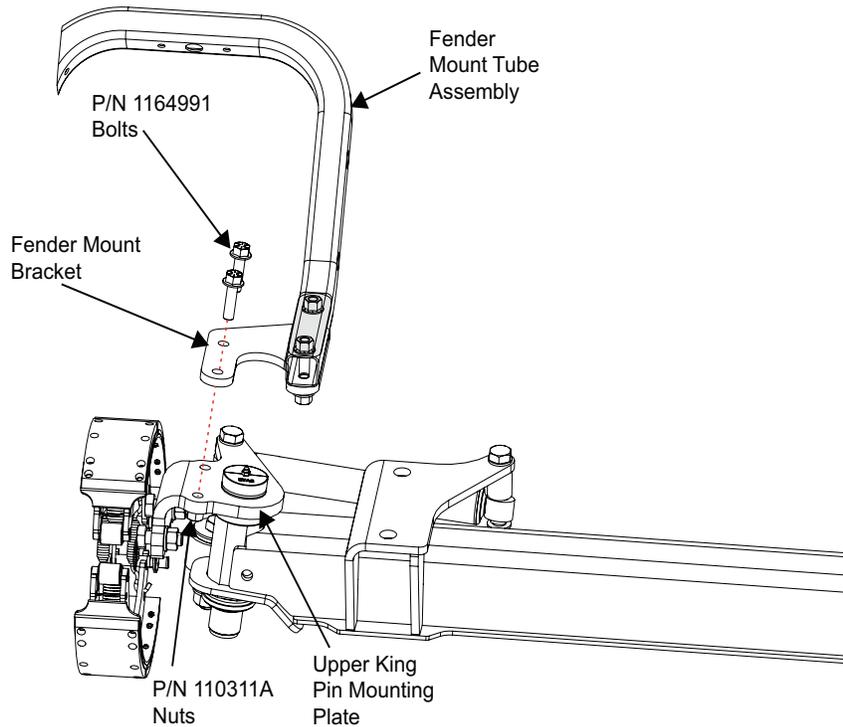
Figure 6: Align the fender mount tube assembly/fender mount bracket to the upper king pin mounting plate.

6. Bolt the Bridgemaster Fender Mount Assembly to the Upper King Pin mounting plate using P/N 1243784 bolts. **See Figure 6.**

Apply a few drops of Red Loctite to the threads of nut. Torque the mounting bolts to 250 ft-lbs; torque from the head of the bolt using a 15/16" socket and the nut using a 15/16" torque wrench.

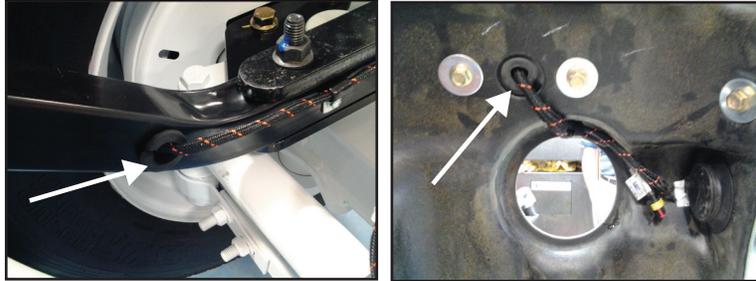
Figure 7: Use rubber grommets where the wire harness enters and exits the fender mount tube.

7. Route the wire harness using any existing hardware and the provided clamps and other new hardware as needed to secure the harness (see Figures 7 and 8 for more information).
 - a. Use a rubber grommet where the wire harness enters and exits the fender mount tube (see Figure 7).

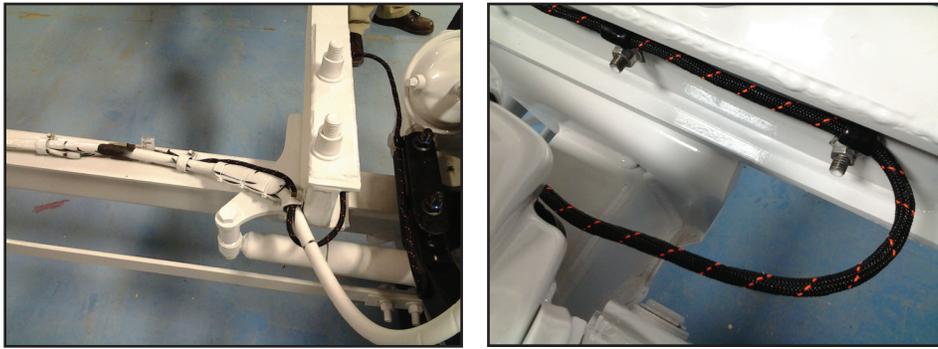
Figure 8: Route harness as shown and use provided hardware.

- b. Route the harness as shown in Figure 8, using the provided hardware.

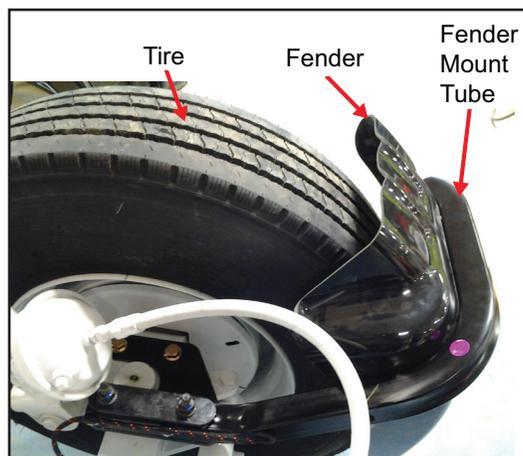
Figure 9: Fender location.

NOTE: The fender is placed between the tire and the fender mount tube (see Figure 9).

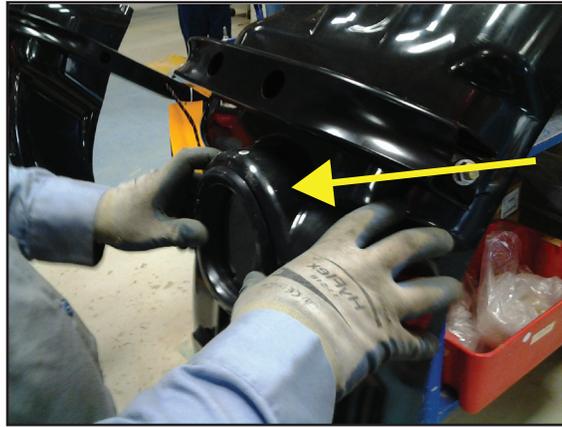
Figure 10: Grommet should be placed with “top” toward the top of the fender. The light is installed with the plug in the upward position.

NOTE: The large grommet for the light is stamped “top” which needs to be positioned at the top of the fender. The light is installed with the plug in the upward position (see Figure 10).
