## PRODUCT RECALL TECHNICAL BULLETIN

### 9100 POWER AWNING, WEATHERPRO AWNING AND MOTOR SERVICE KITS

April 24, 2013

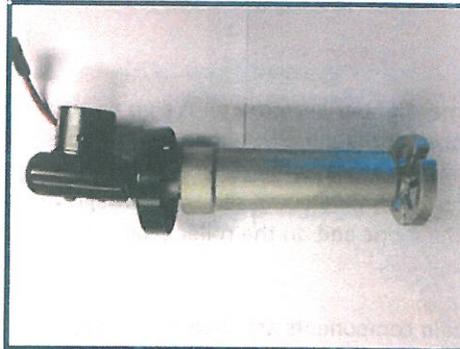
Awning Motor –  
Pre February 13, 2013. This motor  
is **not** affected by the product  
recall.

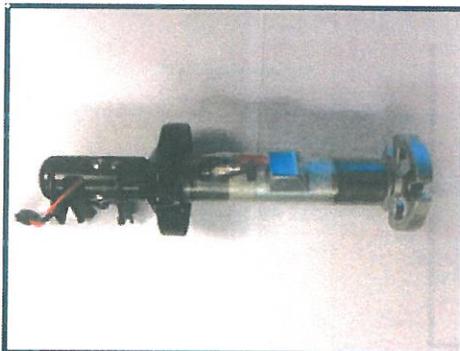
**Condition** Through on-going testing, we have become aware that in some cases this step is being bypassed during installation. In bypassing this installation step, whether **at your location or at the OEM level**, the 9100 Power Awning, WeatherPro Awning, or Motor Service Kit installation can damage the awning motor. **If this motor damage occurs it is possible that the awning can unfurl unexpectedly, either while the coach is at rest or while in transit.**

**Awning Motor –  
This motor is affected by the  
product recall.**  
Serial Range 306xxxxx to 314xxxxx  
Manufacturing Date Range  
02/13/2013 to 04/09/2013

**Action** Due to this potential condition, which will not be evident from post-installation inspection, Dometic is requesting that you do not offer any units with an installed 9100 Power Awning, WeatherPro Awning, or Motor Service Kit manufactured within this date range described above. We need you to confirm the serial number of any units that you may have purchased directly from Dometic (which are included on attached document) or any units that may have been purchased from an OEM or OEM distributor (units repaired at the OEM will have a blue or green dot on the right hand motor end-cap). We have provided the attached visual depiction of the affected motors for your convenience. **We are providing a letter (attached) for YOU to send to your customer** requesting that they should **NOT DRIVE their vehicle** until they have called the number provided in that customer letter. We will be making contact with each dealer to support the replacement and quarantine of these units. If you have confirmed a serial number, as outlined, then please call **1-888-447-0003**. We will provide detailed instructions during this call.

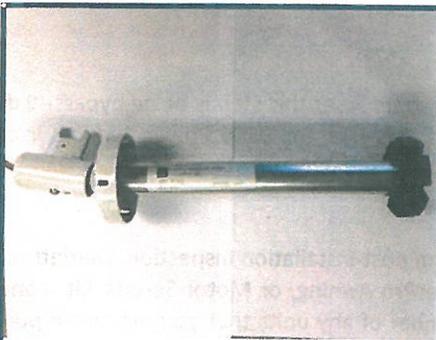
Awning Motor –  
Post April 9, 2013. This motor is  
**not** affected by the product recall.
