Please find below and attached our response to your request for information regarding PE13-008. Enclosed is a CD which contains data detailing our production, complaint and warranty information regarding the subject vehicle. Please note that the production data is sorted by DOB (date of build). All vehicles built after 6/28/2012 were produced with an exhaust extension downturn and a warning sticker in the compartment per Manning bulletin MEBULL0121 (attachment 1).

## **BULLETIN**

Bulletin: MEBULL0121

**Subject: Exhaust Extension and Decal**

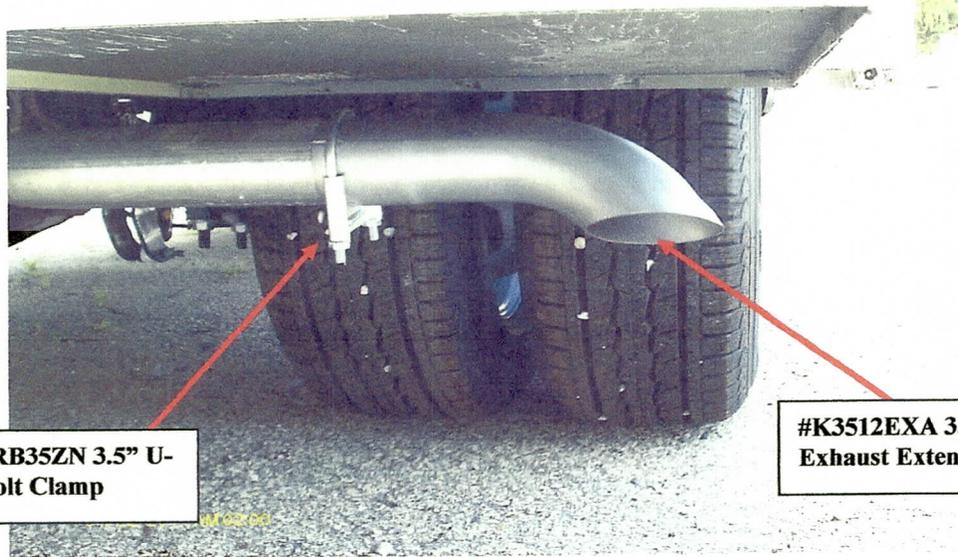
In review of this application we are finding that the exhaust spray on some of these vehicles was discoloring paint and/or primer in the lower floor area of the rear compartment. Also in some cases was damaging the plastic drain plugs in these compartment floors.

**#RB35ZN 3.5" U-Bolt Clamp**

**#K3512EXA 3.5" x 12" Exhaust Extension**

Effective immediately all Ford F350-550 Super Duty Chassis Cab DRW Gas Engines with Service Body Applications will require the installation of exhaust extension #K3512EXA. Attach to end of OEM exhaust tail pipe using #RB35ZN 3.5" U-bolt clamp. The installation of this extension is to extend and redirect the exhaust spray down and away from service body compartment floor. Install Danger Decal #ME32070312SBDL to upper right hand corner inside compartment door above rear exhaust pipe and extension.

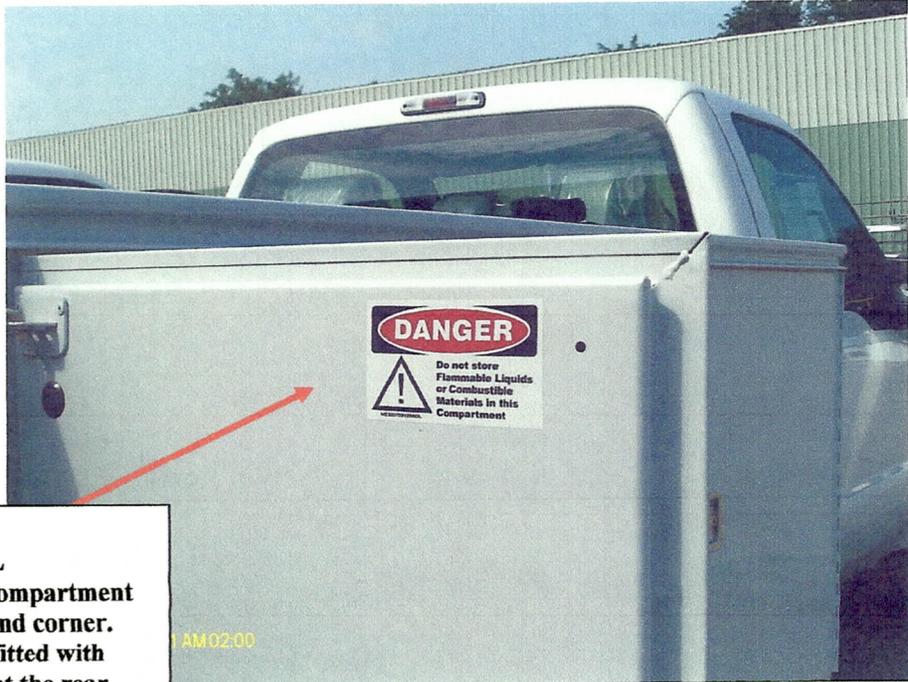
**Danger Decal**  
**#ME32070312SBDL**  
**Install Inside rear compartment door upper right hand corner.**  
**Note: If body is up fitted with two compartments at the rear, decal must be installed in the compartment closest to the truck exhaust pipe.**

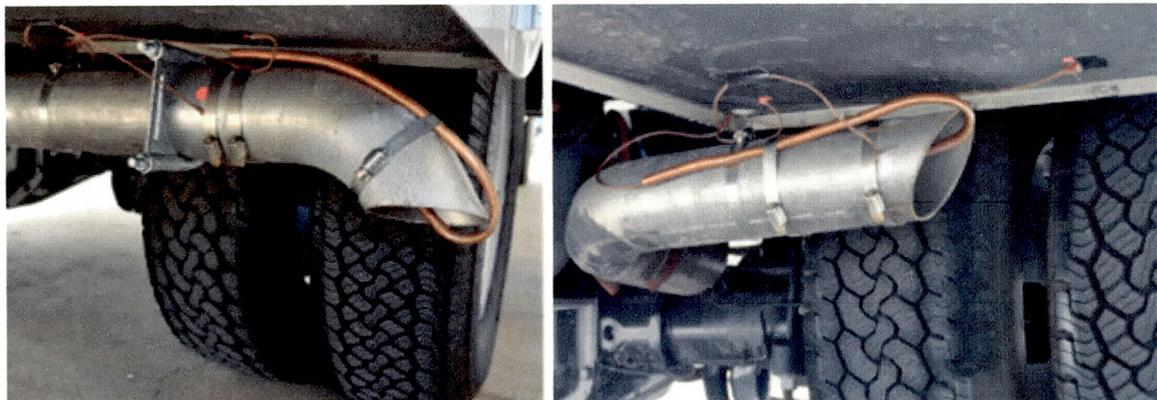
**Figure 4 – Vehicle with aftermarket exhaust tip (left) and OEM exhaust (right).**

A road test was performed for each exhaust configuration (aftermarket tip and OEM tip – Figure 4). Prior to each road test, the vehicle was started and allowed to warm up for approximately five minutes. The road test route (Figure 5) was 12.5 miles in length and included both highway and street driving. After the road test, the vehicle was allowed to idle for approximately ten minutes. Temperature data were collected throughout. Weather conditions for both tests were sunny with an air temperature of 55-65 °F.

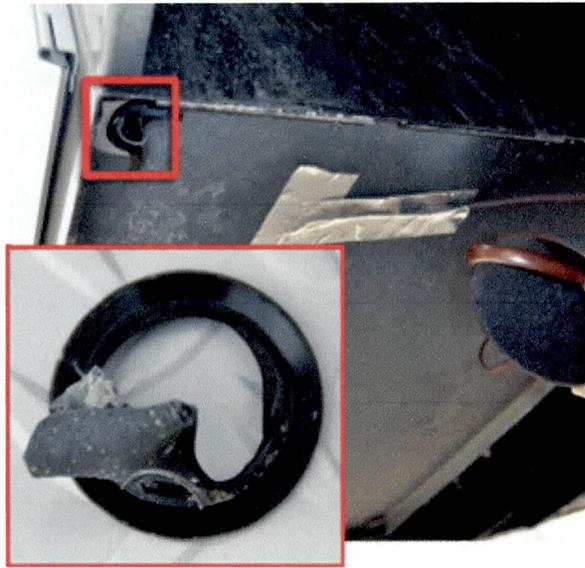
Figure 6 - Rubber plug melted during road test with OEM exhaust configuration (no exhaust tip).

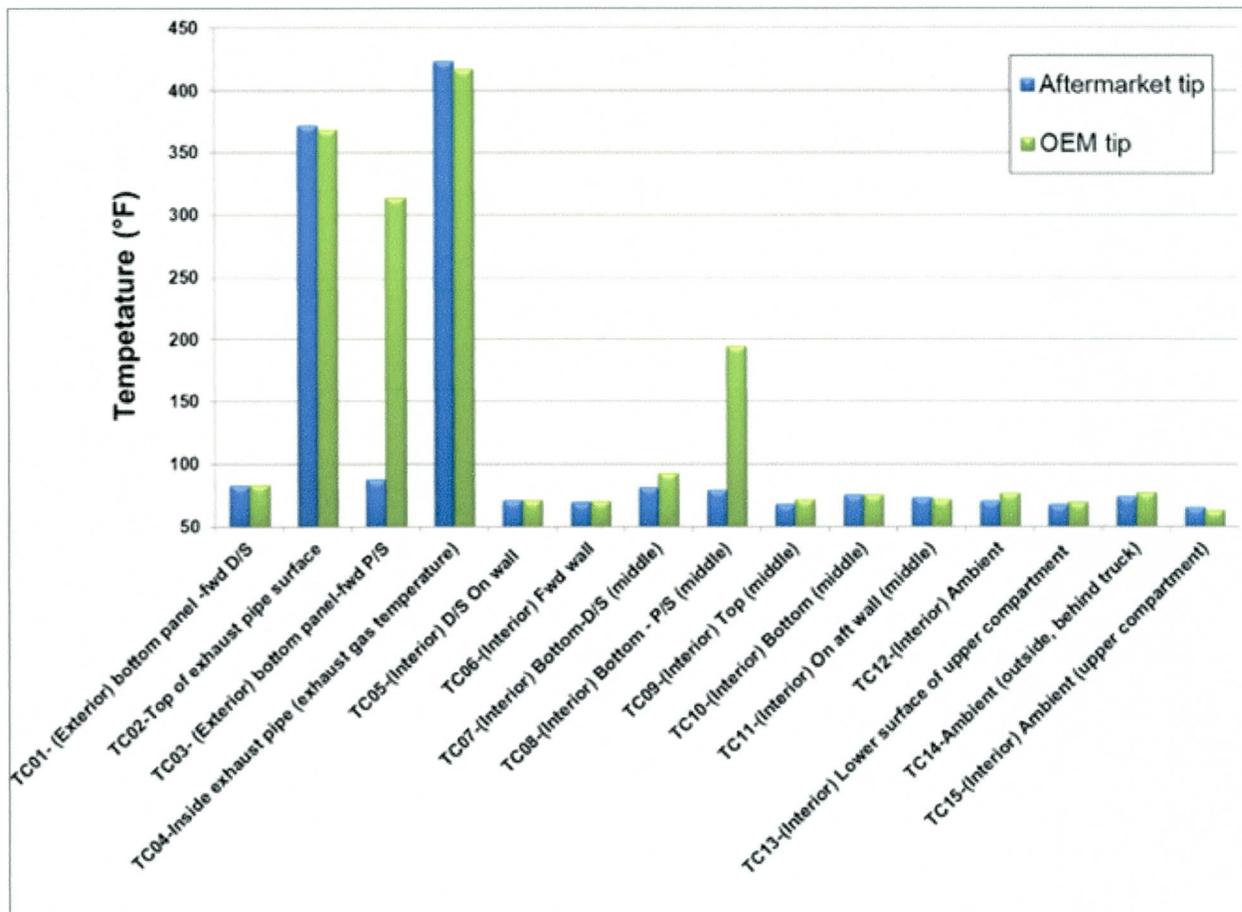
Figure 7 – Maximum temperature achieved during test for each thermocouple (both tests shown).
