Subject: Lakota Trailers Recreational Vehicle Power Awning Recall Notification

POTENTIAL DEFECT NOTIFICATION

PRODUCT RECALL

9100 POWER AWNING, WEATHERPRO AWNING AND MOTOR SERVICE KITS

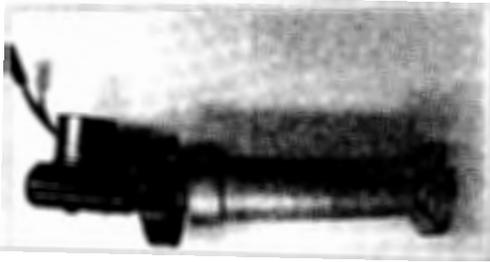
Awning Motor
Pre February 13, 2013. This motor is not affected by the product recall.

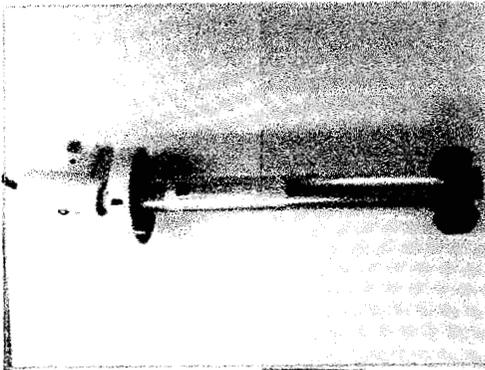
Awning Motor
Post April 9, 2013. This motor is not affected by the product recall.

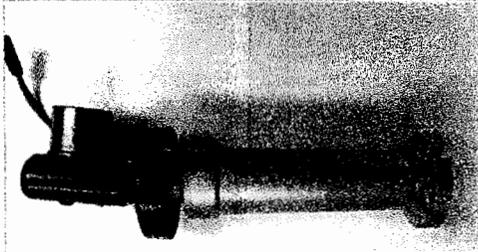
Awning Motor
Pre February 13, 2013. This motor is not affected by the product recall.

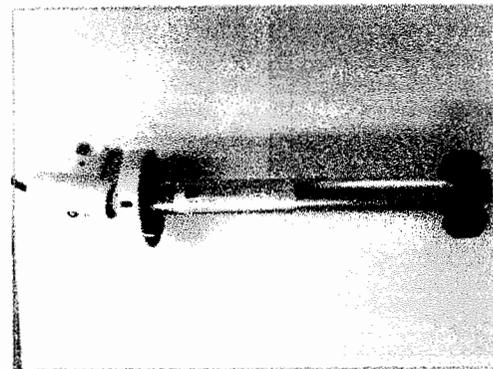
Awning Motor
Post April 9, 2013. This motor is not affected by the product recall.

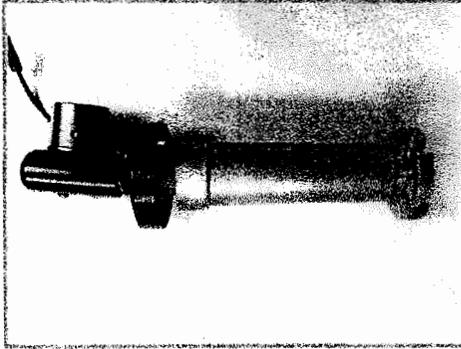
Awning Motor --
Pre February 13, 2013. This motor
is not affected by the product
recall.

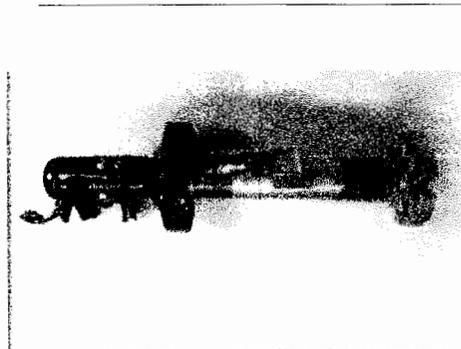
Awning Motor-
This motor is affected by the
product recall.
Serial Range 306xxxx to 314xxxx
Manufacturing Date Range
02/13/2013 to 04/09/2013

Lakota's remedial action is to replace the motor assembly with another model that is not subject to an out-of-sequence installation problems and does not have screws holding the motor assembly together in such a way as to be vulnerable to torque-shearing.
