Recall Bulletin

PRODUCT SAFETY RECALL

SUBJECT: Passenger Airbag Inflator Weld May Fracture Upon Airbag Deployment

MODELS: 2014 Chevrolet Silverado Crew Cab
2014 GMC Sierra Crew Cab

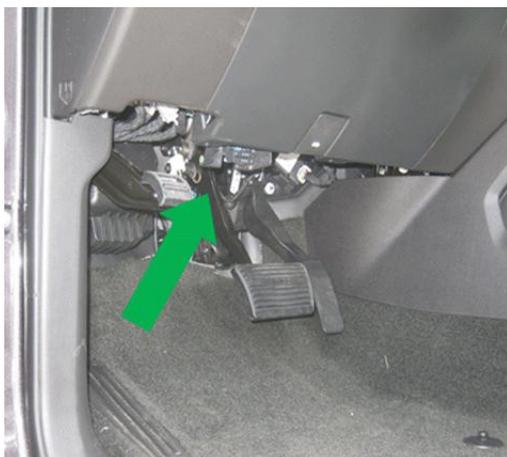
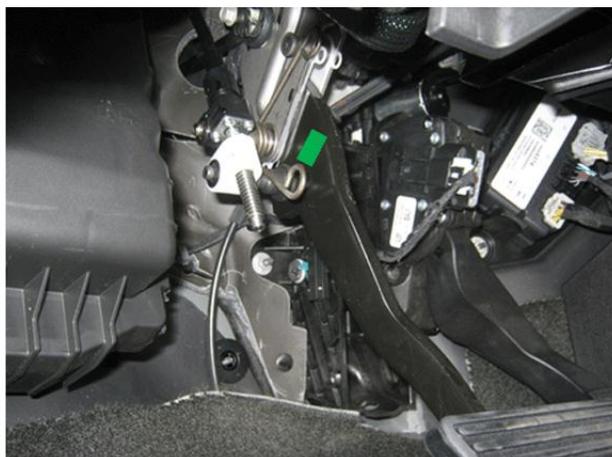
3560199

Determine if the instrument panel airbag has been replaced.

- If there is green paint stripe or green dot on the upper brake pedal arm, do NOT replace the instrument panel airbag. No further action is required.
- If a green paint stripe or green dot on the upper brake pedal arm is NOT present, replace the instrument panel airbag. Refer to the service procedure in this bulletin.

1. Remove the instrument panel airbag. Refer to *Instrument Panel Airbag Replacement* in SI.
2. Install a new instrument panel airbag. Refer to *Instrument Panel Airbag Replacement* in SI.
