Customer Service Notice

Date: April 24, 2013

Units Affected: Units installed at Elizabethtown Final Assembly on Ford F550 chassis with 19,500 lbs GVWR (see attached list)

Battery Cable Routing Change

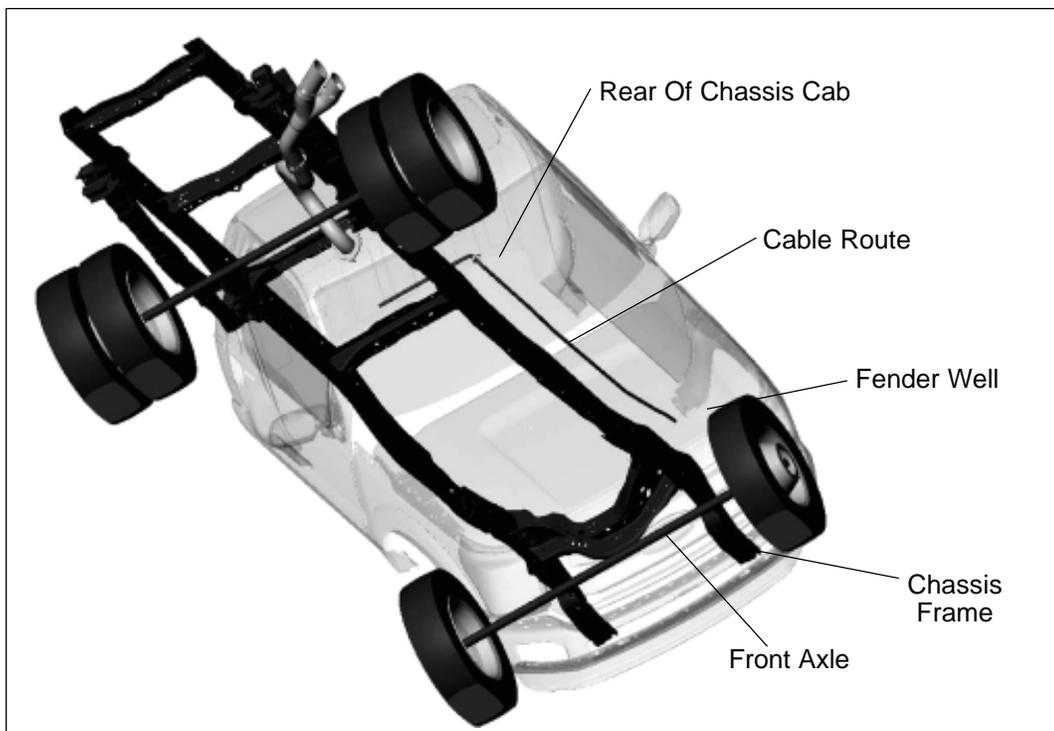
Figure 1 — Cable Routing (View looking under chassis)

A design change in the 2010 model Ford F550 chassis decreased the spacing between the exhaust and the passenger side chassis frame rail. This led to routing of the battery cables for accessory items such as DC pumps, inverters, etc. in a manner in which the cables could be damaged (refer to Figure 1). Cables are now being routed in current production so they no longer pass between the cab and the frame eliminating the potential of being damaged.

Altec requires that all affected units have the battery cables rerouted within 90 days from receiving this CSN or at the next service interval, whichever is earliest. If the cables are found to be damaged or too short to reroute, they must be replaced. Damage may not be visible until part of the inspection is performed.
