Service Bulletin

SAFETY RECALL

2014 CTX700ND ABS MODULATOR REPLACEMENT

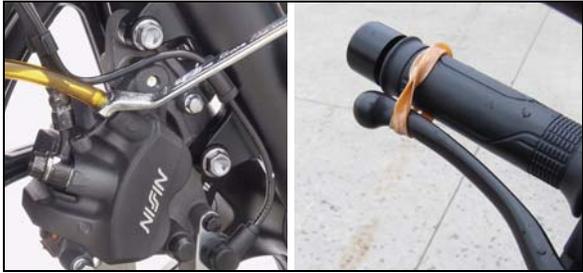
PREVENTING BRAKE FLUID LEAKAGE (Step 10)

1. Connect a bleed hose to the front caliper bleed valve.
2. Loosen the bleed valve and then pull the front brake lever fully against the handlebar. Secure the lever against the handlebar with a band or zip-tie and close the bleed valve.

This will help prevent the brake fluid from leaking out of the reservoir during ABS modulator replacement.

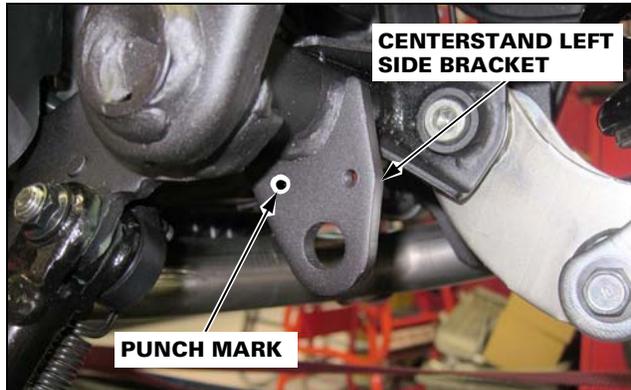
IDENTIFICATION

After you have completed the REPAIR PROCEDURE, make a punch mark on the centerstand left side bracket as shown.

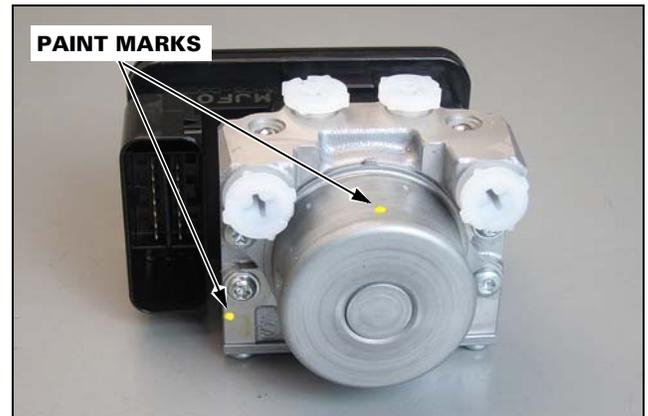
PARTS IDENTIFICATION

Be careful not to mix up the defective and replacement parts. The as packaged countermeasure part is identified by two yellow paint marks as shown. Use care during unpacking and installation as the the paint marks are easily wiped off.
