RE: Submission per 49 CFR 579.5(b)
Recall Campaign #E13-015

Date: 11-Feb-2014

Subject: Update SmartPower™ Receptacle Box and Connector

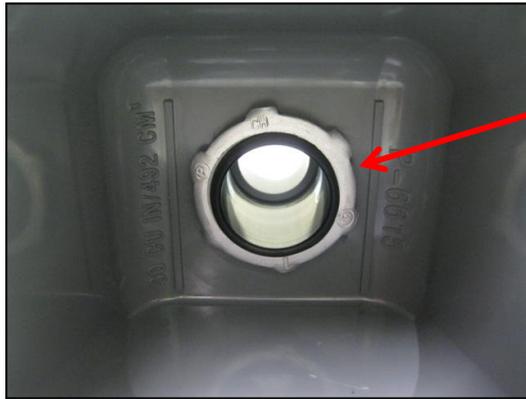
IMPORTANT: Excessive tightening of the connector body may result in the sealing washer being deformed. This will allow the fitting to leak.

13. Install the lock nut on the inside of the electrical box and tighten the connector body securely finger tight. Check to be sure the connector is clean and is seated true and flat on the Receptacle box surface. Torque the connector to 55 pounds•inch (6.2 N•m) If a torque wrench is not available, use a wrench on the connector body to tighten the connector body an additional $\frac{1}{4}$ to $\frac{1}{2}$ turn (90° to 180°).

NOTE: The sharp teeth on the lock nut must face toward the inside surface of the Receptacle box. When tightening the connector body it may be necessary to hold the lock nut to prevent it turning.
