Technical Service Bulletin

GROUP RECALL	NUMBER 13-01-033-1
DATE AUGUST 2013	MODEL(S) Azera (HG)

SUBJECT: AZERA PODS UPDATE (RECALL 111)

Description: This bulletin describes the service procedure to update or replace the PODS (Passive Occupant Detection System).

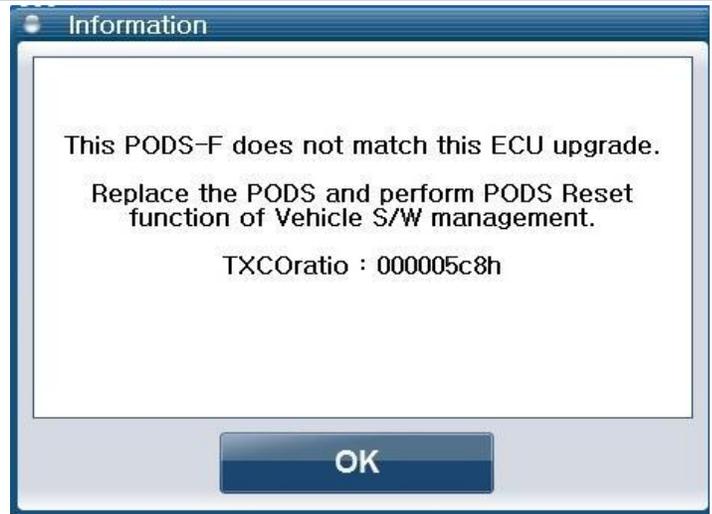
If the PODS Capacitor range is greater than or equal to 1% the message shown to the right will be displayed.

Go to procedure **(24), PODS Replacement Procedure**. Update is not needed.

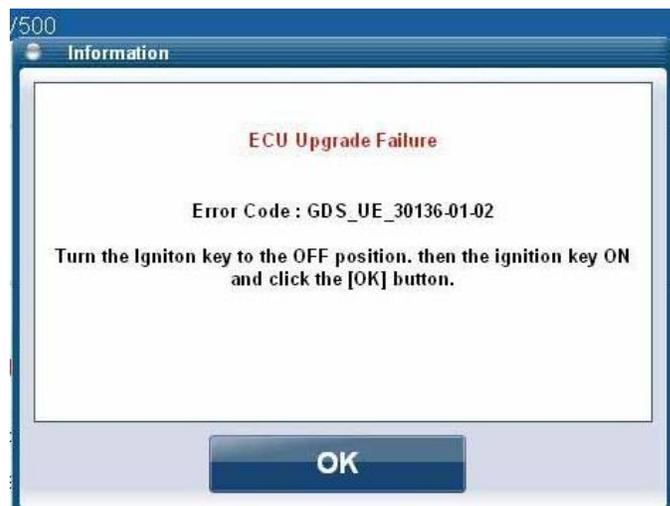
- 22) If the failure message below is shown, turn the ignition to the **OFF** position for 10 seconds then back to the **ON** position and try to do the Auto Mode update procedure (1-7).

This message is sometimes shown although PODS ECU has been successfully updated.

To verify if the update was successful, do procedure (1-7) Auto Mode update; the information message, "**ECU is already updated**" will be shown. No action needed after verification, end procedure.

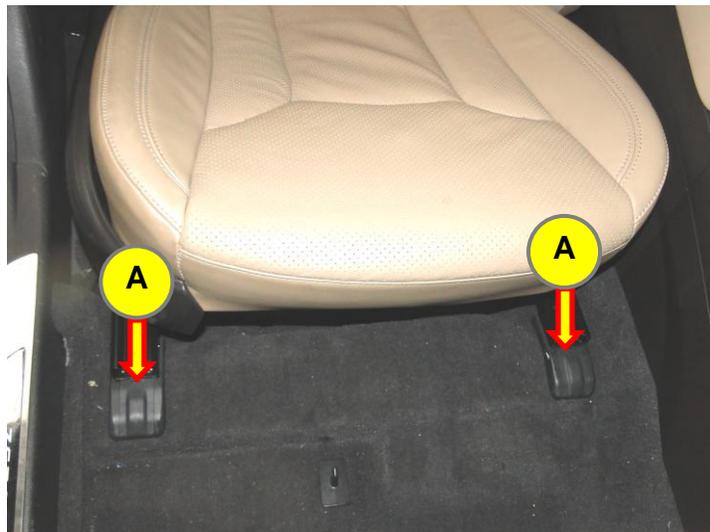
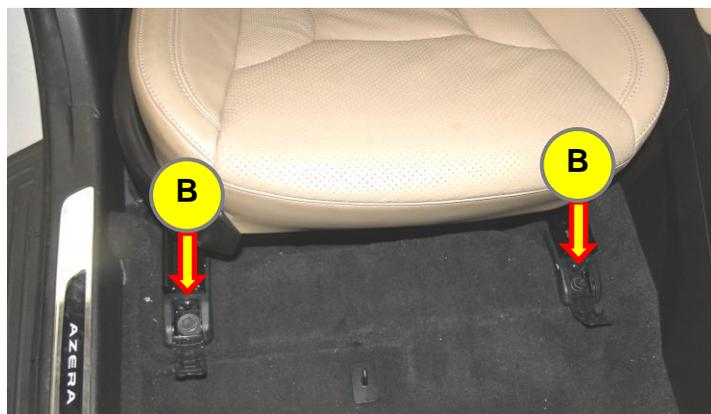
- 24) 1. Move the front passenger seat to the most rearward position.
2. Set the engine start/stop button to the "OFF" position.
3. Open the covers (A), and then remove the front mounting bolts (B) of the front passenger seat.

Tightening torque :**49.0~63.7 N.m (5.0~6.5 kgf.m, 36.2~47.0 lb-ft)**

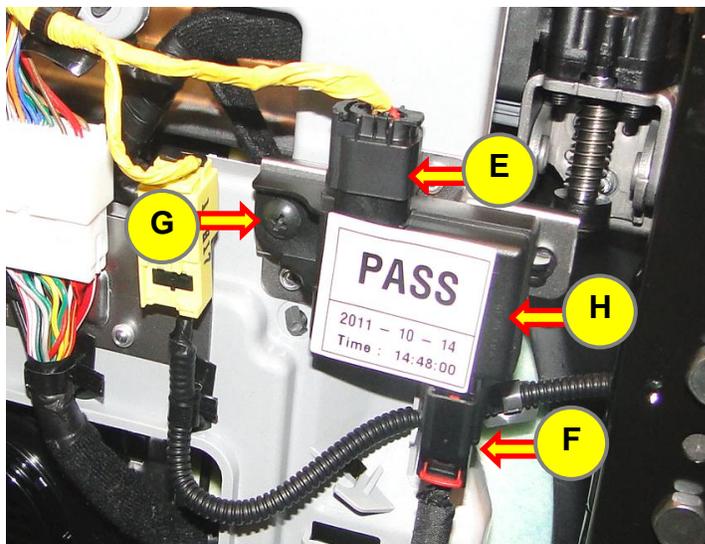
6. Lift the front part of the seat, and then disconnect the PODS connectors (E, F). (Do not remove the seat from the vehicle.)

When lifting the seat, be careful not to damage the wiring harnesses.

When connecting the PODS connectors, ensure the connectors lock.
